Failure Analysis of Two HP-Nb Heat-Resistant Tubes after 46,000 h Exposure to **Reformer Service Conditions**

Harandi, Ali Nazemi; Eslami, Abdoulmajid; Bahrami, Abbas; Bakhtafrouz, Asghar; Yazdan Mehr, Maryam

DOI 10.3390/met13020228

Article Failure Analysis of Two HP-Nb Heat-Resistant Tubes after 46,000 h Exposure to Reformer Service Conditions

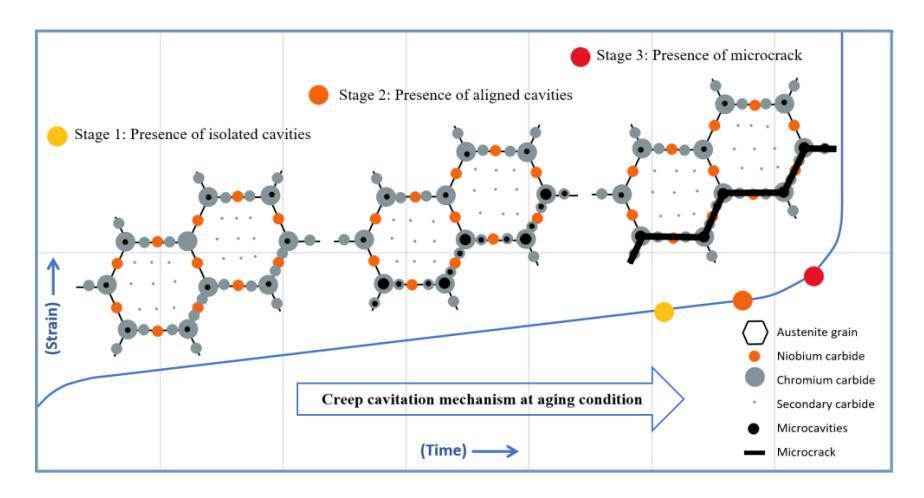
Exposure to high temperatures results in the dissolution of carbide particles present in the structure. This removes the barriers to dislocation movements and decreases creep strength. These conditions lead to the formation of creep pores perpendicular to the direction of the applied stress. Over time, these pores coalesce together and create microcracks. Finally, the growth of microcracks results in the formation of macrocracks and the failure of the specimen. The failure scenario is schematically shown in Figure 11 and summarized in the following steps: including initiation of isolated cavities, aligned cavities, and the formation of microcracks next to continuous carbide particles.

Figure 11. The initiation and growth mechanism for creep pores adjacent to interdendritic carbide particles during service transposed on a general creep graph.
