## Failure Analysis of Two HP-Nb Heat-Resistant Tubes after 46,000 h Exposure to Reformer Service Conditions

# Failure Analysis of Two HP-Nb Heat-Resistant Tubes after 46,000 h Exposure to Reformer Service Conditions

**Abstract:** This study presents a failure analysis in two reformer tubes used for hydrogen production in a petrochemical industry. These tubes (Tube A and Tube B) were made by the centrifugal casting of HP-Nb alloy in such a way that one contained titanium as a micro-element, and the other was free from titanium in its chemical composition. Although the two tubes were subjected to similar creep conditions, Tube A failed after only 46,000 h of operation against the design life of 100,000 h. SEM images showed initiation and growth of creep pores next to chromium carbide particles, as well as the formation of microcracks in Cr<sub>23</sub>C<sub>6</sub> carbides. Pore initiation occurs as a result of grain boundary sliding and is strongly dependent on structural morphology. The tube containing titanium (Tube B) showed higher thermal stability and higher creep resistance than the tube without titanium (Tube A), which was due to the formation of finer and more discrete c

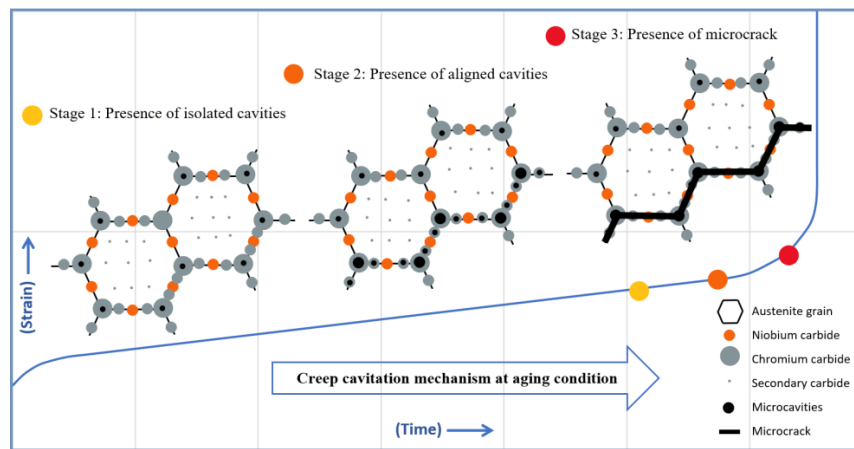
Exposure to high temperatures results in the dissolution of carbide particles present in the structure. This removes the barriers to dislocation movements and decreases creep strength. These conditions lead to the formation of creep pores perpendicular to the direction of the applied stress. Over time, these pores coalesce together and create microcracks. Finally, the growth of microcracks results in the formation of macrocracks and the failure of the specimen. The failure scenario is schematically shown in Figure 11 and summarized in the following steps: including initiation of isolated cavities, aligned cavities, and the formation of microcracks next to continuous carbide particles.

Figure 11. The initiation and growth mechanism for creep pores adjacent to interdendritic carbide particles during service transposed on a general creep graph.
