Performance of flood defences in the Netherlands during the 2021 Summer floods

André Koelewijn¹, Joost Pol² and Malou van Schaijk³

Abstract

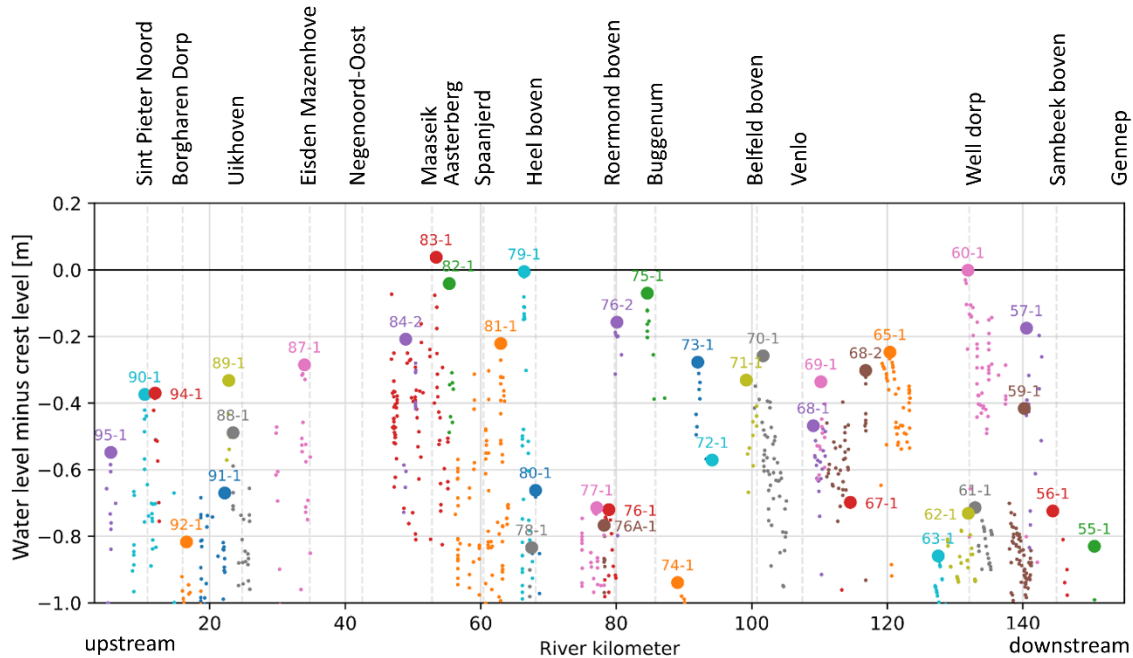
As stated in the introduction, the flood defences were generally high enough for the water levels that occurred. However, at a few locations the water level was very close to the crest level. This can be seen in Figure 2 in which the

crest level and the water level are compared for the dike sections along the Meuse between the Belgian-Dutch border (kilometre 0) and the village of Gennepe (kilometre 155). Each point represents a dike section and the most critical point of each dike ring area is shown with a bigger marker and its code number. It should also be noted that there may be small differences between this figure and the situation in the field during the flood, because of both changes that occurred since the survey for AHN3 (the third version of the nationwide digital elevation model of the Netherlands), and local differences between the hydrological model and reality, resulting from e.g. the model grid size and local backwater effects.

Figure 2: Differences between crest level derived from elevation model AHN3 and modelled water levels for all dike sections along the Meuse between the Belgian-Dutch border and Gennepe (figure courtesy of Jurjen de Jong, Deltares).

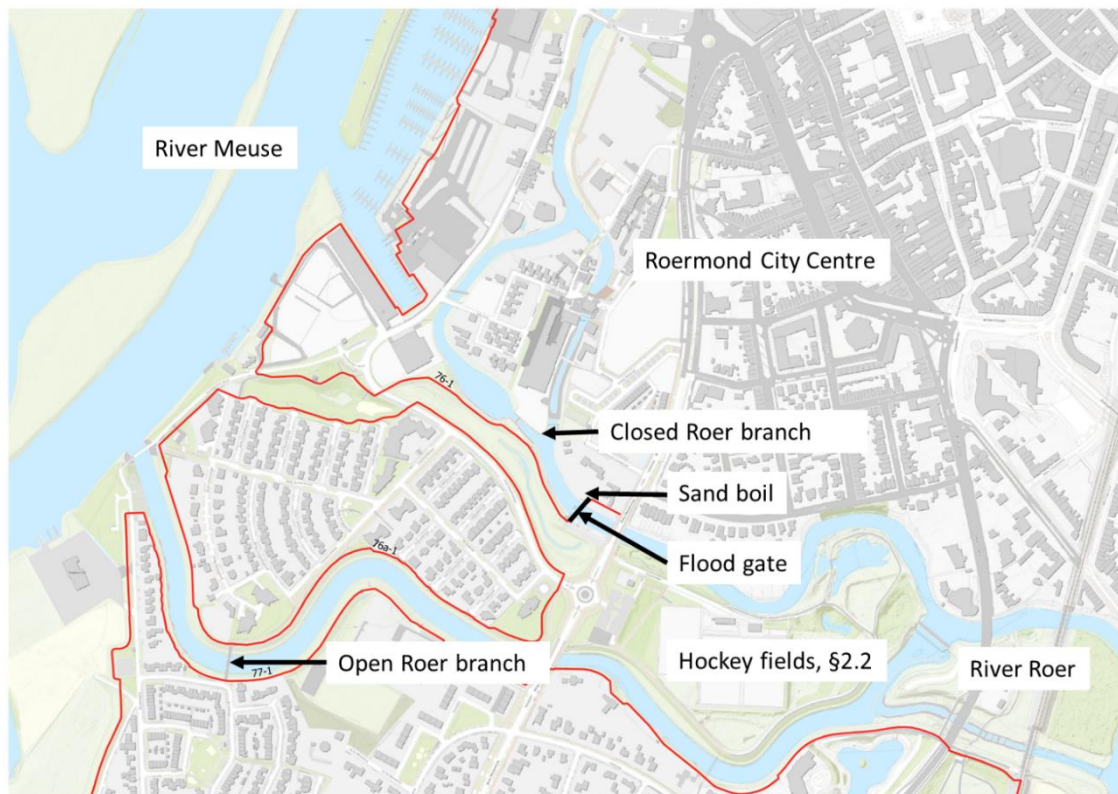
Another incident with internal erosion occurred at a floodgate in the city of Roermond (Figure 8). This floodgate in the Roer river, which is a tributary of the Meuse river, was closed in order to protect the city centre from flooding. At this location, excessive seepage and erosion in the corner of the L-shaped wall on the downstream side was reported on Saturday 17 July at 03:15 AM. The sand boil was bringing up coarse sand and gravel. Half an hour later, the first ring of sandbags was put down (see Figure 9ab) which was eventually built 3 to 4 layers high (Figure 9c). This stopped the erosion process. In the afternoon, again outflow of water and sand was reported, and the ring of sandbags was heightened to a height of 60 to 80 cm which turned out to be sufficient to stop the erosion for the maximum water level drop of more than 1.6 m that was present over the structure. To be sure to stop further erosion, the area near the corner was completely filled with sandbags [Figure 9c].

After the floods, a poor connection was found between the sheet pile and concrete cover on the high-water side (Figure 9d). This opening may have enabled the water to flow through the opening, and down behind the sheet pile, resulting in the formation of the sand boil.

Figure 8: Overview of the area around the Roer flood gate in Roermond.

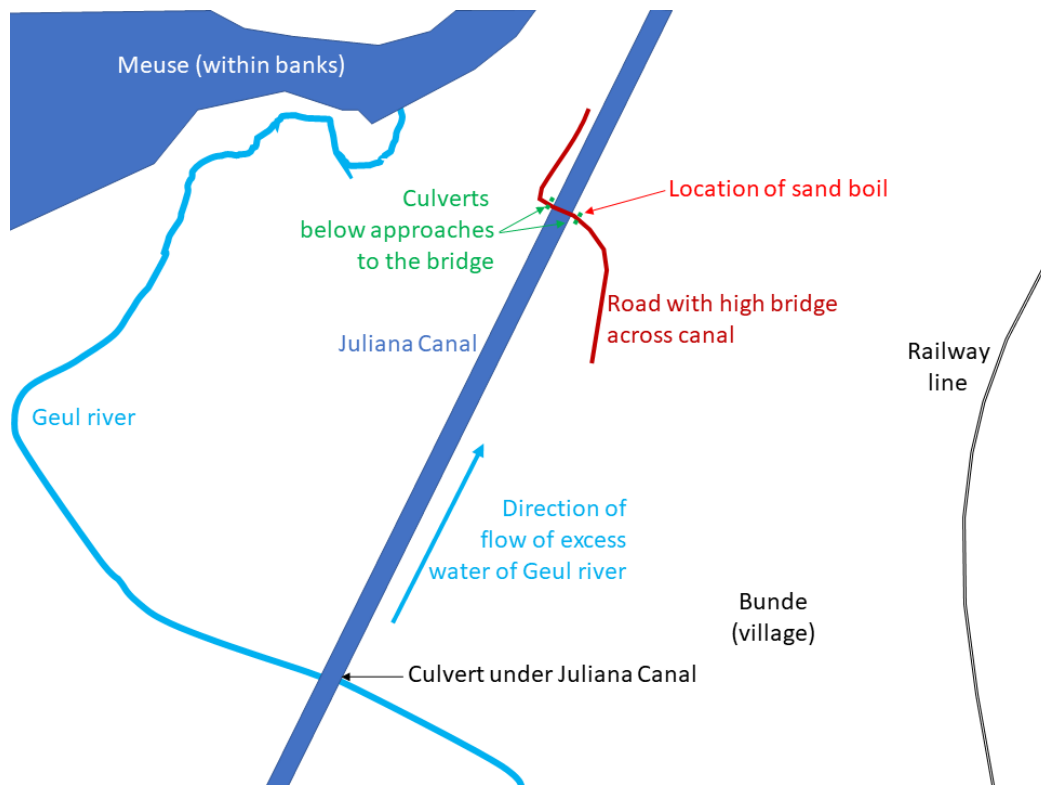
On the afternoon of Friday 16 July, various media reported that a dike had breached near the village of Meerssen or Bunde (1Limburg, 2021b) - (RTL News, 2021) - (De Telegraaf, 2021). On closer inspection, it was found to be a substantial sediment-carrying flow of water which also washed out gravel, just to the north of the approach road leading to the bridge over the Juliana Canal near Bunde, see Figure 14 and Figure 15. As a matter of urgency, this water flow – that was mistaken for a large sand boil– was handled by installing a coffer dam more than a metre high consisting of around 3000 sandbags which stabilised the situation. It was initially thought that the dike along the Juliana Canal which is elevated here was on the verge of failing due to a leak from the canal or from the Meuse. However, it was water from the Geul that was the problem, see Figure 15. Because not all of it could flow through the culvert under the Juliana Canal, it flowed along the eastern side of the Juliana Canal to the north. At the approach roads leading to the bridges near Bunde and Geulle, water then flowed around the road and through the originally constructed culverts. However, near Bunde the culvert had become covered and was not included in asset databases so that the flow of water from this culvert was initially misinterpreted as coming from the subsoil (“sand boiling”). It was discovered that there was a culvert here a week later when further investigation of this location was carried out. This last example clearly shows how the capacity of emergency services can be absorbed to a significant extent by issues that appear to be irrelevant at hindsight – or with sufficiently

Figure 15: Situation plan around Bunde bridge.
