## Performance of flood defences in the Netherlands during the 2021 summer floods

Koelewijn, André; Pol, Joost; van Schaijk, Malou

Journal of Coastal and Riverine Flood Risk

## Abstract

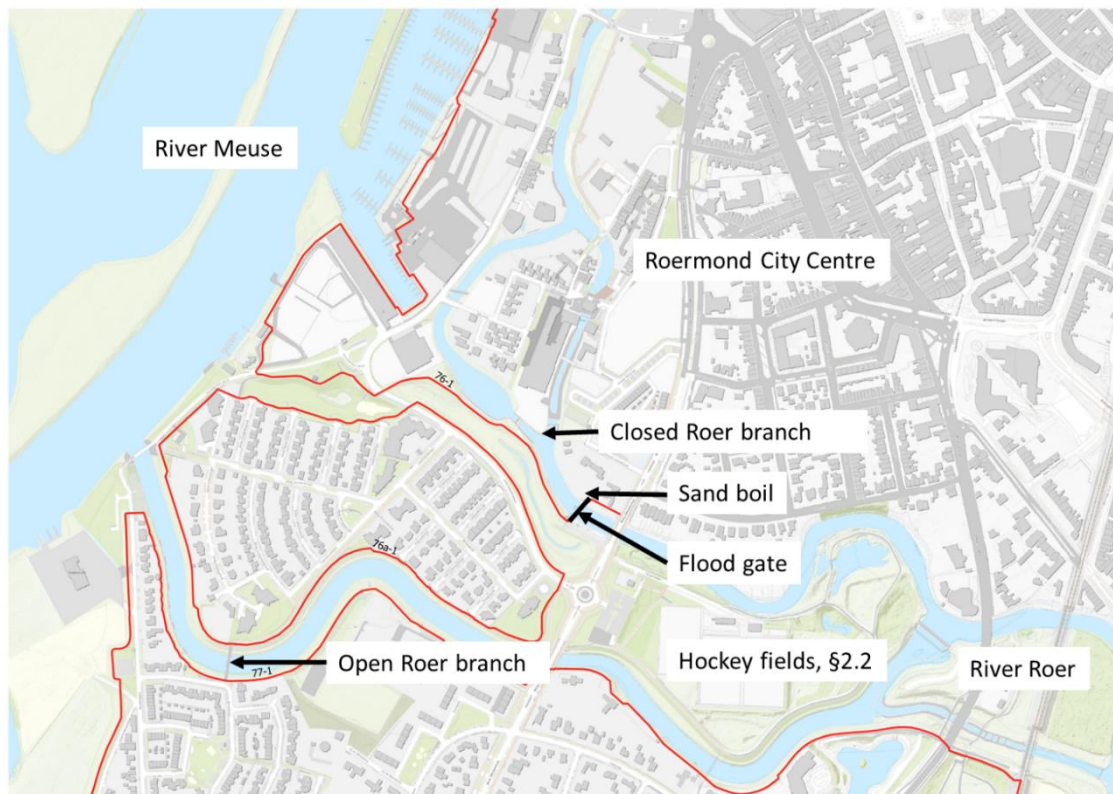
Another incident with internal erosion occurred at a floodgate in the city of Roermond (Figure 8). This floodgate in the Roer river, which is a tributary of the Meuse river, was closed in order to protect the city centre from flooding. At this location, excessive seepage and erosion in the corner of the L-shaped wall on the downstream side was reported on Saturday 17 July at 03:15 AM. The sand boil was bringing up coarse sand and gravel. Half an hour later, the first ring of sandbags was put down (see Figure 9ab) which was eventually built 3 to 4 layers high (Figure 9c). This stopped the erosion process. In the afternoon, again outflow of water and sand was reported, and the ring of sandbags was heightened to a height of 60 to 80 cm which turned out to be sufficient to stop the erosion for the maximum water level drop of more than 1.6 m that was present over the structure. To be sure to stop further erosion, the area near the corner was completely filled with sandbags [Figure 9c].

Figure 8: Overview of the area around the Roer flood gate in Roermond.

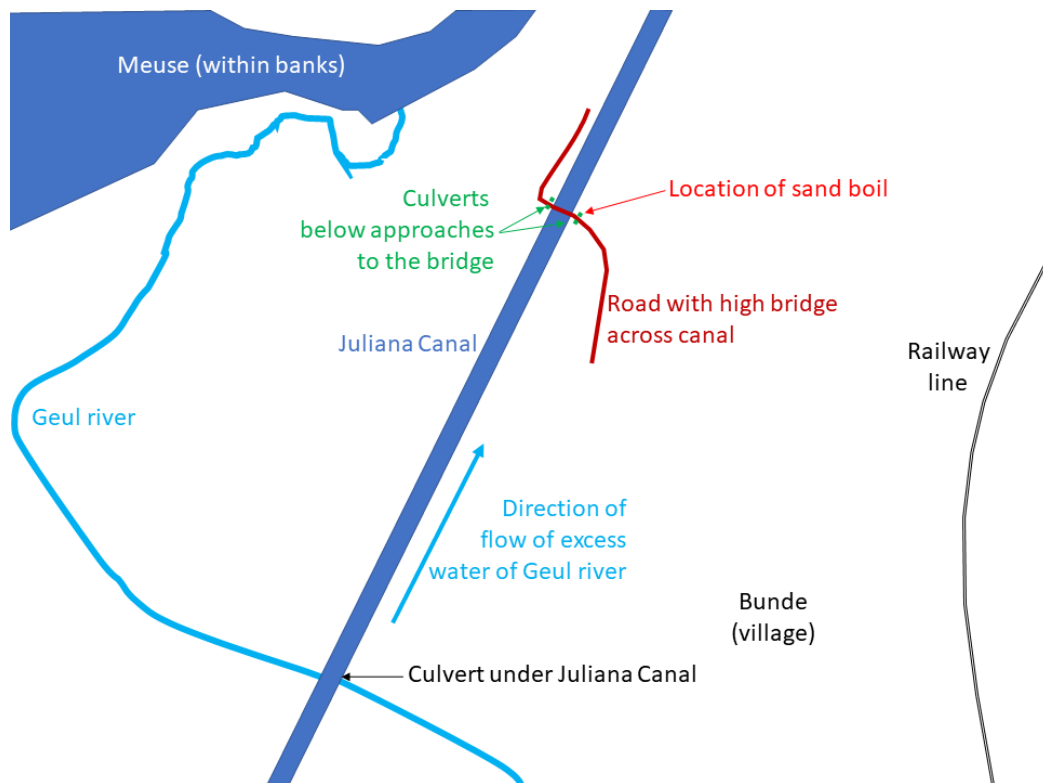
On the afternoon of Friday 16 July, various media reported that a dike had breached near the village of Meerssen or Bunde (1Limburg, 2021b) - (RTL News, 2021) - (De Telegraaf, 2021). On closer inspection, it was found to be a substantial sediment-carrying flow of water which also washed out gravel, just to the north of the approach road leading to the bridge over the Juliana Canal near Bunde, see Figure 14 and Figure 15. As a matter of urgency, this water flow – that was mistaken for a large sand boil– was handled by installing a coffer dam more than a metre high consisting of around 3000 sandbags which stabilised the situation. It was initially thought that the dike along the Juliana Canal which is elevated here was on the verge of failing due to a leak from the canal or from the Meuse. However, it was water from the Geul that was the problem, see Figure 15. Because not all of it could flow through the culvert under the Juliana Canal, it flowed along the eastern side of the Juliana Canal to the north. At the approach roads leading to the bridges near Bunde and Geulle, water then flowed around the road and through the originally constructed culverts. However, near Bunde the culvert had become covered and was not included in asset databases so that the flow of water from this culvert was initially misinterpreted as coming from the subsoil (“sand boiling”). It was discovered that there was a culvert here a week later when further investigation of this location was carried out. This last example clearly shows how the capacity of emergency services can be absorbed to a significant extent by issues that appear to be irrelevant at hindsight – or with sufficiently

Figure 15: Situation plan around Bunde bridge.
