Health Condition Monitoring of Insulated Joints based on Axle Box Acceleration Measurements

Maria Molodova, Maider Oregui, Alfredo Núñez, Zili Li*, and Rolf Dollevoet

Section of Railway Engineering, Faculty of Civil Engineering and Geosciences, Delft University of Technology, Stevinweg 1, 2628 CN Delft, The Netherlands

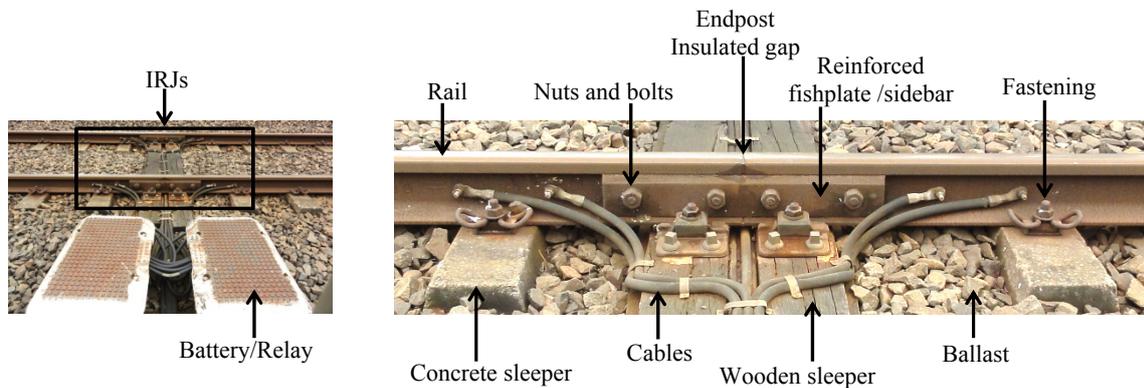
Figure 1: Picture of an IRJ and its main components.

An IRJ constitutes a discontinuity to the track, see Figure 1. The rail ends are connected with two joint bars, placed on both sides of the rail web, and the gap between the rail ends is filled with an isolating component called endpost. The joint bars are attached to the rails by bolts and epoxy adhesive. The IRJs are characterized by high impact dynamic forces at the wheel/rail interface (Wen et al., 2005), caused by the combination of two factors: lower bending stiffness of the joint bars comparing to that of the rail, leading to larger deflection (Jenkins et al., 1974; Kerr and Cox, 1999); and lower values of the Young's modulus of the endpost comparing to the one of the steel (Chen and Kuang, 2002). The impact dynamic forces may have several consequences on the state of an IRJ, such as the resulting high stress concentration producing plastic deformation of the rail surface (Kabo et al., 2006); "cavity-like" damage appearing in the rail head after the gap (Sandstrom et al., 2012); the high maximum shear stress leading to the partial loss of the bond between the joint bars and the rail (Himebaugh et al., 2008), and the contribution to the growth of cracks starting from the holes in the rail (Mayville and Stringfellow, 1995).

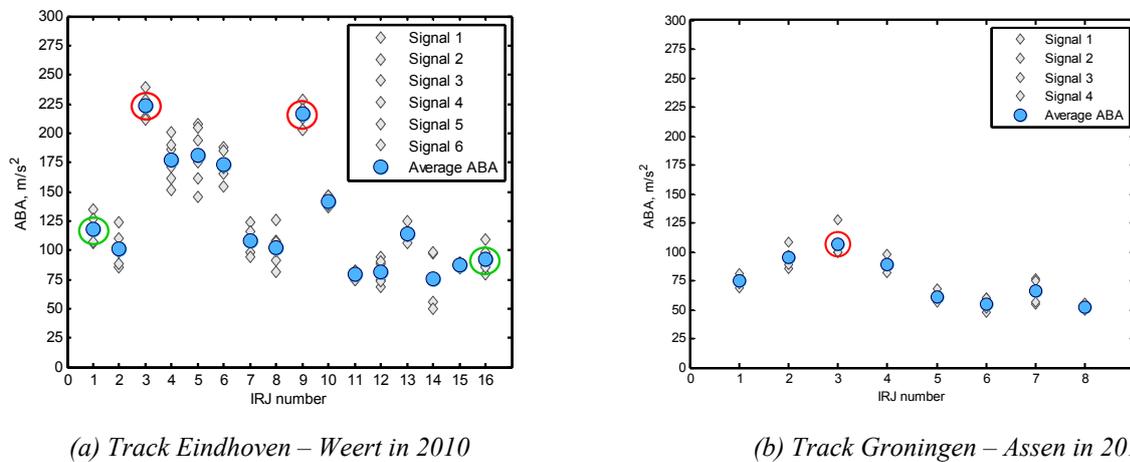
Figure 4: Local maxima of ABA at IRJs. Blue circles indicate average local maxima, grey diamonds denotes the maximum of each ABA measurement.

The IRJs are usually characterized by high values of ABA. In Figure 4, we relate the local maximum ABA to the state of the IRJ from the two tracks. The photos of some of the IRJs of Figure 4 are presented in Figure 5. The ABA signals from repeated measurement runs were low-pass filtered with the cut-off frequency of 2 kHz, to include the frequency range typically excited at short wave track defects (Molodova et al. 2014b). The blue circles in Figure 4 are the average local maximum of six repeated signals on the track Eindhoven – Weert (Figure 4a), and four repeated signals on the track Groningen – Assen (Figure 4b); the range of ABA maximum values was indicated by the grey diamonds.

To study the relationships between the state of IRJs and ABA values we compared two IRJ with high ABA magnitude (IRJs number 3 and number 9 indicated with red circles in Figure 4a) and two IRJs with comparatively low ABA magnitude (IRJs number 1 and number 16 indicated with green circles in Figure 4a). As it appeared from the visual inspection of the IRJs, the two IRJs with high ABA magnitudes (above 200 m/s^2) were indeed in a deteriorated condition: the IRJ number 3 had plastic deformation D_1 on the rail surface caused by the impact at the endpost (Figure 5c) and the IRJ number 9 had a crack in the fastener D_2 (Figure 5g-h). As for the IRJs with comparatively low ABA magnitude (below 150 m/s^2), the IRJ number 1 may be considered as in a good condition (Figure 5a), since only light deformation of the rail surface is visible. While the IRJ number 16 had a significant gap between the two pieces of the rail, as a result of the loss of insulation material D_3 (Figure 5j). Thus, the ABA magnitude at IRJs cannot be an indication of D_3 . Therefore, further investigation of the frequency content of ABA is presented in the next section.

In Figure 4b the ABA on the track Groningen – Assen has less variation in values, than on the track Eindhoven – Weert, with the average local maxima ranging between 50 to 100 m/s². The IRJ with the highest ABA value is number 3, which has moderate degradation of the rail surface D_I (Figure 5l).

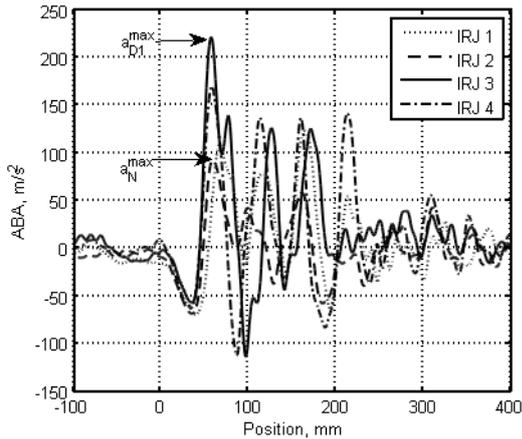
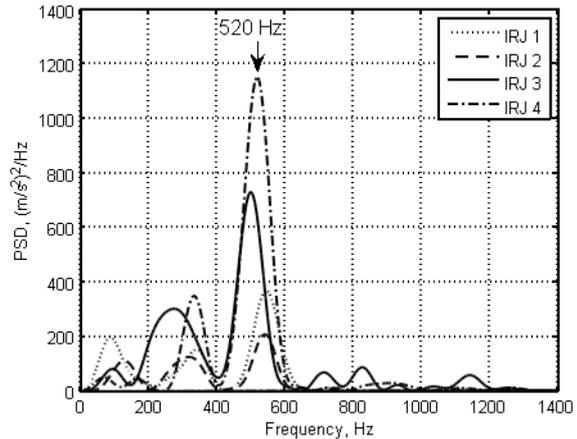
The ABA measured at these four IRJs are shown in Figure 6a. The ABA signals for each IRJ in this section and the next sections are the average signals out of four repetitive ABA signals, filtered with the low-pass Butterworth filter with a cut-off frequency of 2 kHz. The averaging and the filtering were done in order to reduce the noise in the measured signals. The ABA signals at these IRJs had a wavelength of about 50 mm. The local maximum ABA was the highest for IRJ number 3 ($a_{D_I}^{max} = 220 \text{ m/s}^2$) and about 2.4 times higher than ABA at the IRJ number 2 in normal condition ($a_N^{max} = 91 \text{ m/s}^2$). The plastic deformation at IRJ number 3 has the longest wavelength among these four IRJ's, 50 mm (Figure 5c).

The PSD at these IRJs is shown in Figure 6b. The major peaks for the IRJs fall into the following frequency ranges: 70 – 170 Hz, 270 – 350 Hz and 500 – 550 Hz. The largest peak is at 520 Hz for IRJ number 4 with severe rail surface plastic deformation. The peak that appears in each ABA signal in the frequency range between 500 Hz and 550 Hz might be related to the plastic deformation of the rail surface. As the train speed was 100 km/h the vibrations in the range of 500 – 550 Hz are related to the wavelength of the wave pattern of 50 – 55 mm of the rail surface. When the wave pattern on the rail surface starts to develop, the vibrations in the range of 500 – 550 Hz work as a positive feedback mechanism. That is, the wave pattern of 50 – 55 mm increases the vibrations at 500 – 550 Hz, and higher level of vibrations at this frequency causes further plastic deformation with a wavelength of 50 – 55 mm.

IRJ number 3 has the longest wavelength of plastic deformation (50 mm) and the highest local maximum ABA compared to the other three IRJs in Figure 6a. However, the PSD at 500-550 Hz for IRJ number 3 was not the highest among these IRJs, because the energy was distributed over a range of frequencies (270 Hz, 730 Hz, 830 Hz, 1150 Hz, see Figure 6b). This can indicate that there is damage in other components of IRJ number 3 besides plastic deformation of the rail surface (sleeper, fastener, etc.) Thus, there is no direct correlation between degree of plastic deformation of the rail surface and PSD at 500-550 Hz. However, the combination of high ABA magnitudes and high values of PSD at 500-550 Hz can

(a) ABA at IRJs with plastic deformation (E-W)

(b) PSD at IRJs with plastic deformation (E-W)

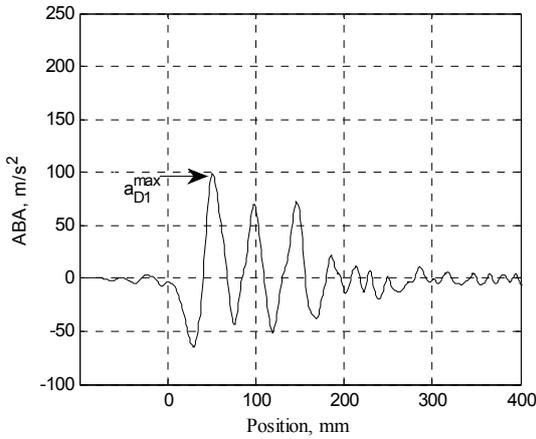
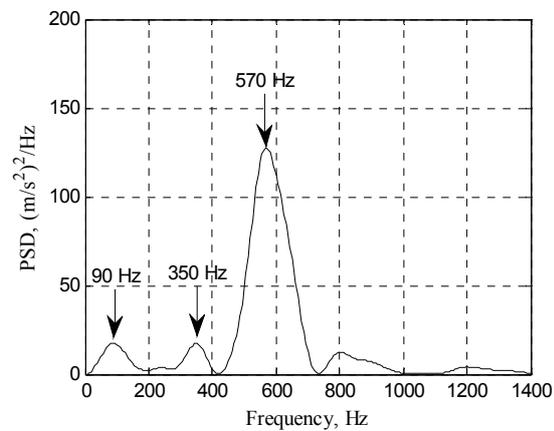
Figure 6c presents the ABA measured at IRJs 3 from the track Groningen – Assen (G-A), see photo in Figure 5l. The ABA signal at this IRJs had a wavelength of about 50 mm. The local maximum ABA was $a_{D1}^{max} = 100 \text{ m/s}^2$, which is quite close to the normal condition ($a_N^{max} = 91 \text{ m/s}^2$). The PSD at these IRJs is shown in Figure 6d. There major peaks for this IRJ are 90 Hz, 350 Hz and 570 Hz, which is consistent with the frequencies in Figure 6b.

(c) ABA at IRJs with plastic deformation (G-A)

(d) PSD at IRJs with plastic deformation (G-A)

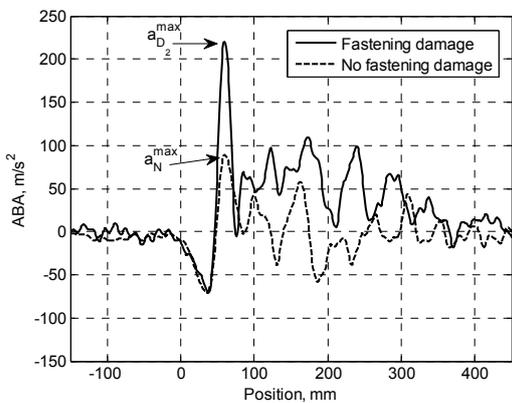
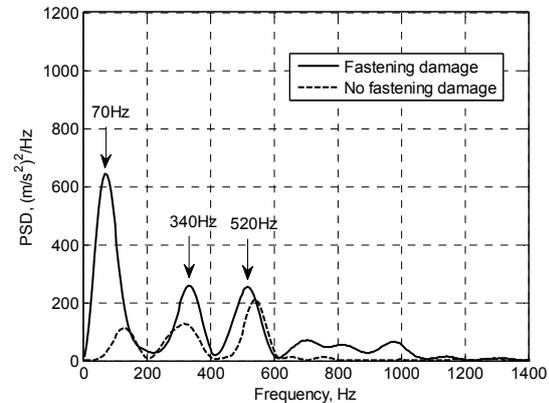
(e) ABA at an IRJ with a crack in the fastener (E-W)

(f) PSD at an IRJ with a crack in the fastener (E-W)

In this section the IRJ with a crack in the fastener was investigated (D_2). That is IRJ number 9 in Figure 5g-h. The dynamic responses at this IRJ were compared to the reference IRJ without visible damage in the fastener (Figure 5b).

The ABA at the IRJ with a crack in the fastener is shown in Figure 6e (solid line) together with the reference IRJ (dashed line). The ABA signal at this IRJ has a high peak of about $a_{D_2}^{max}=220 \text{ m/s}^2$. This peak is also related to high contact force, which caused the deformation of the rail surface, visible in Figure 5g as a broadened shiny wavy running band after the gap. It can also be observed in Figure 6e that the ABA magnitude of the IRJ number 9 is elevated compared to the reference one.

The PSD at the IRJ with a crack in the fastener is presented in Figure 6f. The major peak for an IRJ with a crack in the fastener is at 70 Hz, and the other two peaks at 340 Hz and 520 Hz are similar to the peaks of the reference IRJ. The frequency at 70 Hz is probably related to the change in the stiffness of the fastening caused by the crack. This frequency might be responsible for the higher level of vibration after the gap.

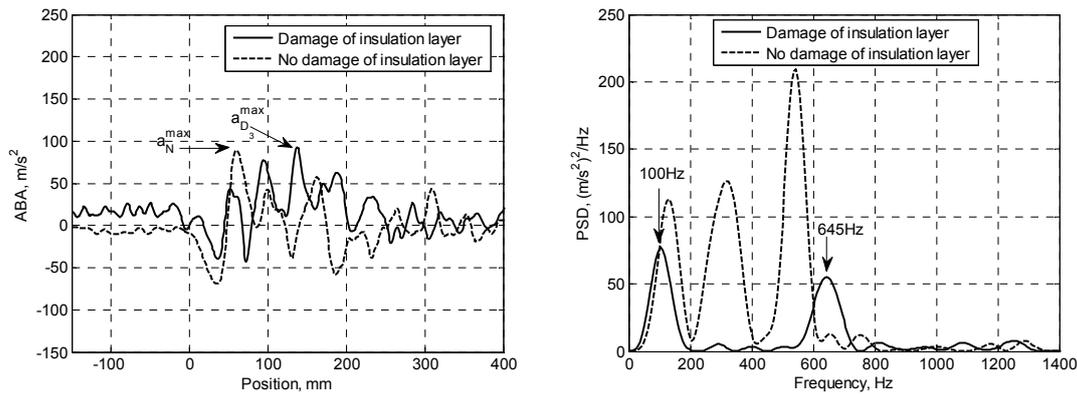
In this section, an IRJ number 16 with two types of damage was investigated: with damaged insulation layer (Figure 5j) and the crack in the fastener (Figure 5k). The damage of the fastener for this IRJ was similar to the one of IRJ number 9 in Figure 5h.

The ABA at this IRJ is shown in Figure 7a with a solid line. The ABA magnitude at this IRJ is comparable to the reference IRJ ($a_{D_3}^{max}=86 \text{ m/s}^2$), but the wavelength is shorter than that of the reference signal. The PSD at the IRJ with the damaged insulation layer is shown in Figure 7b. The major two frequencies for this IRJ are 100 Hz and 645 Hz.

(a) ABA at an IRJ with damaged insulation layer (2010) (b) PSD at an IRJ with damaged insulation layer(2010)

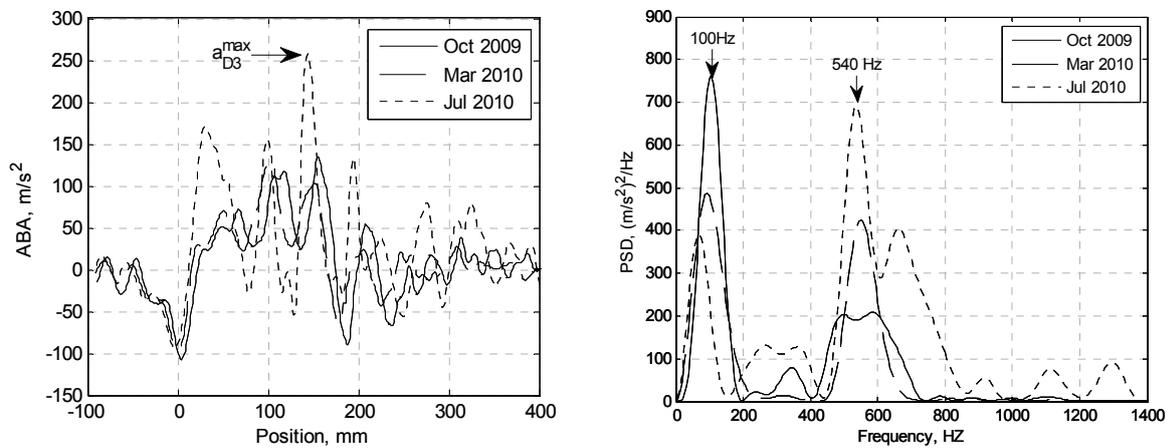
From these data it is impossible to extract the information about the health state of the IRJ due to low ABA magnitude and PSD. Thus, the retrospective analysis of the ABA measurements was performed to obtain more information. Figure 7c presents the ABA signals measured in October 2009 – July 2010. The ABA magnitude at this IRJ in October 2009 was $a_{D_3}^{max}=134 \text{ m/s}^2$, in March 2010 was $a_{D_3}^{max}=129 \text{ m/s}^2$, and in July 2010 was $a_{D_3}^{max}=257 \text{ m/s}^2$.

The major two frequencies in the PSD for this IRJ are 100 Hz and 540 Hz (Figure 7d). The frequency of 100 Hz is close to the frequency of 70 Hz obtained by the analysis of Figure 6f and must be related to the crack in the fastener. As for the damage of the insulation layer, it was difficult to see in these data any specific features related to this phenomenon.

(c) ABA trends at an IRJ with damaged insulation layer (d) PSD trends at an IRJ with damaged insulation layer

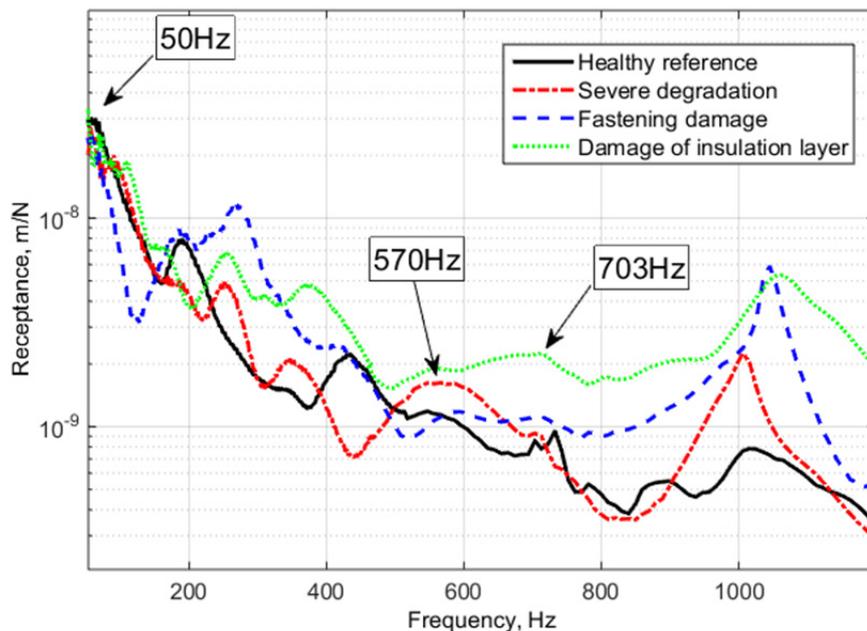
Figure 9: Receptance functions at the investigated IRJs.

Figure 9 presents the calculated receptance functions of the nominal and damaged IRJs studied in Section 4.2. For the IRJ with light surface deformation the following peaks were observed: 190 Hz, 350, 430 Hz, 560 Hz, 730 Hz, 900 Hz and 1006 Hz. Some of them (190 Hz, 350 Hz, and 560 Hz) agree with the results from the ABA analysis. For the IRJ with severe plastic deformation, there are peaks at 80 Hz, 190, 250 and 570 Hz that agree well with the results from the ABA measurements. The other two peaks, at 350 Hz and 1006 were not clearly observed in the ABA measurements. For the IRJ with a crack in the fastener the peaks in the receptance function were at about 50 Hz, 190 Hz, 270 Hz, 420 Hz, 580 Hz and 1045 Hz. The peak at about 50 Hz agrees with the major peak at 70 Hz from the ABA analysis; the peaks at about 270 Hz and about 580 Hz correspond more or less to the peaks observed in the ABA at 340 Hz and 520 Hz. The major peaks observed in the receptance function for the IRJ with a damaged insulation layer were at 107 Hz, 250 Hz, 370 Hz, 703 Hz and 1055 Hz. The

peaks at 107 Hz and 703 Hz agree with those at 100 Hz and 645 Hz observed in the ABA analysis.

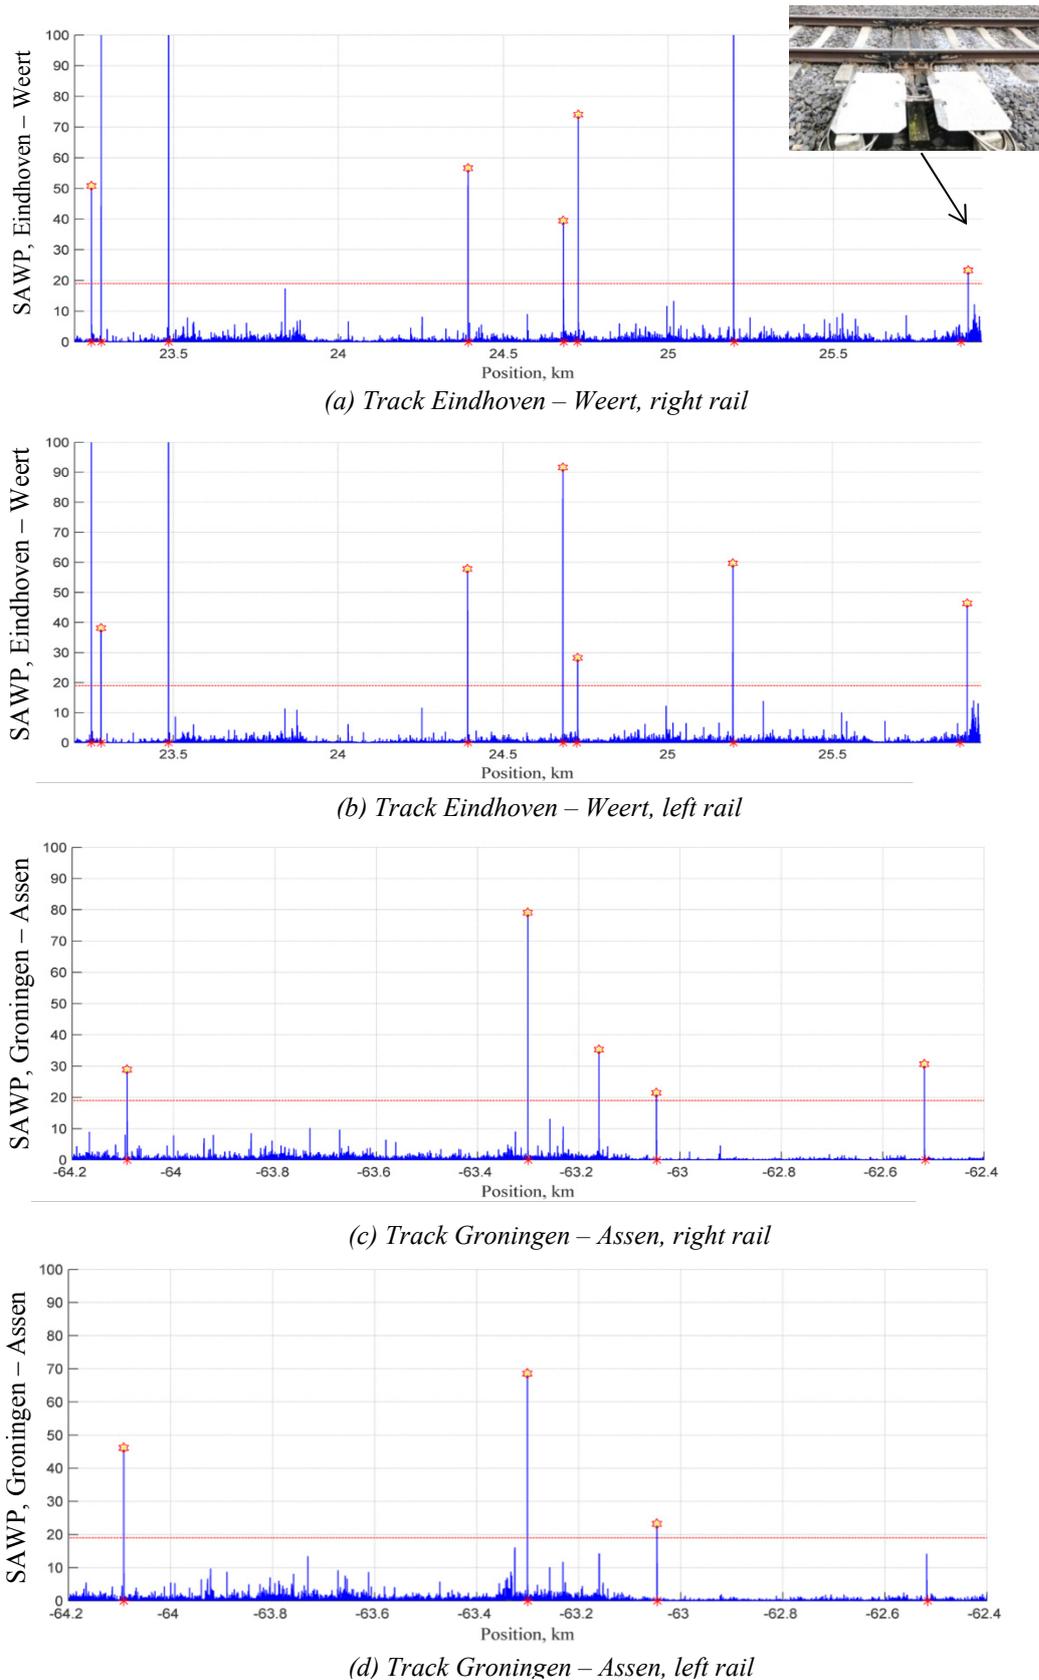
Figure 10: Detection of IRJs.

Figure 10a-b shows the calculated SAWP functions for right and left rails on a section of this track with 8 IRJ's locations, marked with red asterisks. The detection resulted in 77 predicted locations, with 62 of them being correct; 13 locations have been missed and 15 locations were falsely predicted. The hit rate of this detection is 83% and the false alarm rate is 19%.

Figure 10c-d presents the prediction for another track, Groningen – Assen. The length of the investigated track was 2.2 km with 4 IRJ's locations in total. One of the IRJs at position - 62.5km on the left rail was missed by the automatic detection. However, this location was detected from the signal on the other rail, and thus, by combination of the signals from both rails all the IRJs can be detected. In Figure 10c there is also one rail defect at -63.160 km.

which was falsely detected as an IRJ. This is an artificial rail surface defect, which was made for another research (Molodova et al., 2014b) by removing a thin layer of the material on the rail head. Since this artificial defect is an unusual situation on the rail, it can be excluded from our investigation, and we can conclude that the false alarm rate is zero for this track. The combined hit rate of detection from the two tracks is 84% with the false alarm rate 19%.

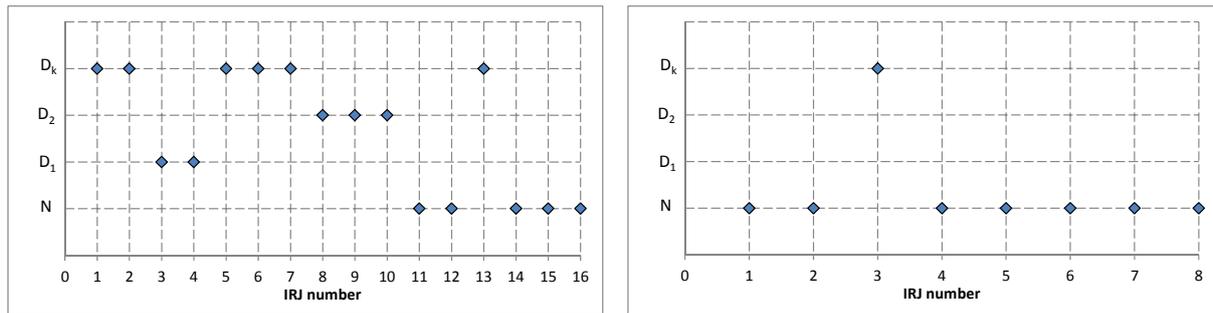
When the locations of the IRJs are detected, the assessment of the IRJs health condition can be performed based on the damage-IRJ analysis presented in section 4. The normal health condition is characterized by low ABA magnitude ($a_N^{max} < 100 \text{ m/s}^2$) and low PSD values ($P_{a_N a_N}([70;100]) < 200 \text{ (m/s}^2\text{)}^2/\text{Hz}$, $P_{a_N a_N}([520;570]) < 400 \text{ (m/s}^2\text{)}^2/\text{Hz}$). The IRJs with sever plastic deformation of the rail surface are characterized by high ABA values ($a_{D_1}^{max} > 100 \text{ m/s}^2$), and high PSD values around 520 – 570 Hz ($P_{a_{D_1} a_{D_1}}([520;570]) > 400 \text{ (m/s}^2\text{)}^2/\text{Hz}$). The IRJs with fastener damage are characterized by high ABA values ($a_{D_2}^{max} > 100 \text{ m/s}^2$), and high PSD values around 70 – 100 Hz ($P_{a_{D_2} a_{D_2}}([70;100]) > 200 \text{ (m/s}^2\text{)}^2/\text{Hz}$).

Figure 11 presents the assessment of IRJs health condition for the two tracks. The normal health condition is denoted by N , the plastic deformation of the rail surface after the gap is denoted by D_1 , the fastener damage is denoted by D_2 , and the uncertain health condition is denoted by D_k . The results presented in Figure 11 agree with the observation of the IRJs health conditions in Figure 5. Further investigation of various health conditions of IRJs is needed in order to improve these results and assess the IRJ with uncertain health conditions. The health conditions D_1 , D_2 and D_k indicate that deterioration of the IRJ has started and it is recommended to the inframanager to increase the frequency of inspections to prevent the failure of the IRJ. The proposed assessment can be used as performance indicator (Stenström et al., 2015), in order to simplify the overall analysis. The methodology can facilitate the maintenance operations providing crucial information that can be used to optimally design a condition based inspection plan strategy (Uzarski and Grussing, 2013) and maintenance decision making under risk averse situations (Rockafellar and Royset, 2015).
