**Investigation of Olympus TJF-Q180V Scopes at UMC Utrecht regarding contamination found after cleaning and disinfection
Reporting, Conclusions and Suggestions**

Reporting, Conclusions and Suggestions

April 19th 2017

Dr. Arjo J. Loeve

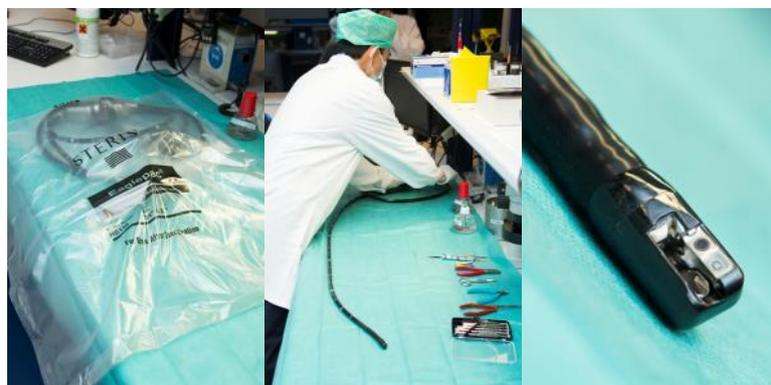
08:44 hrs Scope A is taken out of the bags by P8 and the external inspection starts. The tip appears to have no anomalies in this first inspection.

Figure 28: (from left to right) Scope A on the examination table; Scope A unwrapped; The tip of Scope A.

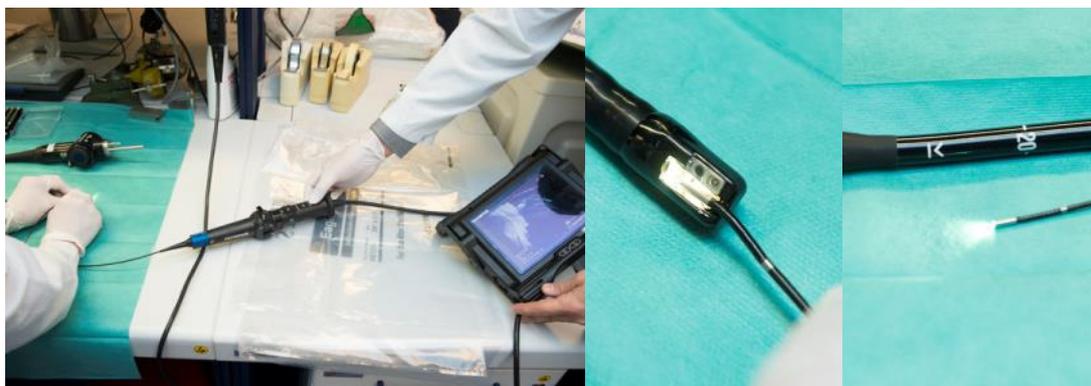
- Brown and white deposits in the forceps elevator region.
- Brown deposit behind the light cover glass
- Various scratches in the suction/biopsy channel, and one noticeable area of damage (~ 1 mm) in the distal section of the suction/biopsy channel.
- The Olympus representatives state that the channel does not appear to be from Olympus originally. The material is blue instead of white or clear (see appendix H) and appears to have a ribbed structure.
- When the borescope is inserted completely, the end of the suction/biopsy channel is not reached.

Figure 34: (from left to right) Suction/biopsy channel with borescope; Tip of the borescope in the forceps elevator area; Reference photo on which on can see the extent to which the borescope was inserted from the tip side of Scope A.

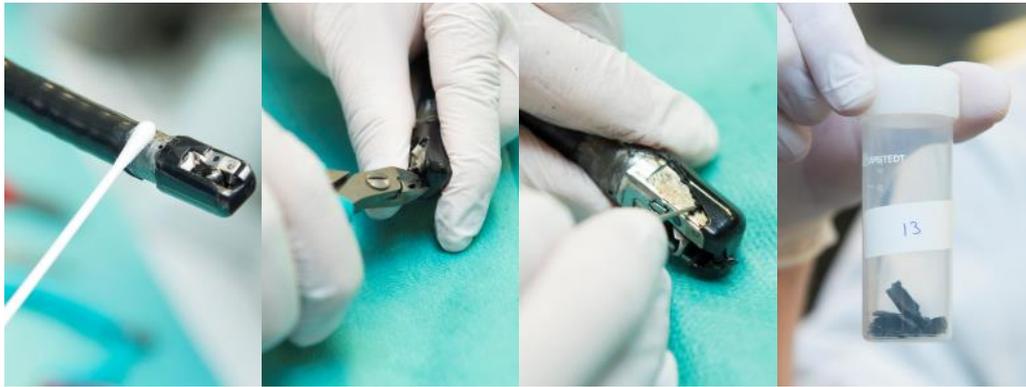
- The tip cover feels harder than usual according to P8.
- The tip cover falls apart during removal. Olympus indicates that this should be tough and must be able to be removed nearly whole from the tip. This observation was recognized by AL from previous removals.

Figure 38: (from left to right) Sampling of front bonding joint of cardan rubber {11}; Cutting loose of tip cover; Loosening tip cover; Storage of tip cover pieces {13}.

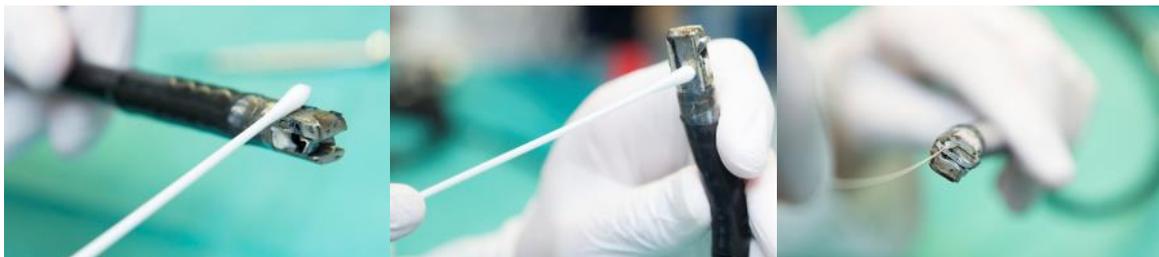
Figure 39: (from left to right) Sampling of tip parts underneath the cover {14}; Sampling underneath the cover {15}; Sampling of forceps elevator recess {16}.

- Insufficient (see appendix H) amount of black glue in the edge around the arm cover, through which there are openings in the seal.
- Brown deposit under the tip cover.
- P8 expresses doubts about the origins of the arm cover: a normal lip around the arm cover to make the arm cover easy to remove is missing according to P8.
- Arm cover is soldered to the tip, which is not consistent with Olympus standards (see appendix H).
- The glue is not everywhere on the arm cover, so the seal is not complete.
- Brown deposit under the arm cover.

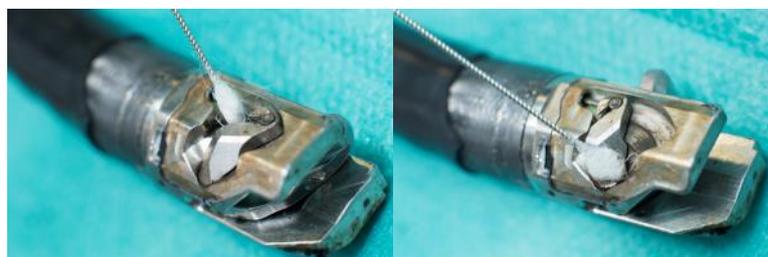
Figure 40: (from left to right) Side view of arm cover that shows part of the locking groove is without glue; Front view of tip with brown deposit; Opened arm cover, still attached to the tip due to soldering, with brown deposit underneath the arm cover.

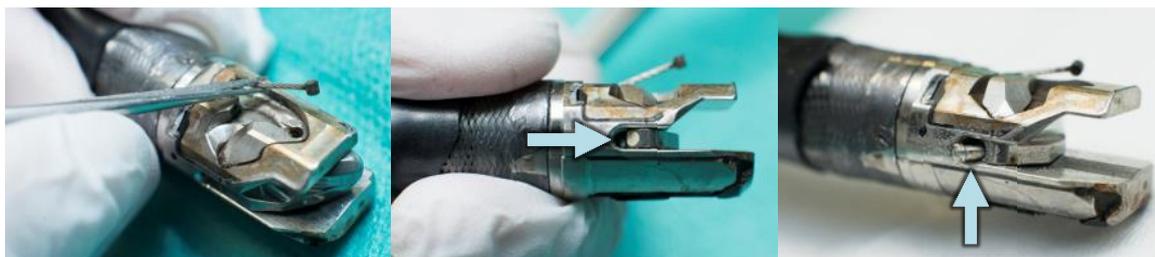
Figure 41: (from left to right) Sampling in the drive unit with partly raised forceps elevator {20}; Sampling in the drive unit with forceps elevator raised all the way {20};

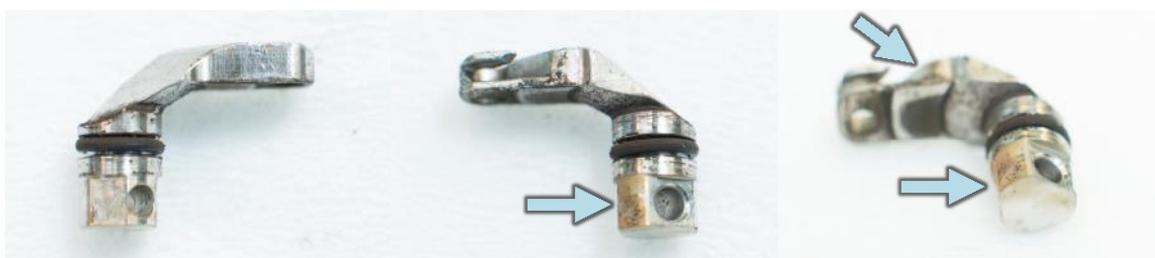
Figure 42: (from left to right) Removal of drive cable; White glue on screw with which the forceps elevator is fixed to the lever shaft; Screw removed with brown deposits on the screw thread.

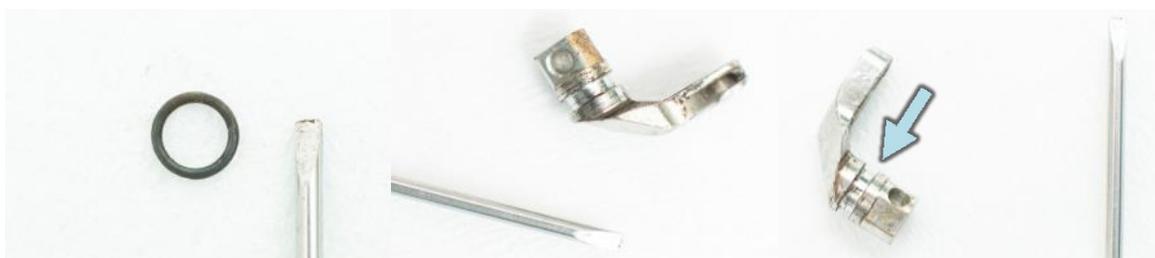
Figure 43: (from left to right) Lever with lever shaft and O-ring; Brown deposit on the lever and both sides of the O-ring; Brown deposit on the lever and lever shaft on several surfaces.

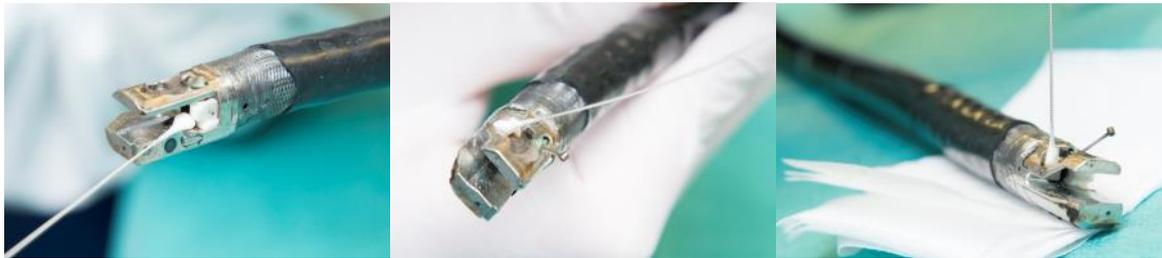
Figure 45: (from left to right) Forceps elevator with brown deposit in shaft opening; Forceps elevator with brown deposit in several places; Forceps elevator with brown deposit around the shaft opening.

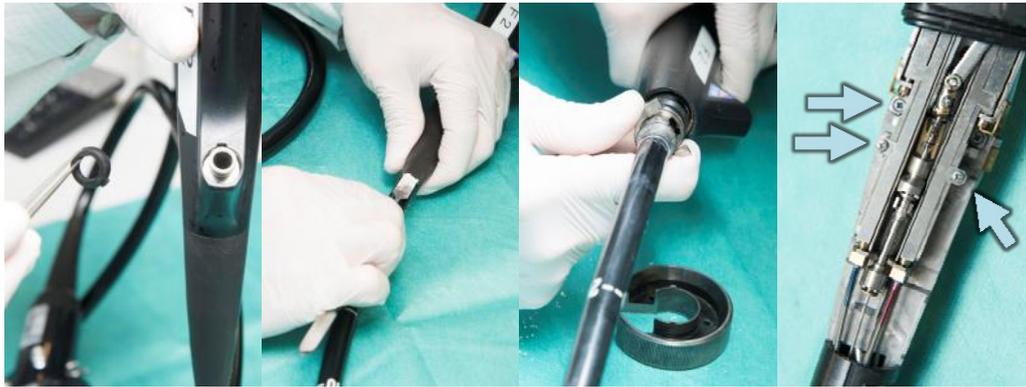
Figure 47: (from left to right) Rubber ring removed from input of suction/biopsy channel; Proximal sleeve of insertion tube with soapstone powder for removal; Underneath distal sleeve no Olympus brand name on insertion tube, insertion tube is not original; Inside control section, in which screws without bonding material are visible.

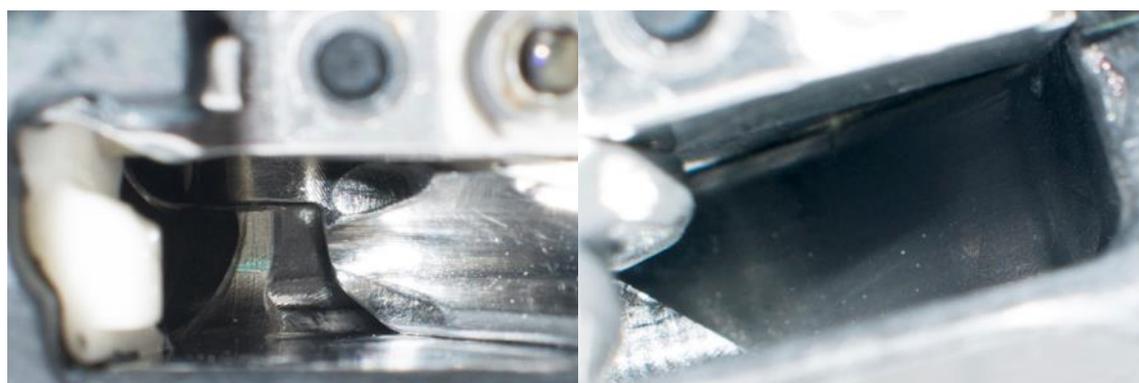
Figure 52: (from left to right) Close-up of the tip with brown deposit behind the cover glass; Space between the frame of the tip and the tip cover, the tip cover does not line up properly.

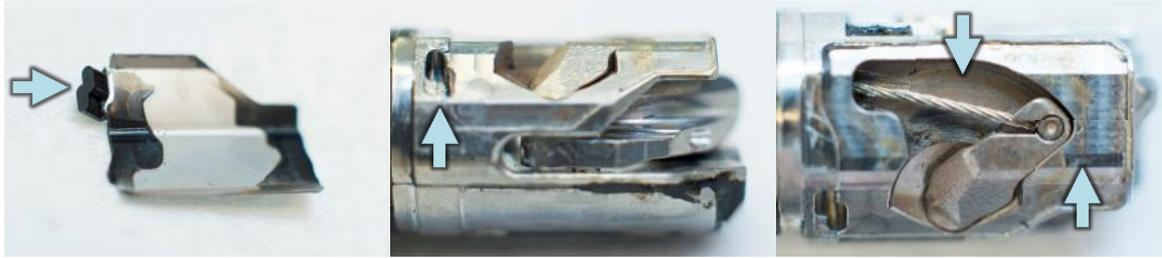
- Insufficient amount of black glue in the edge around the arm cover, through which there are openings in the bonding joint.
- P8 expresses doubts about the origins of the arm cover: a normal lip around the arm cover to make the arm cover easy to remove is missing according to P8.
- Arm cover is soldered to the tip, which is not consistent with Olympus standards (see appendix H).
- The glue is not everywhere on the arm cover (see appendix H), so the bonding joint is not complete.
- The "extra" cavity in the tip (see figure 60) appears to P8 not to be original. When reviewing the photos of the other scope, this cavity also appears to be present there.
- A piece of black glue that fits into the "extra" cavity is found to be stuck to the arm cover and is stored separately {49}.

Figure 59: (from left to right) Brown deposit under the tip cover; Opening in the bonding joint on the arm cover;

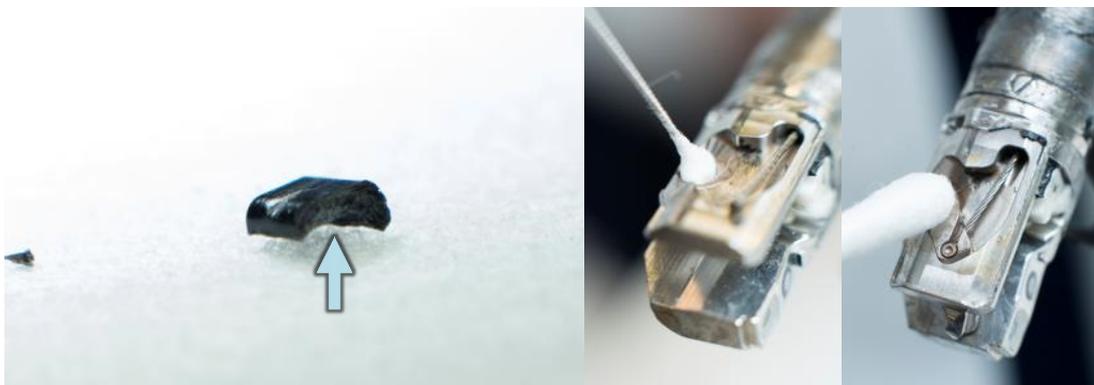
Figure 61: (from left to right) Brittle broken piece of tip cover; Sampling underneath the arm cover {56}; Sampling the lever shaft opening {57}.

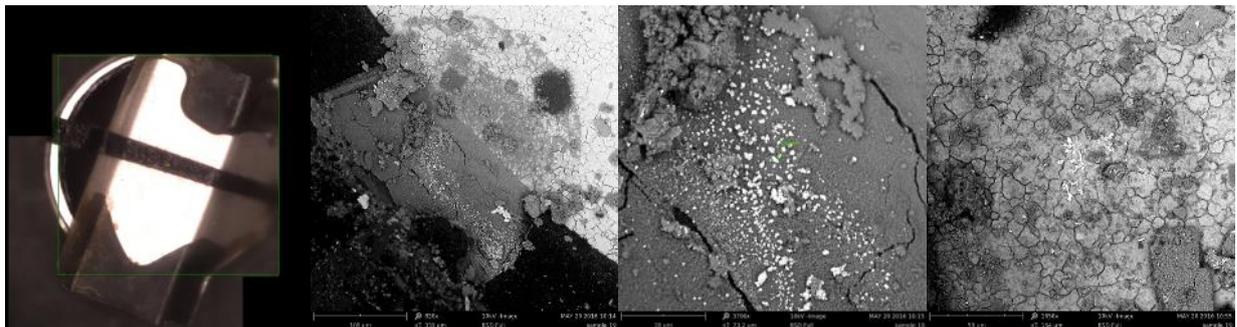
Figure G01: (from left to right) Interior piece tip cover Scope A; Detail scan (480x). Structure of the plastic; Detail scan (890x). Surface structure with particles; Detail scan (2700x). Visible air bubbles.

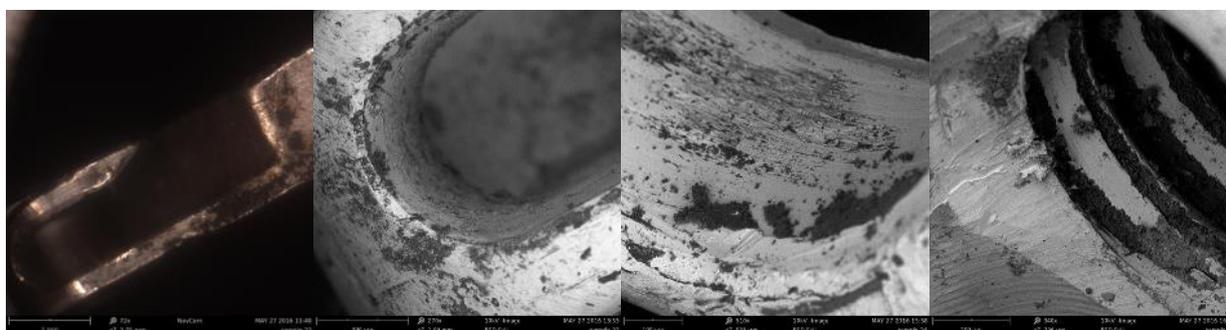
Figure G05: (from left to right) Lever with lever shaft Scope A; Detail scan (235x). Brown deposit in groove for the O-ring; Detail scan (2100x). Part of brown deposit; Detail scan (6200x). Brown deposit is visually similar to oxidation products that develop in the presence of bacteria.
