Investigation of the formation of corrugation-induced rail squats based on extensive field monitoring

Deng, Xiangyun; Qian, Zhiwei; Li, Zili; Dollevoet, Rolf

International Journal of Fatigue

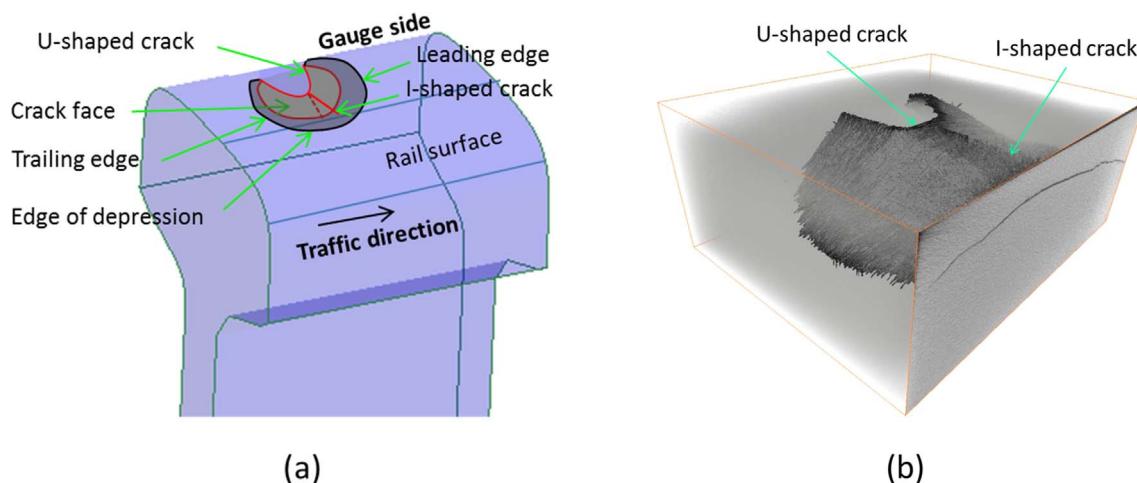
Fig. 8. 3D crack face in a two-lung-shaped squat: (a) Inferred from the surface-visible Y shape and the cracking angle α of Fig. 7(c); (b) obtained from specimen 2b (squat caused by corrugation) from [20] with computed tomography, courtesy of Meysam Naeimi.

The U-shaped crack initiated at the bottom point of the U and then propagated toward the gauge side in both the traffic and opposite-traffic directions simultaneously, as illustrated in Fig. 8. The crack also propagated into the rail at an angle of approximately 20°. This cracking process was observed at more than 20 monitored squats, as shown above. Based on this finding, the shape of the crack was constructed and is shown in Fig. 8(a). This shape was verified with 3D computed tomography [20], as seen in Fig. 8(b).

In Fig. 8, the crack face encloses a peninsula-shaped part. The intersection of the peninsula-shaped part with the rail surface is a U-shaped crack. When the U-shaped crack grows, the two arms of the U extend toward the gauge side; this makes the peninsula-shaped part longer. At the same time, the crack propagates downward into the rail, i.e., the peninsula-shaped part extends deeper into the rail. Consequently, the depressed area grows with the peninsula-shaped part simultaneously in both the surface dimension and depth.

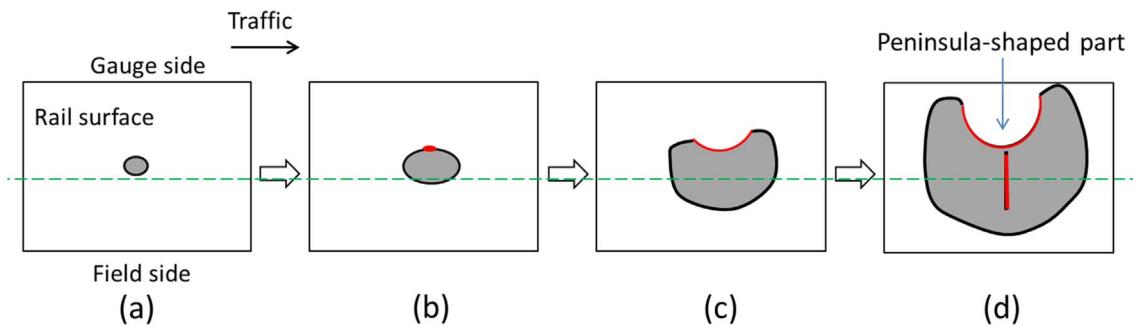
Fig. 11. Schematic diagram of the squat development process, including crack initiation and growth. The green line represents the rail centerline, the red line represents the cracks, and the gray area represents the squat/black depression with the black curved line representing its edge: (a) Elliptical small black depression; (b) crack initiation point, usually on the gauge side edge of the black depression; (c) U crack starts to form, causing the elliptical depression to become kidney shaped; crack propagates slightly more rapidly in the traffic direction due to traction force; (d) two-lung-shaped mature squat with a Y-shaped crack. (For interpretation of the references to color in this figure legend, the reader is referred to the web version of this article.)

Based on the observations and analyses described above, a squat development process is proposed. A schematic diagram of the process is shown in Fig. 11 to describe the squat evolution and cracking processes.

Initially, a small black depression is generated at a corrugation (Fig. 11(a)). The black depression results from microcracks due to plastic deformation and work hardening in the surface layer of the rail material, typically up to a depth of 1.1 mm, and it is caused by the cyclic wheel-rail impact forces excited by the corrugation. The black depression grows roughly in the shape of a complete ellipse until it reaches a critical size, and a primary macrocrack is initiated in/near the rail surface on the gauge side edge of the depression (Fig. 11(b)). Then, the shape of the black depression starts to change and follows the propagation of the crack, while the uncracking part remains elliptical. The surface crack propagates in a U shape toward the gauge side in both the traffic direction and the opposite-traffic direction (Fig. 11(c)). This process forms a U-shaped crack with the bottom point of the U being the initiation point of the primary crack. In this stage, the squat becomes a kidney-like shape with a concave part in the middle region bordered by the U-shaped crack. Moreover, the squat grows more rapidly in the traffic direction if the longitudinal contact force is tractive. It also propagates into the rail toward the field side at an angle of approximately 20°. When the squat grows to a certain stage, a ridge is

formed in the middle of the black depression, and an I-shaped crack can occur at this ridge. The combination of the U-shaped crack and I-shaped crack forms a Y-shaped crack (Fig. 11(d)). In this process, the U-shaped part grows into a peninsula-like shape around the time of the formation of the I-shaped crack. Eventually, this evolution process leads to a mature two-lung-shaped squat with a Y-shaped crack. The proposed development process is derived from and is valid for corrugation-induced squats, and it is elaborated in the next section.

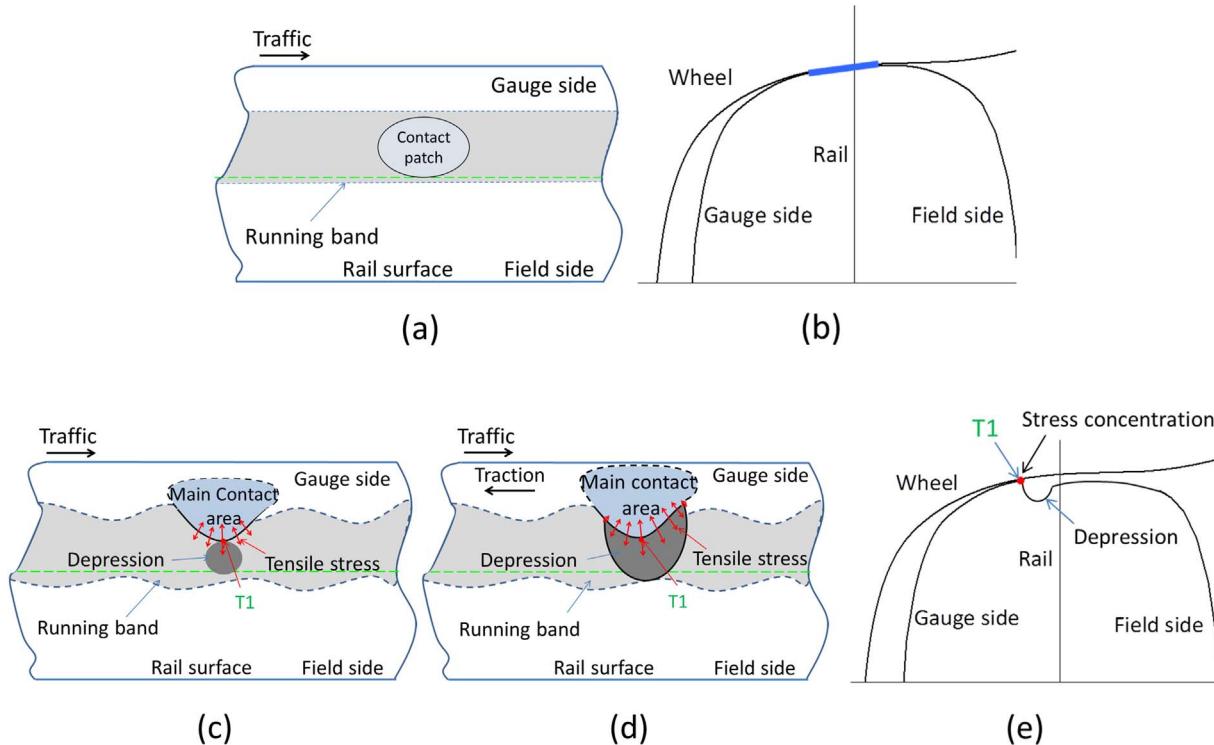
Fig. 12. Wheel-rail contact patch. The green line represents the rail centerline; the blue dashed lines mark the running band and corrugation; and the blue solid line indicates the main contact area: (a) and (b) When the rail is smooth; (c) and (e) when corrugation and a small black depression exist. The red arrows indicate tensile stress along the border of the main contact area; the length of the arrows is schematically proportional to the magnitude of the tensile stress. (c) corresponds to Fig. 11(b), and (d) corresponds to Fig. 11(c) and (d). (For interpretation of the references to color in this figure legend, the reader is referred to the web version of this article.)

When a small black depression grows to a certain size, it significantly changes the effective contact patch at the wheel-rail interface, as illustrated in Fig. 12. The contact patch can be approximated as elliptical when the rail surface is smooth, as shown in Figs. 12(a) and 10(b). However, its location and shape are different in the region when a small black depression exists. The main contact patch at the depression shifts to the gauge side, as shown in Fig. 12(c) and (d). The border of the main contact area at the edge of the depression exhibits a U shape with the opening of the U facing toward the gauge side. The U shape comes from the intersection of the wheel and the rail surfaces as a wheel is loaded onto a rail. This change in the contact patch is generalized and marked in Fig. 12(c) and (d). This main contact area is most clearly indicated by the brighter contact area bordered by the U-shaped crack at the monitored squats, such as those seen in Figs. 1, 4(d) and (e), 5, 6(d) and (e), 7, 9, 10, 15 and 17.

The region at the black depression sustains the impact from the wheels; the dynamic force is large. At the same time, the depression causes stress concentration at edge T1, as seen in Fig. 12(c), (d) and (e). The large contact force and stress concentration lead to stress that is much larger than elsewhere on the rail surface. According to the Hertz theory [25], tensile stress is present immediately outside the contact patch, and its value is maximal at the border of the contact. In the case of corrugation with surface depression, a tensile stress distribution arises along the border of the main contact area in a U shape, as indicated by the red arrows in Fig. 12(c). The tensile stress is the greatest at T1. Since the material at the depression is brittle, this greatest tensile stress results in a macrocrack at T1 by mode I fracture. This crack initiation phenomenon is analogous to the ring/cone crack formation of brittle materials under sphere contact [26] and the formation of crack

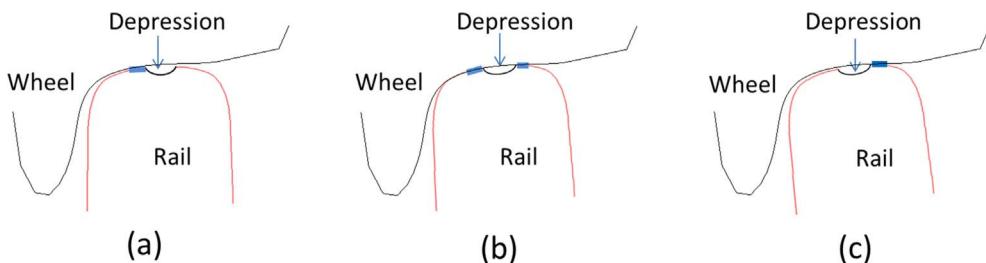
Fig. 13. Positions of the main contact areas (indicated by the blue line) that determine the locations of the primary cracks: (a) Rail inclination of 1/40; (b) a slight increase in the rail inclination; (c) a larger increase in the rail inclination. (For interpretation of the references to color in this figure legend, the reader is referred to the web version of this article.)

The case between the situations Fig. 13(a) and (c) is a slight increase in the rail inclination that slightly shifts the contact to the field side.
