### A case study of St. Christopher in Maria Church, Nisse

# Application of shearography and the percussion method for the structural inspection of wall paintings: a case study of St. Christopher in the Mariakerk, Nisse

Valentina Gatto\*<sup>a</sup>, Andrei G. Anisimov<sup>b</sup>, Wouter Lettinga<sup>b</sup>, Nan Tao<sup>b</sup>, Merel Lantman<sup>a</sup>,  
Roger M. Groves<sup>b</sup>

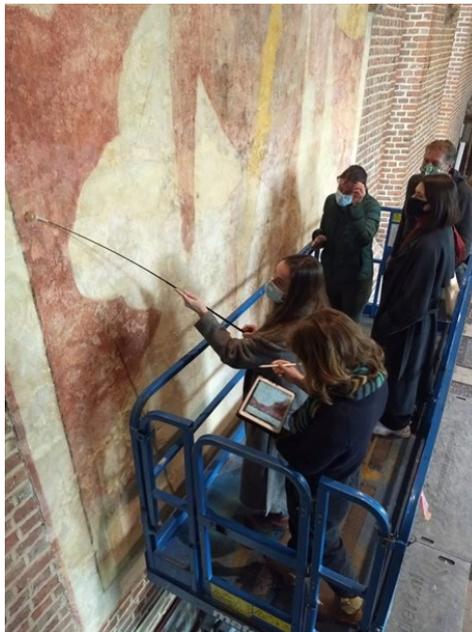
Figure 2. Percussion testing in Maria Church, wall painting depicting St. Christopher.

The percussion tests were executed in a collective approach, in order to reduce biases and subjective inclinations (Figure 2). After the tapping or the rolling of an area had occurred, the generated acoustic reactions were discussed and subsequently mapped (Figure 4 (a)). It can be easily observed that the implementation of the two percussion methods, despite involving the same mechanism of interpretation and collection of data, gave somewhat different results (Figure 4 (a)). It can be stated that the percussion method involving the tapping of a nail resulted in identifying more areas with delaminations than the percussion methods involving the rolling of the acoustically isolated plastic ball. In overall, some similarities in the results obtained were observed, especially in areas surrounding the wooden lintel, part of the door underlying the wall painting of St. Christopher (left and right side on the lower part of the wall painting in Figure 4 (a)).

possible to ascertain that both methods involved a small degree of accidental damages to the painted surface, in the form of losses of paint and the generation of plaster debris.
