## Non-Destructive Testing for Detection, Localization and Quantification of Damage on Composite Structures for Composite Repair Applications

Shrestha, Pratik; Groves, Roger

Proceedings of the 10th International Symposium on NDT in Aerospace

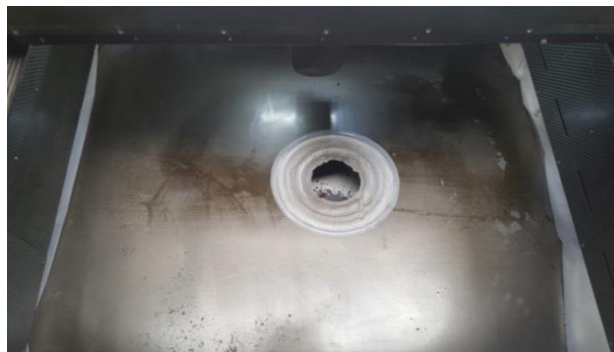
**Fig. 9.** Damage removed using the MobileBlock.

Furthermore, since the damage location detected and quantified by these two different NDT techniques overlaps with each other, the certainty of the detected damage location is increased. As a result, based on the damage information determined by the algorithm the maximum damage length in the x-direction and y-direction is selected to model the cut-out profile for damage removal, as shown in Fig. 8 (d): with ellipses of maximum x-length of 253.2 mm at the top surface and 101.6 mm at the bottom surface of the panel, and maximum y-length of 235.4 mm and 83.8 mm at the top and bottom surface, respectively. The parameters output by the algorithm was then used for the damage area removal as shown in Fig. 9.
