IN-SITU FATIGUE DAMAGE ASSESSMENT OF CARBON-FIBRE REINFORCED POLYMER STRUCTURES USING ADVANCED EXPERIMENTAL TECHNIQUES

Keywords: fatigue, damage assessment, Acoustic Emission, Digital Image Correlation

This study focused on the in-situ fatigue damage assessment of open-hole carbon/epoxy coupons using Acoustic Emission (AE) and Digital Image Correlation (DIC) techniques. Constant amplitude fatigue tests were performed and the main objective was to investigate the damage process, the degradation process of the fatigue modules and to identify features, derived from the experimental data, that can be used as sensitive-to-damage indexes. To this end, the two experimental techniques were reviewed as potential online monitoring tools for the fatigue damage assessment.

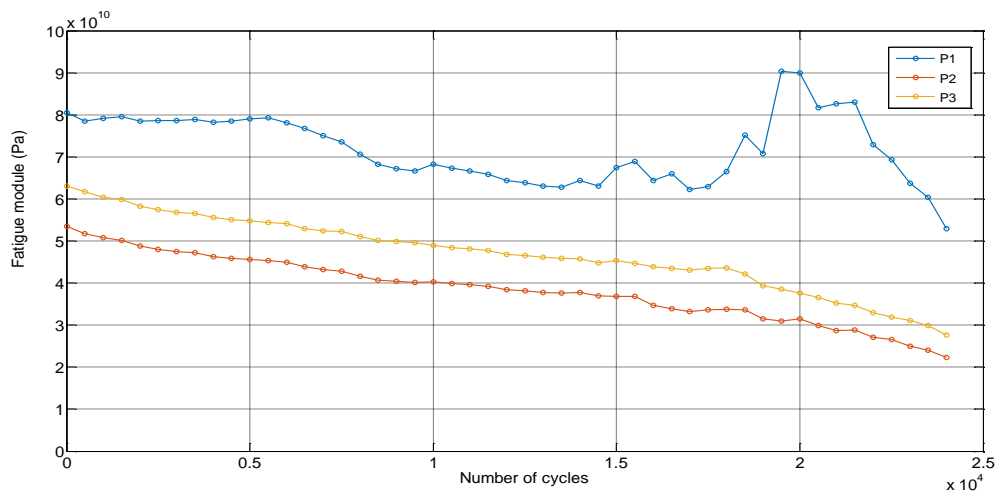
Figure 5 presents the degradation of fatigue module for the 3 selected points. Although the fatigue modules have different absolute values, the degradation processes have similar trends. It was noted that the fatigue module for point P1 increased between 17500 and 20000 cycles something that can be attributed to the inaccurate correlation during the strain analysis because, as it can be seen in Figure 2, damage occurred very close to point P1.

Figure 5. The fatigue module degradation for points P1, P2 and P3 of specimen 2.
