Carriage interior noise-based inspection for rail corrugation on high-speed railway track

Wei, Zilong; Sun, Xianfu; Yang, Fei; Ke, Zaitian ; Lu, Tao; Zhang, Pan; Shen, Chen

Applied Acoustics

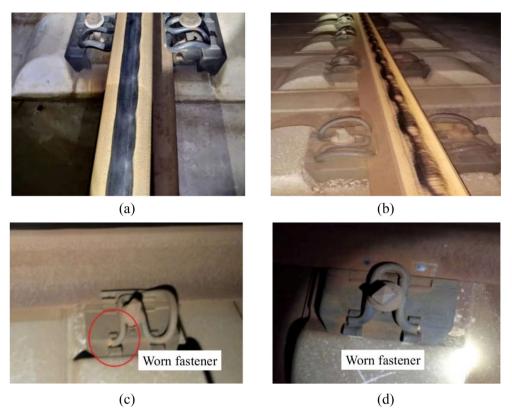
Fig. 1. Examples of rail corrugation on HSR lines: (a) Sharp curve, (b) Tangent track, (c) and (d) Failure of the fastener at track sections with rail corrugation.

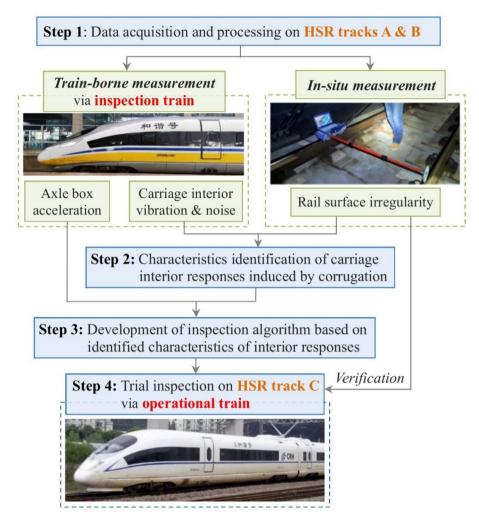
Fig. 2. Flow chart depicting the methodology in this study.

The train-borne measurements were conducted in the tourist cabin of a CRH380B-type high-speed train, see Fig. 2. Since the pantograph was not installed on the roof of the first carriage, the disturbances of the pantograph-induced aerodynamic noise [24] can be excluded. The carriage interior instrument includes four main components, i.e., an accelerometer, a MEMS Global Navigation Satellite System (GNSS)/ Inertial Navigation System (INS) integrated navigation system, a signal acquisition device, and a microphone. The sensors were mounted on the carriage floor above the leading bogie and close to the driver's cage. Among them, the accelerometer is employed for recording the acceleration of the car body, while the microphone for the noise inside the carriage, and the sampling frequency of both sensors were set to 5 kHz. The GNSS/INS integrated navigation system was employed to record the position and speed of the measurement train. In particular, the GNSS antenna was arranged next to a side window, while the INS module was triggered when the GNSS signal is poor (e.g., within train station and tunnel). Apart from the sensors inside the carriage, an accelerometer with a sampling frequency of 5 kHz was also installed on the axle box of the leading bogie of the first

The proposed algorithm is demonstrated on the HSR track C with an unknown rail surface condition. The train-borne measurement was conducted using the operational train, see Fig. 2. The length of the train-borne measurement is 80 km, and the train speed varies significantly from 44 km/h to 346 km/h during the measurement. In the inspection algorithm, the values of T_W , T_F and I_T are set to 2 s, 0.5 s and 2, respectively. Fig. 12 gives the distribution of the rail corrugation index I_{C} on the HSR track C. For illustration purposes, the track curvature and train speed are attached. In Fig. 12(a), the rail corrugation index $I_{\rm C}$ exceeds the threshold I_T at two regions, i.e., C1 and C2. Both the two regions are located on tangent tracks, where the train speeds are 116 km/h and 161 km/h, respectively. Regarding the identified wavelengths, they are 51 mm and 104 mm at C1 with the latter being dominant (Fig. 12(b)), and the value shifts to 73 mm at C2 (Fig. 12(c)).

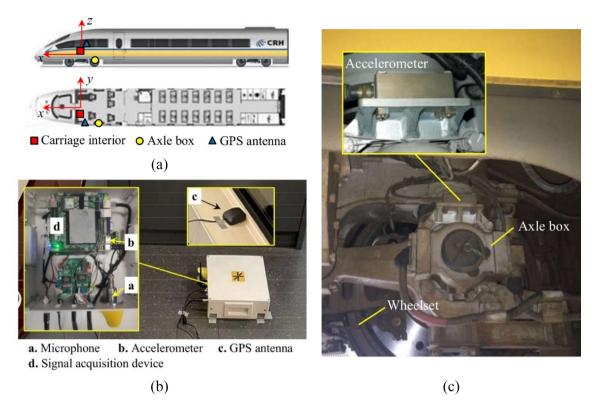
Fig. 3. Schematic diagram of train-borne measurement. (a) Instrumented position of sensors, (b) Singal acquisition device, and (c) Accelerometer mounted on axle box.

carriage (see Fig. 3(c)), so that the dynamic responses of running gear components can be extracted.

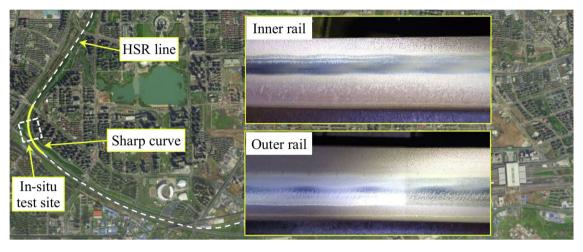
Fig. 4. Rail corrugation on the sharp curve of the HSR track A.

In the HSR network, there exist sharp curves around many railway stations, at which rail corrugation commonly has a high likelihood to initiate and develop [31]. Fig. 4 gives examples of rail corrugation occurring on the transition curve of a sharp curve of the HSR track A. In the figure, the rail corrugation can be observed on both the inner and outer rails. The transition curve is with a minimum radius *R* of 1600 m, and the train measurement speed is around 110 km/h.

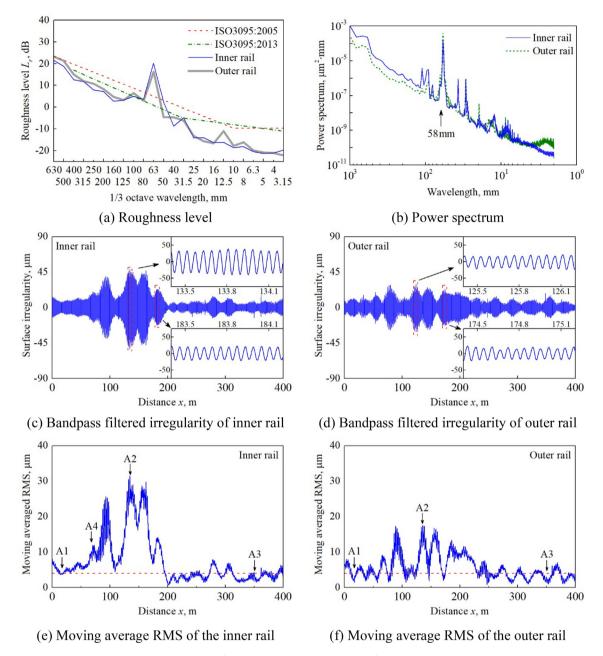
Fig. 5. Rail surface irregularity on the sharp curve of the HSR track A.

Fig. 5 shows the distribution of rail surface irregularity measured on the sharp curve of the HSR track A. Regarding the roughness level in Fig. 5(a), the values at the 1/3 octave wavelength of 63 mm are 20.3 dB on the inner rail and 16.4 dB on the outer rail, both of which exceed the limit of 0.9 dB according to Standard ISO 3095:2013. The power spectrum of the rail irregularity in Fig. 5(b) further indicates that the wavelength of 58 mm is dominant on both rails. To clearly illustrate the geometric characteristics of rail corrugation, the measured data is filtered with the passband of $30 \sim 100 \text{ mm}$ following Standard EN 13231-3:2006, and the results are given in Fig. 5(c)~(d). On the inner rail, the peak-to-peak value (V_{PP}) of filtered rail irregularity exceeds 30 µm at 63 ~ 104 m,

118 ~ 173 m, and 177 ~ 189 m, with the maximum of 101 μ m occurring at x = 134 m. On the outer rail, the V_{PP} exceeds 30 μ m at 68 ~ 92 m, 115 ~ 152 m, and 167 ~ 204 m, with the maximum of 58 μ m occurring at x = 126 m. Fig. 5(e)-(f) shows the moving average RMS of the filtered rail surface irregularity with the passband of 30 ~ 100 mm. As can be seen, the values of V_{RMS} reach the maxima of 31.5 μ m on the inner rail and 17.4 μ m on the outer rail. Judged by the threshold of 4 μ m according to Standard EN 13231-3:2006, 75.2% and 42.3% of the in-situ measured track section (i.e., 400 m) exceeds the limit on the inner rail and outer rail, respectively.

To gain an insight into the relationship between the severity of rail corrugation and the energy of carriage interior responses, three sites, namely A1 (x = 16 m), A2 (x = 134 m) and A3 (x = 350 m) are picked up from Fig. 5(e), with the amplitudes of V_{RMS} being 3.7 µm, 31.5 µm, and 3.2 µm on the inner rail, respectively. Fig. 6(c)-(d) compares the GWPS of the carriage interior responses at the sites. For both the CBA and interior noise signals, the power spectrum at 500 ~ 550 Hz raises with the exacerbation of rail corrugation. The GWPS of the interior noise in Fig. 6(d) is 4.4 × 10⁻³ Pa² and 3.6 × 10⁻³ Pa² at A1 and A3 respectively, where the corrugation amplitudes are similar between the two sites, and the value increases to 1.5 × 10⁻² Pa² at A2. Regarding the GWPS of the CBA, however, the values at A1 and A3 (e.g., 6.2×10^{-3} m²/s⁴ and 2.8 × 10⁻³ m²/s⁴ differ significantly from each other, indicating its poor correlation with the corrugation amplitude.

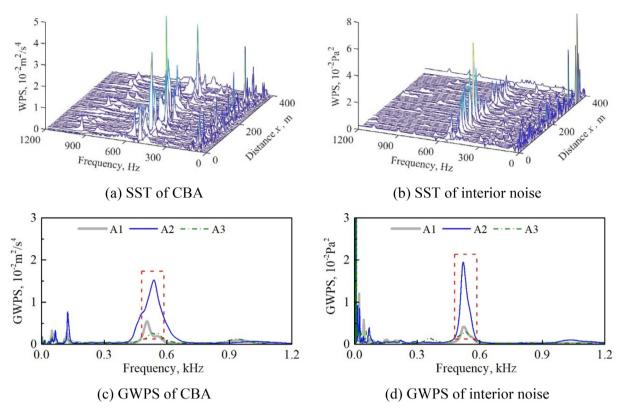
Fig. 6. Time-frequency distributions of the carriage interior responses on the sharp curve of the HSR track A.

Fig. 6 shows the time and frequency distributions of the carriage interior responses on the sharp curve. In Fig. 6(a)-(b), large energy concentrations in the frequency range of 500 \sim 550 Hz can be observed from both the CBA and noise signals. Since the typical wavelength of the rail surface irregularity is 58 mm, the corrugation-induced vehicle responses should tack place at around 527 Hz under the train speed of 110 km/h. This indicates that the 500 \sim 550 Hz components are strongly correlated with the excitation of rail corrugation.

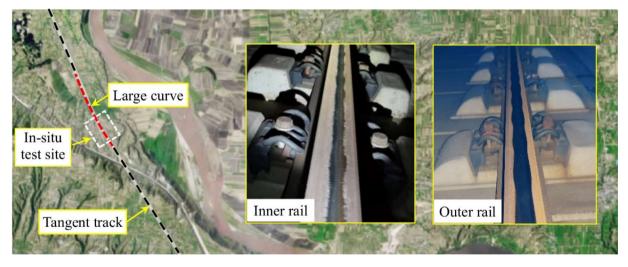
Fig. 7. Rail corrugation on the large curve of the HSR track B.

Fig. 7 gives another example of rail corrugation on a large curve of the HSR track B. The degraded track section is within a tunnel of HSR track B, the curve radius is 10000 m, and the measurement speed is around 300 km/h.

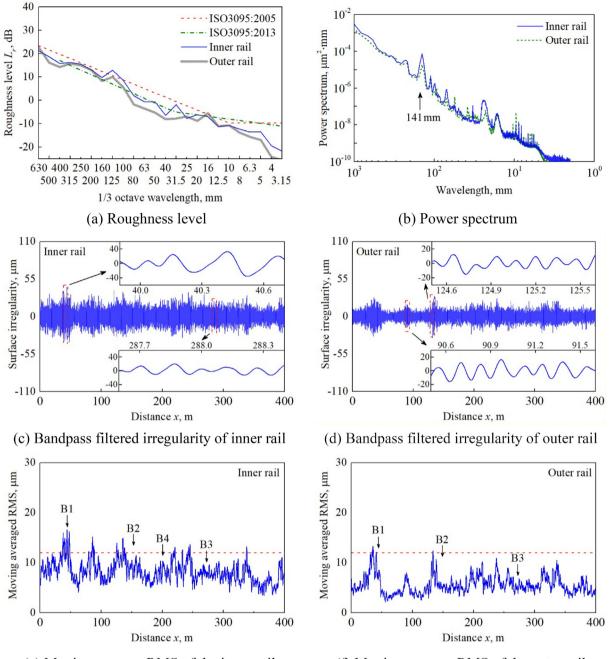
(e) Moving average RMS of the inner rail

(f) Moving average RMS of the outer rail

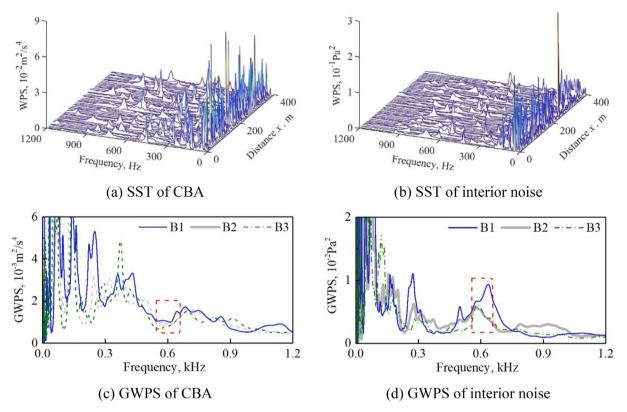
Fig. 9. Time-frequency distributions of the carriage interior responses on the large curve of the HSR track B.

Fig. 9 shows the time and frequency distributions of the carriage interior responses recorded on the HSR track B. Since the typical wavelength of rail surface irregularity is 141 mm, the induced vibrations and noises are most likely to take place at around 591 Hz under the train speed of 300 km/h. In Fig. 9(a)-(b), however, the 550 \sim 650 Hz components can be hardly observed from both the CBA and interior noise. This is mainly attributed to the great energy concentration at lower frequencies (e.g., 30 \sim 100 Hz), which makes the higher frequency components unimpressive under the same scale. To investigate the relationship between the severity of rail corrugation and the energy of carriage interior responses, three sites with different irregularity amplitudes, namely B1 (x = 40 m), B2 (x = 150 m) and B3 (x = 274 m), are picked up from Fig. 8(e), with the amplitudes of V_{RMS} being 16.6 µm, 8.7 µm, and 8.0 µm on the inner rail, respectively. Fig. 9(c)-(d) compares the GWPS of the carriage interior responses at the three sites. As can be seen, the exacerbation of rail corrugation promotes the energy concentration of the interior noise at around 600 Hz, see Fig. 9(d). In particular, the value of GWPS at B1 is 52% and 56% larger than those at B2 and B3. Regarding the GWPS of the CBA signal, the power spectrum at 550 \sim 650 Hz is not significant compared to the values nearby, and it does not raise at a larger corrugation amplitude, which may have been effectively isolated by the suspensions.

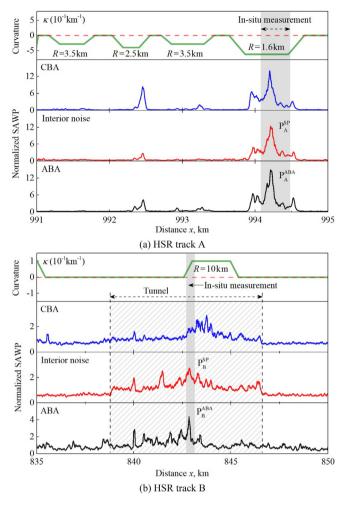
Fig. 11. Comparison of SAWP between different vehicle response signals.

Fig. 11 shows the SAWP extracted from different vehicle response signals. In the figure, the concerned frequencies are restricted to $500 \sim 550$ Hz for the HSR track A and $550 \sim 650$ Hz for the HSR track B, respectively. For comparison purposes, the SAWP is normalized by dividing its mean value along the whole measured length. On the HSR track A, both the CBA and interior

noise coincide well with the ABA signals in terms of both the waveform and amplitude, see Fig. 11(a). The maxima of the SAWP take place at around x = 994.20 km for all the measured signals, with the normalized values being 13.8, 12.3, and 14.9 for the CBA, interior noise, and ABA, respectively. This information indicates that both of the two measured carriage interior response signals succeed in capturing the region with rail corrugation.

On the HSR track B, the SAWP of the interior noise and ABA signals shows a good approximation in terms of the waveform, with the maxima of both signals occurring at around x = 842.85 km. Note that the SAWP of the interior noise within the tunnel is higher than the adjacent regions [32,33], while the phenomenon is not obvious for the ABA and CBA signals. The maximum SAWP of the CBA takes place at x = 843.75 km, shifting forward by 0.9 km compared with the ABA. As shown in Fig. 9(c) and Fig. 11(b), the CBA measured from the HSR track B fails in capturing both the characteristic frequency components and the exact position of rail

Table 1 further compares the distributions of SAWP between the interior noise and ABA. For illustration purposes, a threshold of 2 is specified for the normalized SAWP, so that the positions with rail corrugation (the shadow region in Fig. 11) can be picked up, namely P_A^{SP} and P_A^{ABA} on the HSR track A as well as P_B^{SP} and P_B^{ABA} on the HSR track B. On the HSR track A, the wavelength of rail corrugation extracted from the interior noise is 59 mm, which is identical to the value from ABA. On the HSR track B, the wavelength from the interior noise is 131 mm, which is 2 mm smaller than that from ABA. Regarding the identified length of the degraded section, the deviation between the two signals is 21 m on HSR track A, and enlarges to 99 m on HSR track B.

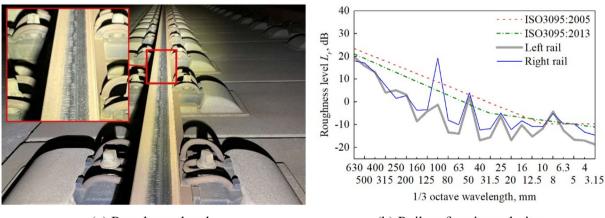
(a) Roughness level

(b) Rail surface irregularity

To examine the performance of the inspection algorithm, in-situ measurement of rail surface irregularity was conducted at track site C1, whereas site C2 is inaccessible due to safety regulations. Fig. 13 gives the photo captured at C1. The observed anomaly initiates from an improper rail grinding strategy, and the rail surface contains several periodic irregularity components with different wavelengths. This is confirmed by the roughness level of the measured rail surface irregularity, see Fig. 13(b). At the 1/3 octave wavelength of 100 mm, the roughness level on the right rail reaches 19.3 dB, which is 14.4 dB higher than the limit of Standard ISO 3095:2013. At the 1/3 octave wavelength of 50 mm, the roughness level is 2.3 dB on the left rail and 4.9 dB on the right rail, both of them exceed the limit of -1.1 dB.

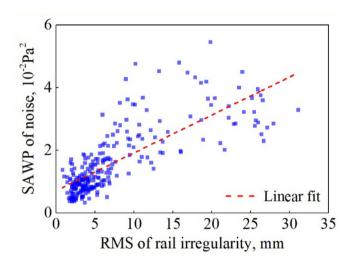
Fig. 14. Relation between the measured rail irregularity and interior noise on the HSR track A.
