Skin-stringer separation in post-buckling of butt-joint stiffened thermoplastic composite panels

van Dooren, K. S.; Tijs, B. H.A.H.; Waleson, J. E.A.; Bisagni, C.

Composite Structures

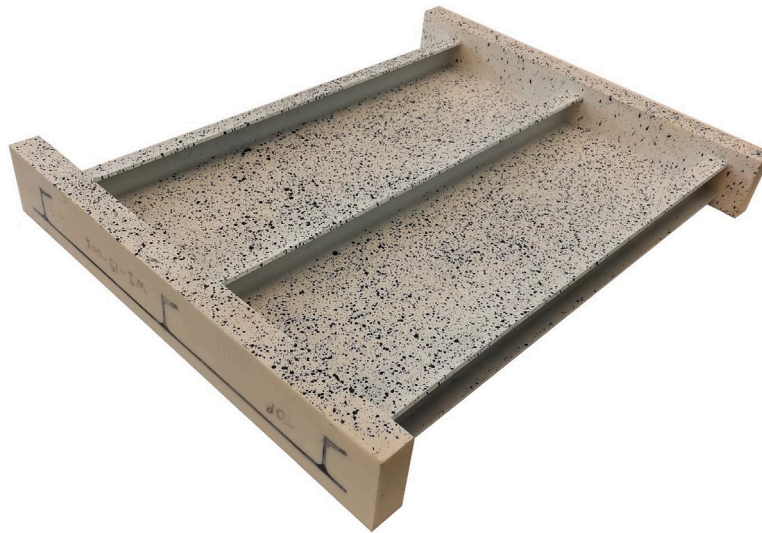
Fig. 1. Thermoplastic composite stiffened panel.

The thermoplastic stiffened panels investigated in this research have three stringers, with a butt-joint and angled cap. The panels are designed and manufactured by GKN Fokker [32]. The panels include an initial damage in the middle skin-stringer interface, that is representative of Barely Visible Impact Damage (BVID). The buckling and failure behaviour of the panels is analysed by the use of Finite Element (FE) analysis, in which skin-stringer separation is modelled using the VCCT approach [33,34]. The experimental tests make use of Digital Image Correlation (DIC) to capture the deformation field during buckling. Skin-stringer separation is recorded by cameras and panel final failure is captured by the use of two high-speed cameras. The FE analysis and the tests were performed at the Delft University of Technology.

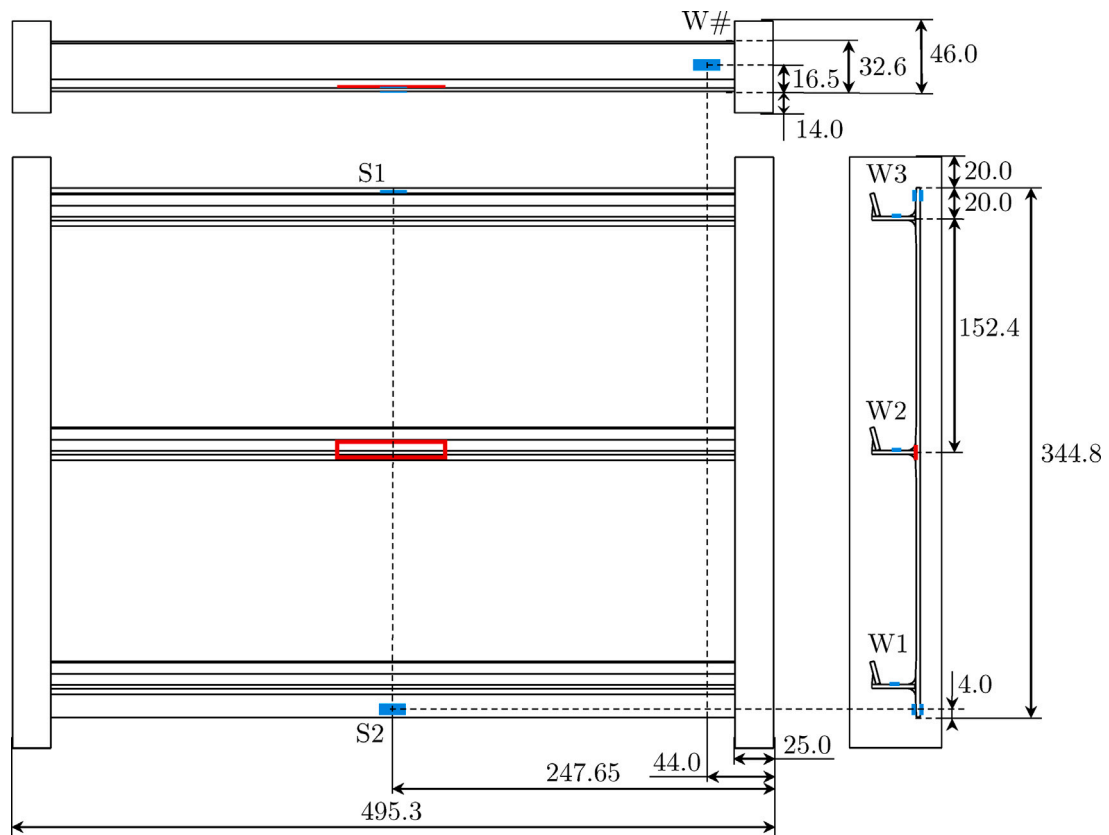
Fig. 2. Geometry of thermoplastic composite stiffened panel (dimensions in mm), with initial damage location and strain gauges highlighted in red and blue, respectively.

The panels are 495.3 mm long including the potting, 445.3 mm long in between the potting, 344.8 mm in width and the stringer spacing is 152.4 mm, as shown in Fig. 2. The web is 28 mm in height, the cap is 15 mm wide and is angled upwards at 105 degrees w.r.t. the web, as shown in Fig. 3. Short fibre filler material joins the laminates of the stringer and skin, to constitute the so-called butt-joint. The panels have an initial damage in between the bottom of the filler and the top of the skin at the middle stringer, as highlighted by the red area. The initial damage is approximately 70 mm long and is considered a typical damage size to represent BVID for this design. To determine the BVID size, impact tests were performed by GKN Fokker on a larger structure using an indenter with a diameter of 1/2 inch to obtain an initial indent depth of 1 mm, which is assumed to be at least 0.3 mm after material relaxation [35]. For the larger structure with 15 ply skin, an impact from the inside with a dent depth of 1 mm resulted in a 70 mm crack. Consequently, the initial damage for these three-stringer panels is created by inserting a 40 mm Teflon insert during manufacturing. After manufacturing the damage is extended in a testing machine to a length of approximately 70 mm by applying out-of-plane displacement to the skin. This method creates a sharp crack tip to represent more closely BVID.

A total of 7 strain gauges are attached to each panel to measure strains. A strain gauge is attached to each web under the cap towards the bottom of the panel, while the other strain gauges are attached back-to-back on the free edges of the skin. The locations of the strain gauges are shown in Figs. 2 and 3, with the strain gauges on the web and on the skin named W# and S#, respectively. The locations are chosen according to the results of the numerical predictions, such that the strain gradient is low at each location. The strain gauges on each web show if each stringer is equally loaded in pre-buckling, and how the load distribution changes in post-buckling due to the growth of the skin-stringer separation. The strain gauges on the skin are used to determine loading imperfections due to bending.

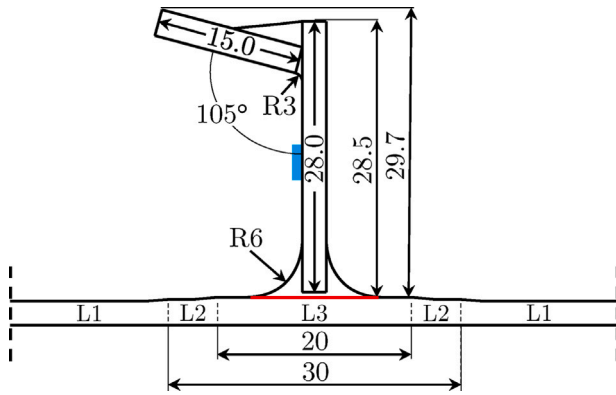
Fig. 3. Stringer cross-section (dimensions in mm), with initial damage location and strain gauges highlighted in red and blue, respectively.

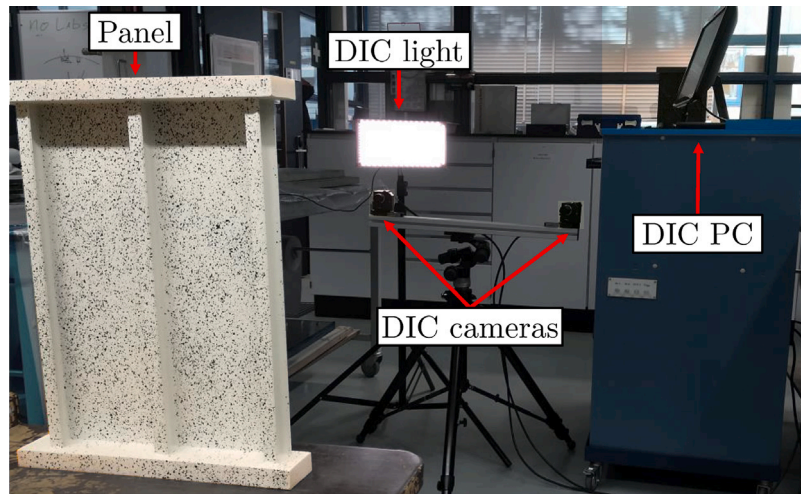
Fig. 4. DIC measurement setup.

The geometrical imperfections are measured by DIC. The nominal design of the skin is flat, and the geometrical imperfections are therefore measured as the out-of-plane deviation of the skin of the panels with respect to the flat plane. The DIC measurement setup uses two stereo camera and additional lighting, and is shown in Fig. 4.

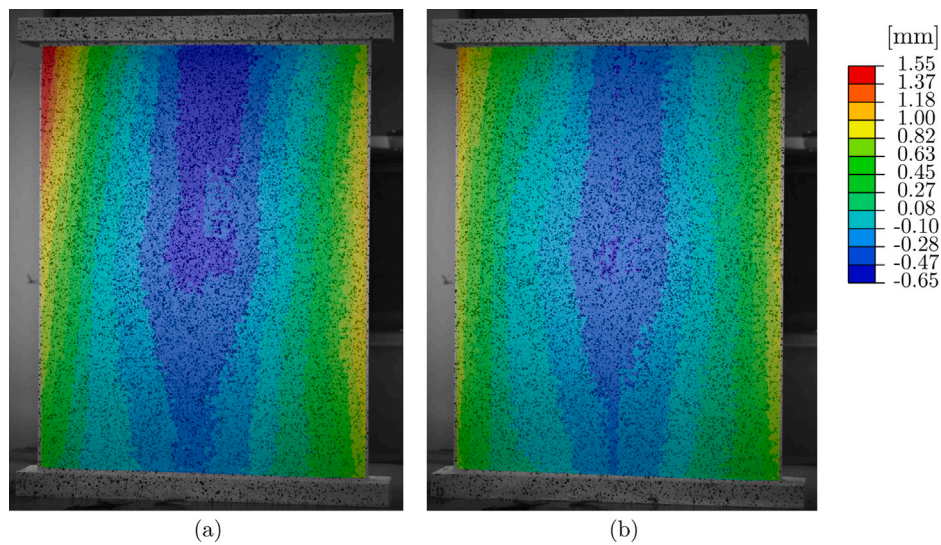
Fig. 5. Out-of-plane geometrical imperfection of skin-side: (a) panel 1; (b) panel 2.

The measured skin-side imperfections are reported in Fig. 5, where the out-of-plane deviation is projected onto each panel as a contour plot. The measurements show a maximum out-of-plane imperfection of 0.65 and 0.56 mm in outwards direction, and a maximum of 1.55 and 1.08 mm in inwards direction, respectively for the two panels. It is possible to note a slightly V-curved shape in the transverse direction and a slight curvature in the longitudinal direction. The curvature in transverse direction is most likely caused by internal stresses due to the potting curing process and by the mismatch in stiffness of the potting material and composite laminates.

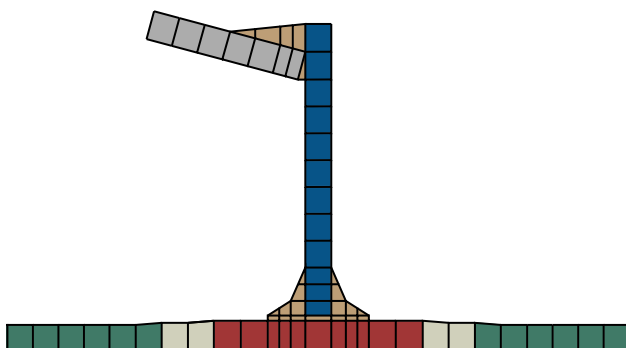
Fig. 6. FE mesh of the stringer cross-section.

The modelling approach makes use of shared nodes to connect the different sections, as shown in the stringer cross-section in Fig. 6. Shared nodes instead of ties shows better computational efficiency and more consistent mesh convergence. The interface between the filler and the skin of the middle stringer is partially bonded by a contact pair definition with VCCT. This area, which is the length of the stringer between the potting, is 445.3 mm long and 9.7 mm wide and has an initial damage of approximately 70 mm in the middle. It is assumed that the pre-crack is present only between the filler and the skin, and that it also only grows in this interface. The possible crack growth into the filler is neglected to lower the complexity of the model. This assumption is based on failure behaviour seen during internal tests by GKN Fokker and three point bending tests by Baran et al. [25]. It is chosen to use VCCT as it shows good results for a relatively coarse mesh [11,30,33], needed for large structures as in this work, which was also shown by Bertolini et al. [7] in a direct comparison between VCCT and CZM. Furthermore, VCCT requires a pre-crack, and this requirement is automatically fulfilled due to the initial damage in the skin-stringer interface.

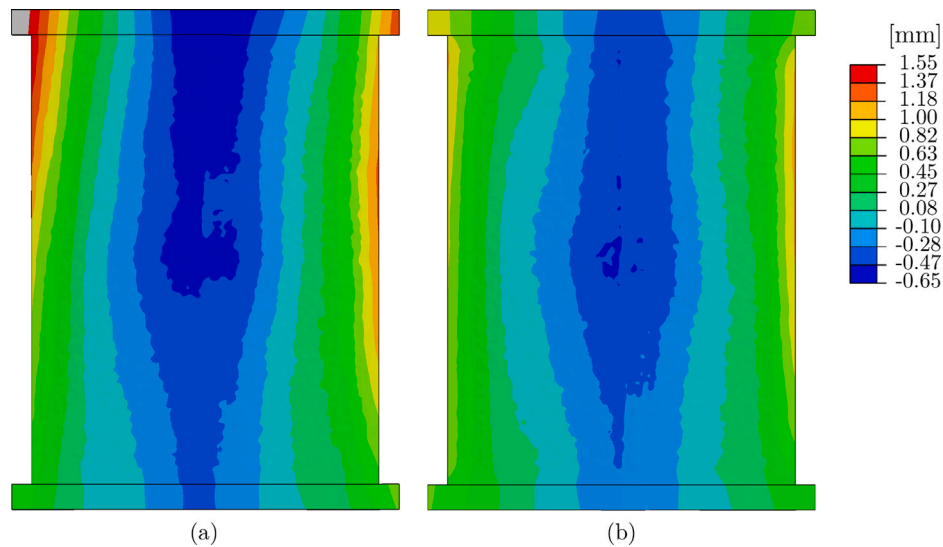
Fig. 7. FE out-of-plane geometrical imperfection of skin-side: (a) panel 1; (b) panel 2.

analysis outputs a nodefile that only includes the deformation field. The nodefile can be used to apply the imperfection in the non-linear analysis, without transferring the stress state of the previous linear analysis. The resulting out-of-plane displacement fields of the linear analysis for both panels, which are the geometrical imperfection used for further analysis, are shown in Fig. 7.

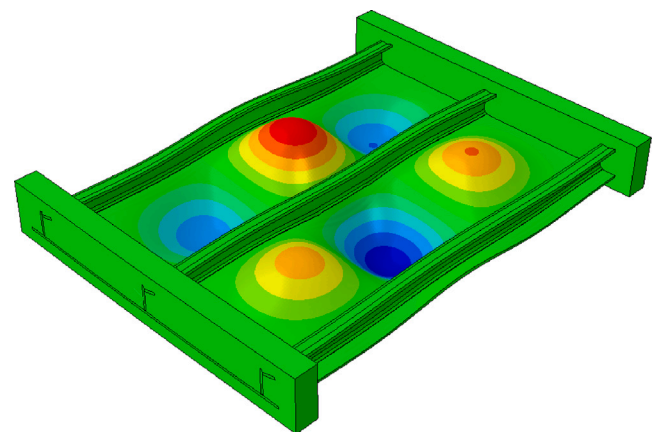
Fig. 8. FE eigenvalue buckling shape.

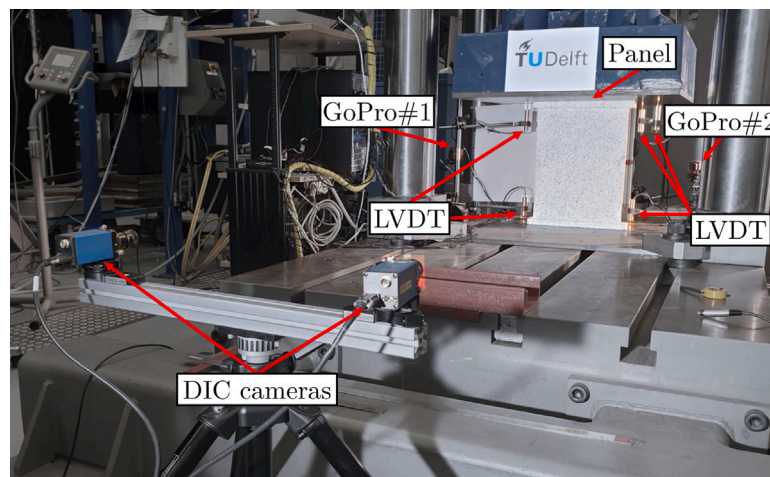
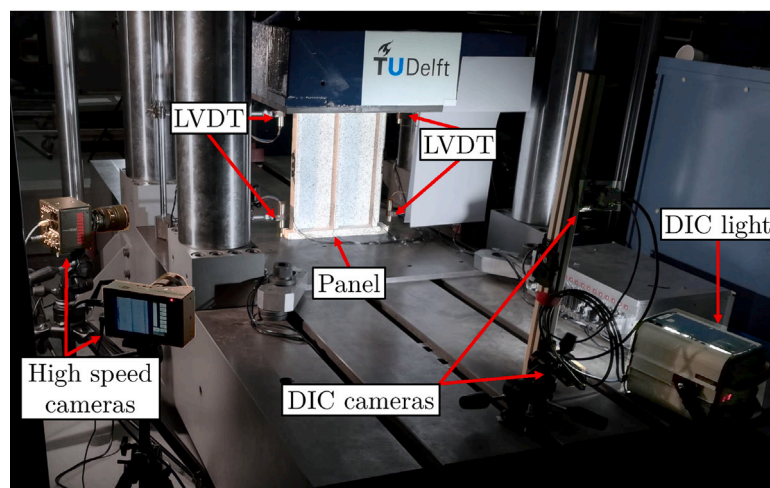
Fig. 9. Test setup: (a) skin-side; (b) stringer-side.

The experimental test setup is shown from the skin-side and stringer-side of the panel in Fig. 9. The panel is placed between the base and the compression plate of the test machine, after which a low preload of 0.5 kN is applied to keep the panel in place. The tests are performed at a loading rate of 0.1 mm/min until final failure of

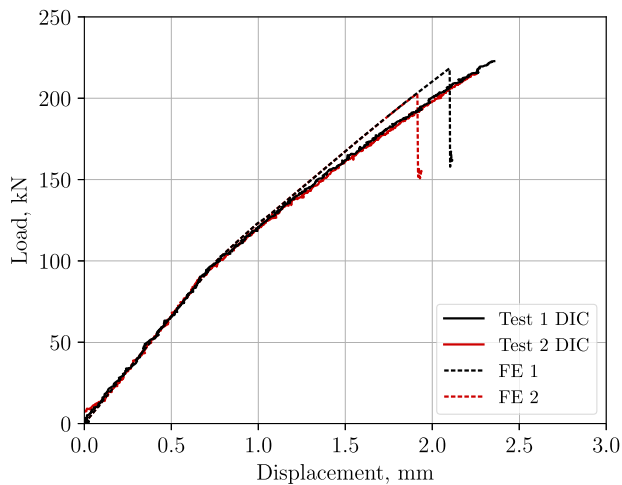
Fig. 10. Load–displacement curves from tests and numerical predictions.

The panels show slight settling behaviour till a load of approximately 20 kN, after which a linear stiffness of 132 kN/mm is measured until buckling occurs at a load of approximately 94 kN for both panels. In the post-buckling field the stiffness is reduced, and continues to be reduced due to a buckling shape change and the growth of the skin-stringer separation. At a load of approximately 145 kN and 187 kN slight drops in stiffness occur for panel 1, while panel 2 shows only one reduction of stiffness at a load of approximately 138 kN. These stiffness reductions are caused by crack growth events, which could also be heard during the test. The panels fail due to skin-stringer separation at a load of 223.0 kN and 215.9 kN for panel 1 and 2, respectively. The difference in load for both the crack growth events and the final failure between the two panels is most likely caused by the difference in the initial damage shape and size and in the geometrical imperfections.

The numerical prediction shows a linear stiffness of 132 kN/mm, followed by buckling at approximately 99 kN. The linear stiffness is

predicted accurately and there is a 5.3% over-prediction in buckling load. The loss of stiffness due to crack growth in the post-buckling field can also be seen in the numerical prediction, but the stiffness is less affected in comparison to the test results and is slightly overestimated. The final failure load is predicted to be 218.3 kN and 202.8 kN for panel 1 and 2, respectively, with a difference of 2.1% and 6.0% compared to the tests. The maximum loads measured during the tests and the loads estimated by the analyses are reported in Table 7.

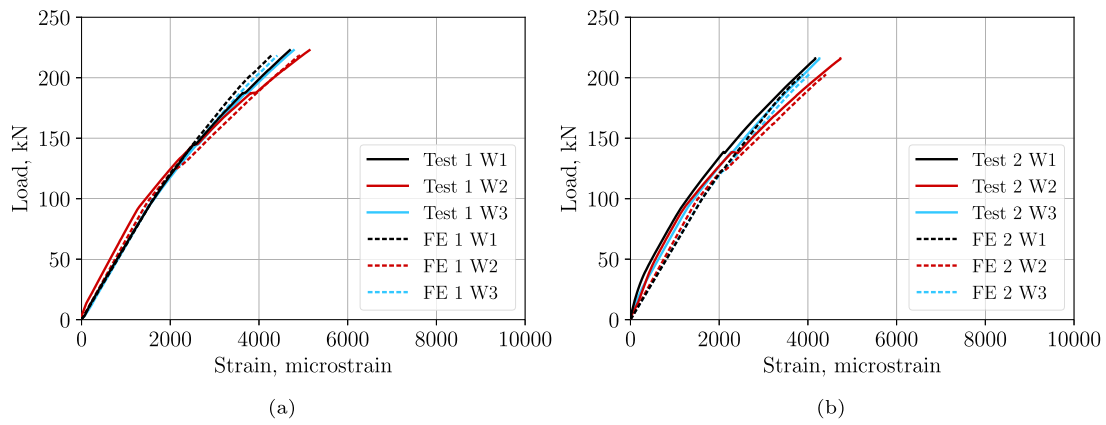
Fig. 11. Experimental and numerically predicted compressive strains in stringer webs: (a) panel 1; (b) panel 2.

The strains measured by the strain gauges on the webs of panel 1 are shown in Fig. 11(a). It can be seen that initially the pre-buckling strains in the outside webs are slightly higher compared to the middle web, indicating that there is a small loading imperfection. Then, all three webs show the same stiffness until buckling. In the post-buckling field the strains show a decrease in stiffness. At 145 kN and 187 kN small load drops are seen indicating crack growth events. The strains of the webs of panel 2 are shown in Fig. 11(b). It can be seen that there is more settling compared to panel 1, most likely due to a slightly larger loading imperfection, and there is one load drop indicating a crack growth event at 138 kN.

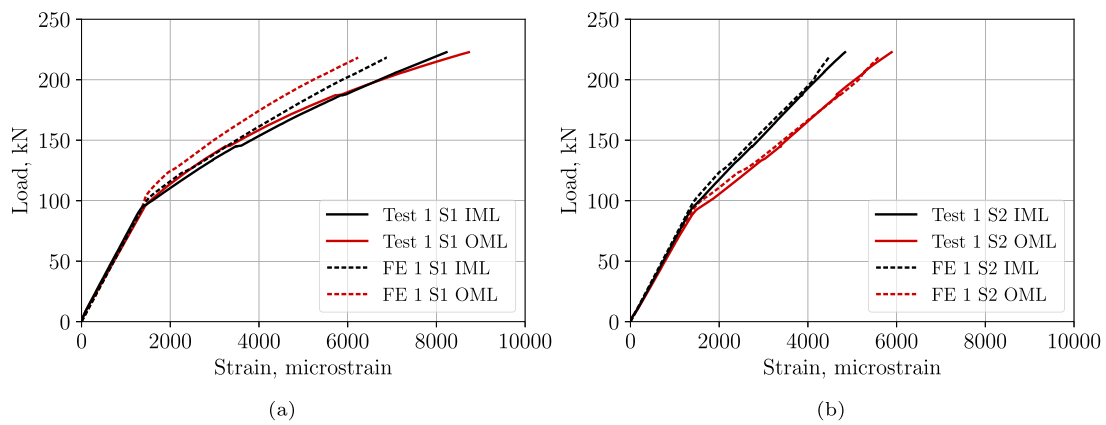
Fig. 12. Experimental and numerically predicted compressive strains of panel 1: (a) S1; (b) S2.

The strains in the skin of panel 1 are shown in Figs. 12(a) and 12(b) for location S1 and S2, respectively, with notation IML and OML for inner and outer mould line. At location S1 the measured strains show a small difference between inner and outer mould line indicating a small bending component. At location S2 the influence of bending is more clear, with a larger difference between IML and OML in the post-buckling field. The measured strains at location S1 are considerably higher compared to location S2 in post-buckling. This difference is most likely caused by the non-symmetric stringer, with S1 being located on the opposite side of the cap and S2 being located underneath the cap.

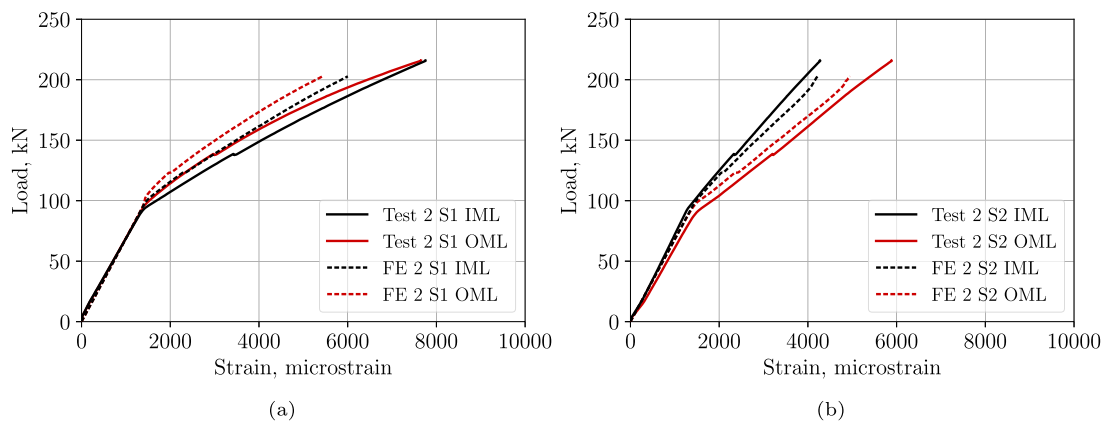
Fig. 13. Experimental and numerically predicted compressive strains of panel 2: (a) S1; (b) S2.

The strains of the skin of panel 2 are shown in Figs. 13(a) and 13(b) for location S1 and S2 respectively. In pre-buckling, location S2 shows a minor bending component, which is not seen for panel 1. This is most likely caused by a small loading imperfection. For both location S1 and S2 the measured strains of panel 2 show more bending compared to panel 1.

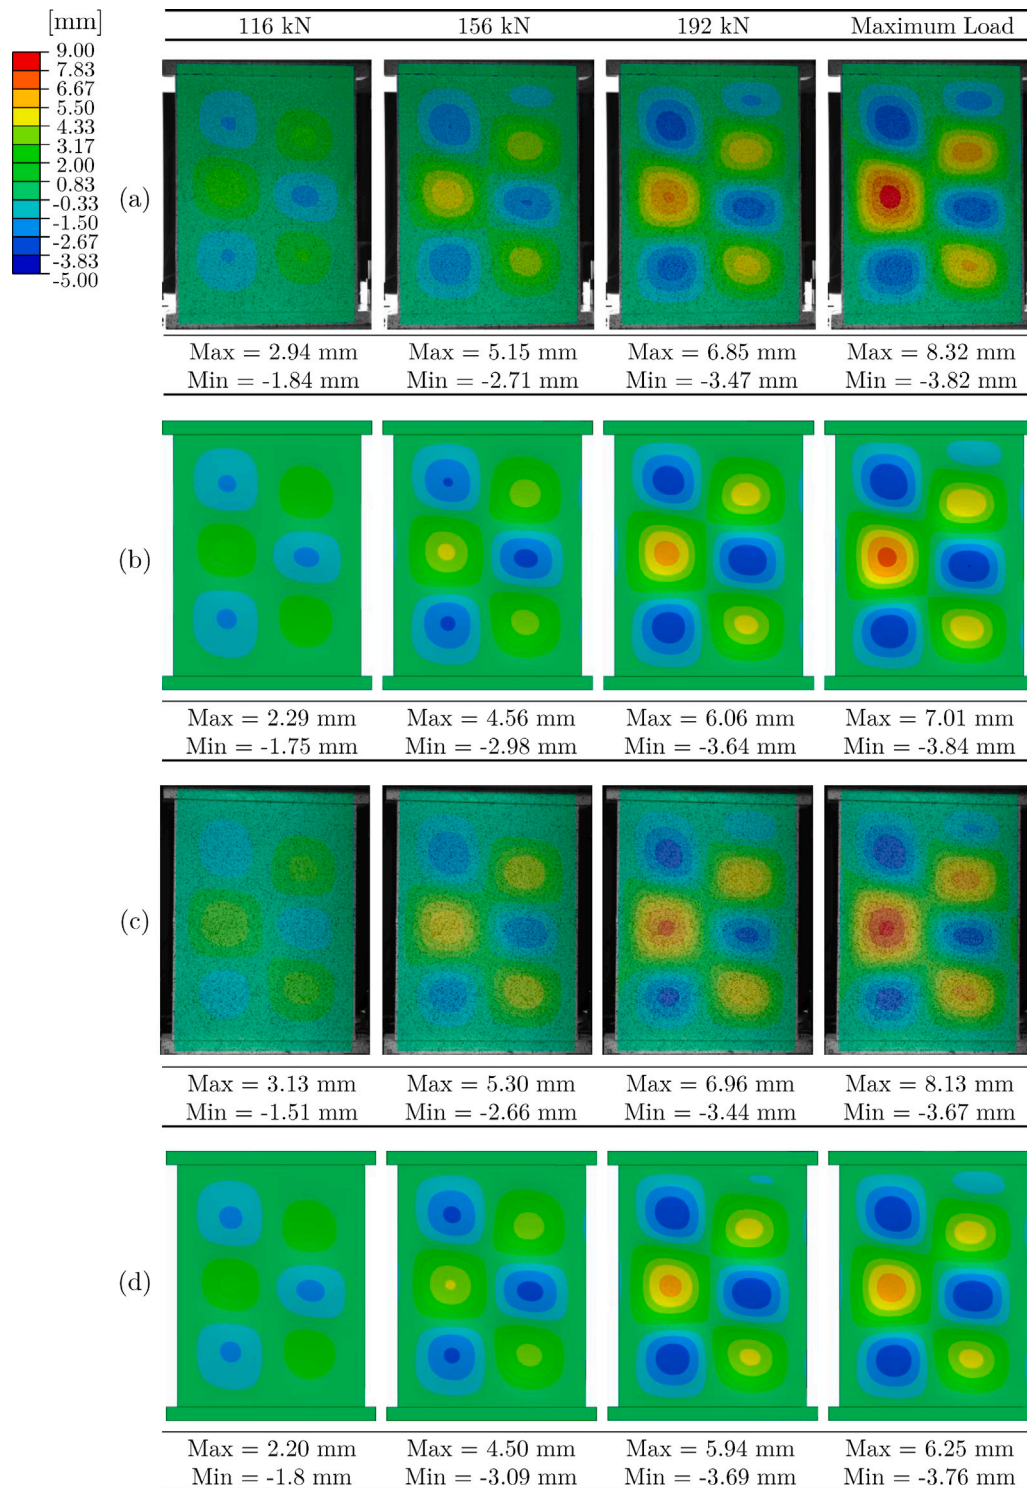
Fig. 14. Out-of-plane displacement: (a) panel 1 test; (b) panel 1 FE; (c) panel 2 test; (d) panel 2 FE.

The out-of-plane displacements of the two panels captured by the DIC system are reported in Fig. 14 by contour plots at four load levels, to show the evolution of the deformation in the post-buckling field. For each contour plot the maximum and minimum out-of-plane displacement are reported. A positive sign is for displacement in inwards direction towards the stringer, and a negative sign is for outwards direction away from the stringer. The contour plots for both tests are compared with the results of the numerical analysis.

The test of panel 1 shows an initial three half wave buckling mode, antisymmetric with respect to the middle stringer. At higher loads the buckling shape changes slightly, with a fourth half wave appearing at the top of the right bay. It can be noted that there is a higher inward out-of-plane displacement, in the direction of the stringers, compared to the outward displacement. Initially after buckling it is seen that the magnitude of the out-of-plane displacement is approximately equal in both bays. At higher loads the fourth half-wave becomes more prominent and the magnitude of the displacement becomes higher in the left bay in both inwards and outwards direction compared to the right bay. The half-waves in the left bay are also longer compared to the right bay. This difference becomes more prominent when the fourth half-wave appears in the right bay, and the difference continues to increase until final failure.

The test of panel 2 shows the same three half wave buckling shape as panel 1. In comparison to panel 1, the buckling shape changes with a fourth half-wave at the top of the right bay at a higher load, and the fourth half-wave is smaller in magnitude. The out-of-plane displacement at 116 kN of panel 2 is higher in inwards direction and lower in outwards direction compared to panel 1. This difference might be caused by differences in the geometrical imperfections or loading imperfections, and becomes less at higher loads when the out-of-plane displacements of panel 1 and 2 converge.

The three half-wave buckling shape is accurately predicted, with a great level of similarity in terms of half-wave position and length. The buckling shape change with the fourth half-wave at the top of the right bay is also predicted, but it happens at a higher load compared to what is seen in both tests. The magnitude of the out-of-plane displacements are smaller for inwards direction, while the outwards displacements are initially larger. The outwards out-of-plane displacements at the maximum load is accurately predicted for both panels, indicating that the amount of crack opening due to the outwards displacements might be the dominating factor for final failure.

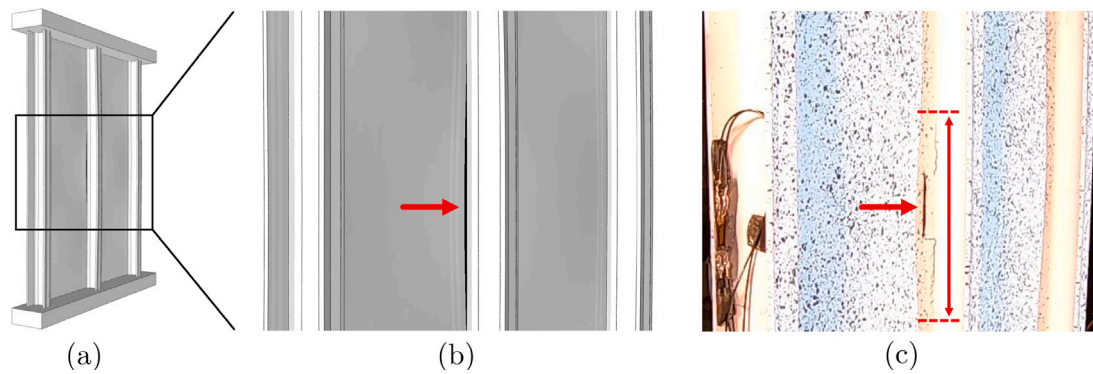
Fig. 15. Crack opening seen from left side of panel 1 at 156 kN: (a) full view of panel; (b) close-up FE; (c) close-up camera footage with visual separation length marked in red.

As panel 1 and panel 2 show very similar behaviour, only camera footage of panel 1 is here reported. At 156 kN, approximately between buckling and final failure, crack opening can be well distinguished, as shown in Fig. 15. The crack has opened and grown, with more crack

growth in downwards direction compared to upwards direction. The cap-side of panel 1 is shown Fig. 15(c). The opposite side of panel 1, corresponding to the side of the stringer without cap, is shown in Fig. 16, where no crack opening can be seen. The one-sided crack opening is due to the buckling shape, where the outwards half-wave on the cap-side opens the crack, while the inwards half-wave on the opposite side of the cap tends to close it.

shown in Figs. 15(a–b) and 16(a–b) for the cap and the opposite side, respectively, for a comparison with the camera footage.

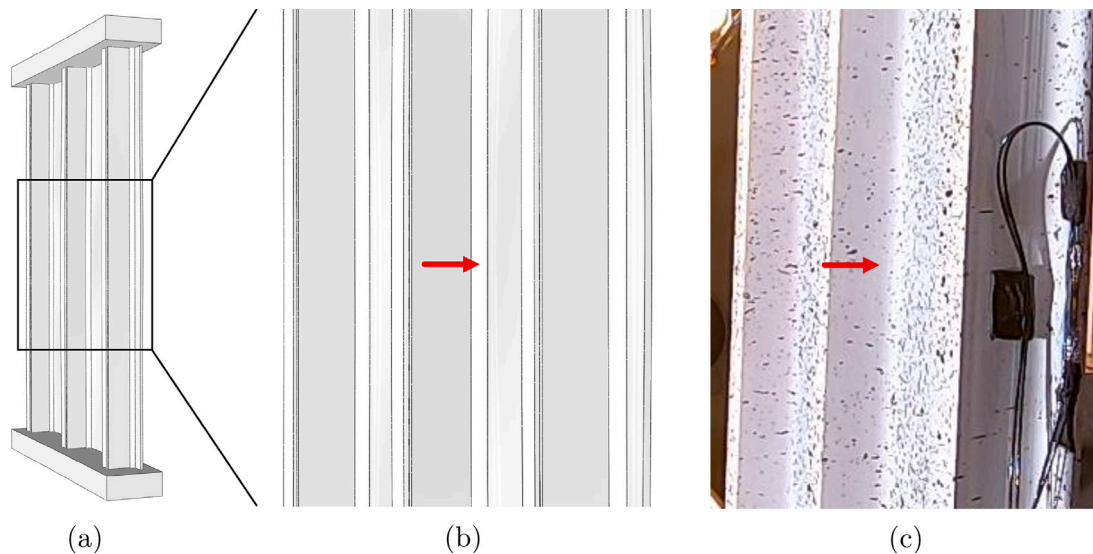
Fig. 16. Closed crack seen from right side of panel 1 at 156 kN: (a) full view of panel; (b) close-up FE; (c) close-up camera footage.

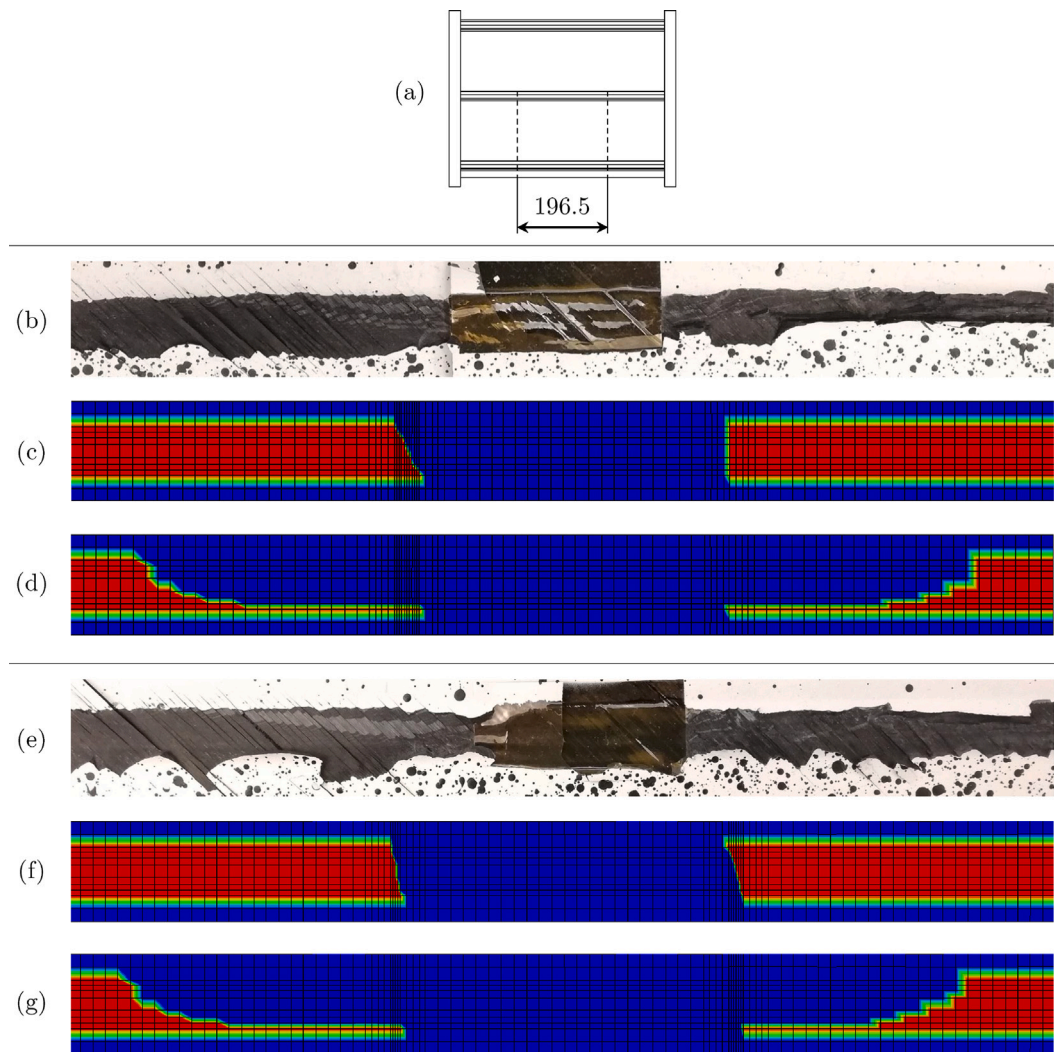
Fig. 17. Top view skin-stringer interface: (a) Interface area of interest; (b) test panel 1 fracture surface; (c) FE panel 1 initial damage; (d) FE panel 1 at 156 kN; (e) test panel 2 fracture surface; (f) FE panel 2 initial damage; (g) FE panel 2 at 156 kN.

To further investigate the skin-stringer separation, the fracture surface is analysed. It is shown over a length of 196.5 mm, as highlighted in Fig. 17(a), which corresponds to the area that is separated before the final failure. The fracture surface of panel 1 is shown in Fig. 17(b),

where the foil inserted in the joint for the initial damage can be noted. The grey marks close to the foil are considered to be caused by the extension process of the initial damage, as the distance between the markings match the initial damage length. Larger grey marks can be seen further away from the foil, with a slight elliptical shape. The shape of these marks is most likely caused by the one-sided crack growth in the post-buckling field.

The fracture surface of panel 2 is shown in Fig. 17(e). The fracture surface is very similar to panel 1, but it shows less grey marks. This might be due to the single unstable crack growth event in post-buckling compared to panel 1. Also, more filler material remains attached to the skin, and delaminations can be seen on both sides of the foil.

The skin-stringer interface of the numerical analysis for panel 1 is shown for the initial damage and at the load of 156 kN in Fig. 17(c) and Fig. 17(d), respectively, where red indicates intact interface, and blue indicates separated interface. The numerical prediction at 156 kN shows a quasi elliptical crack front shape, with a narrow horizontal line of intact interface.

The skin-stringer interface of the numerical analysis for panel 2 for the initial damage and at the load of 156 kN are shown in Fig. 17(f) and Fig. 17(g), respectively. The initial damage is similar to panel 1, but is slightly longer. The interface at 156 kN shows slightly more crack growth compared to panel 1, which might have led to the lower final failure load of panel 2.

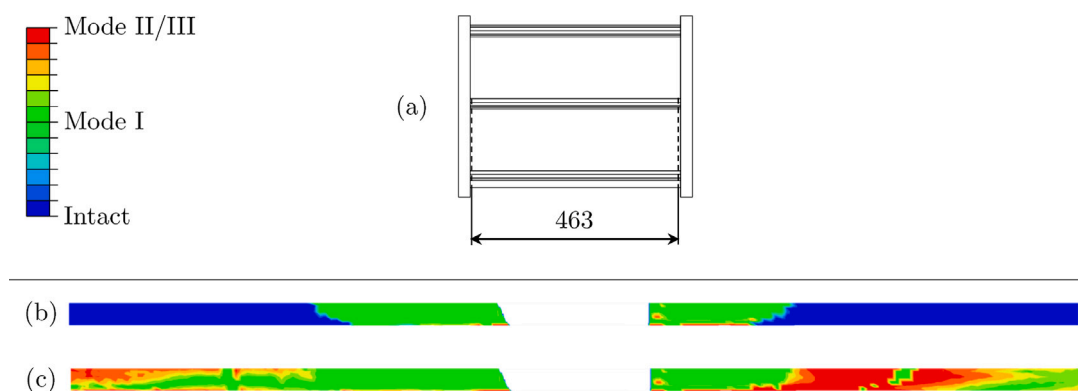
Fig. 18. Panel 1 mode-mixity: (a) Interface area of interest; (b) mode-mixity at start of final failure; (c) mode-mixity after final failure.

The mode-mixity is determined by using the energy release rates for mode I, II and III as shown in Eq. (4), resulting in a value of 0 for pure mode I and a value of 1 for pure mode II/III. In case of an intact interface, a value of -1 is assigned. The interfaces are analysed over a length of 463 mm, as reported in Fig. 18(a). The mode-mixity of the fracture surface at the start of final failure is shown in Fig. 18(b). The one-sided crack growth before failure is mode I dominated, with final failure being initiated by a narrow line of mode II/III fracture. The fracture surface after the final failure of the panel is shown in Fig. 18(c). The crack growth towards the left is mode I dominated while the crack growth towards the right is mode II/III dominated. The majority of the fracture surface is either dominated by mode I or mode II/III, with only small areas of mixed-mode loading.

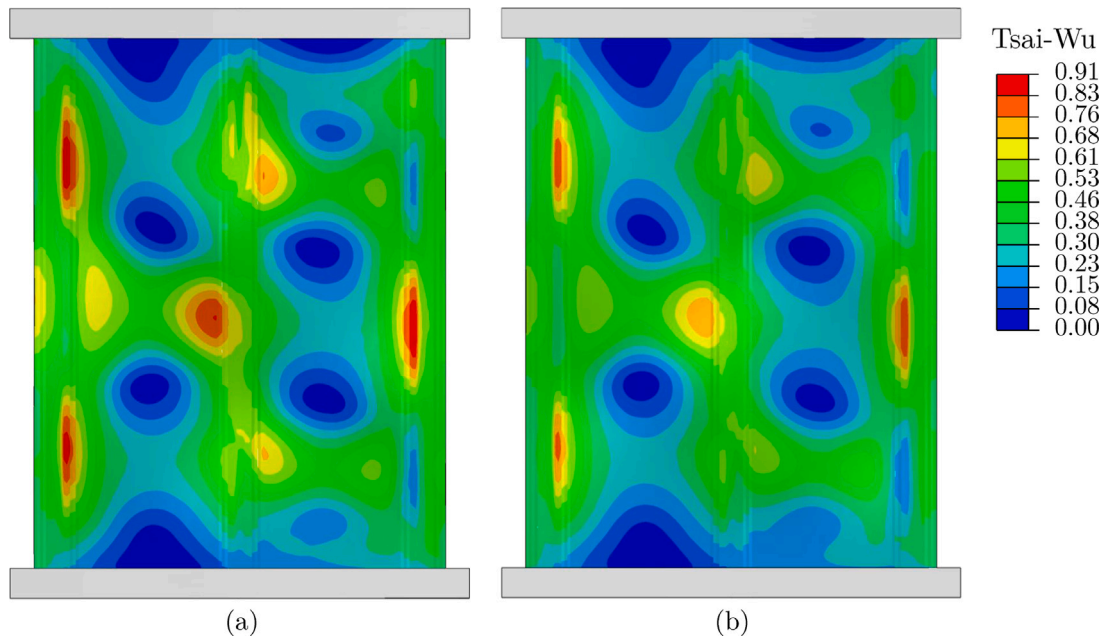
Fig. 19. Tsai-Wu failure criterion of the skin bottom zero ply from the numerical prediction at maximum load: (a) panel 1; (b) panel 2.

critical ply according to the Tsai-Wu criterion is the bottom zero ply in the skin, for which the contour plots of both panels are shown in Fig. 19. It can be noted that the most critical locations are underneath the outer stringers, approximately coinciding with the longitudinal location of outwards half-waves of each corresponding bay.

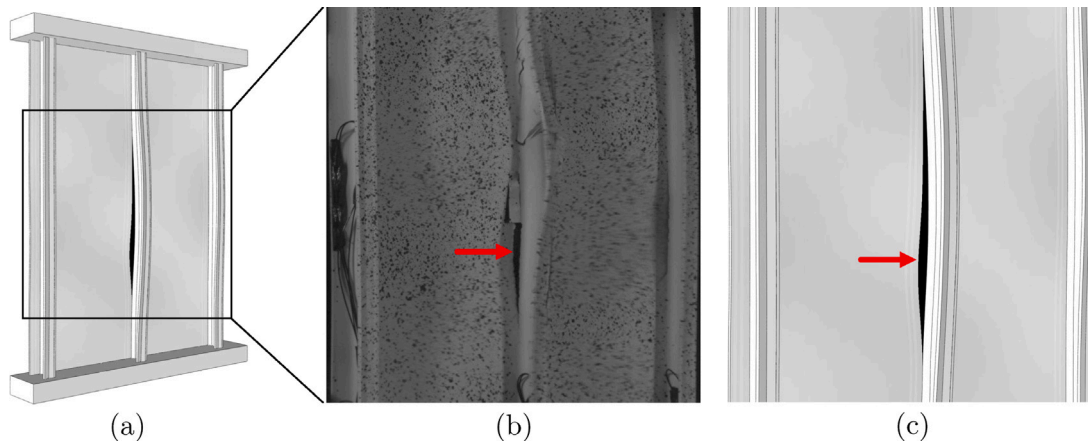
Fig. 20. Crack opening of panel 1 during final failure: (a) full view of panel; (b) high speed camera; (c) close-up FE.

The final failure mode is captured by two high speed cameras. The area that is recorded by high speed camera 1 is shown on the FE model in Fig. 20(a). A frame of the 3000 fps high speed footage of panel 1 is shown in Fig. 20(b). It highlights the behaviour during separation of the middle stringer. The crack in the butt-joint grows in downwards

direction and a tunnel forms between two outwards buckling half-waves. Due to the separation of the stringer from the skin, the cap and the web of the stringer also start to show failure, and consequently load carrying capabilities are lost. The numerical prediction of the final failure of the panel is shown in Fig. 20(c). The analysis also reveals crack growth in downwards direction, with a tunnel between two outwards buckling half-waves, similarly to the failure behaviour seen in the tests.

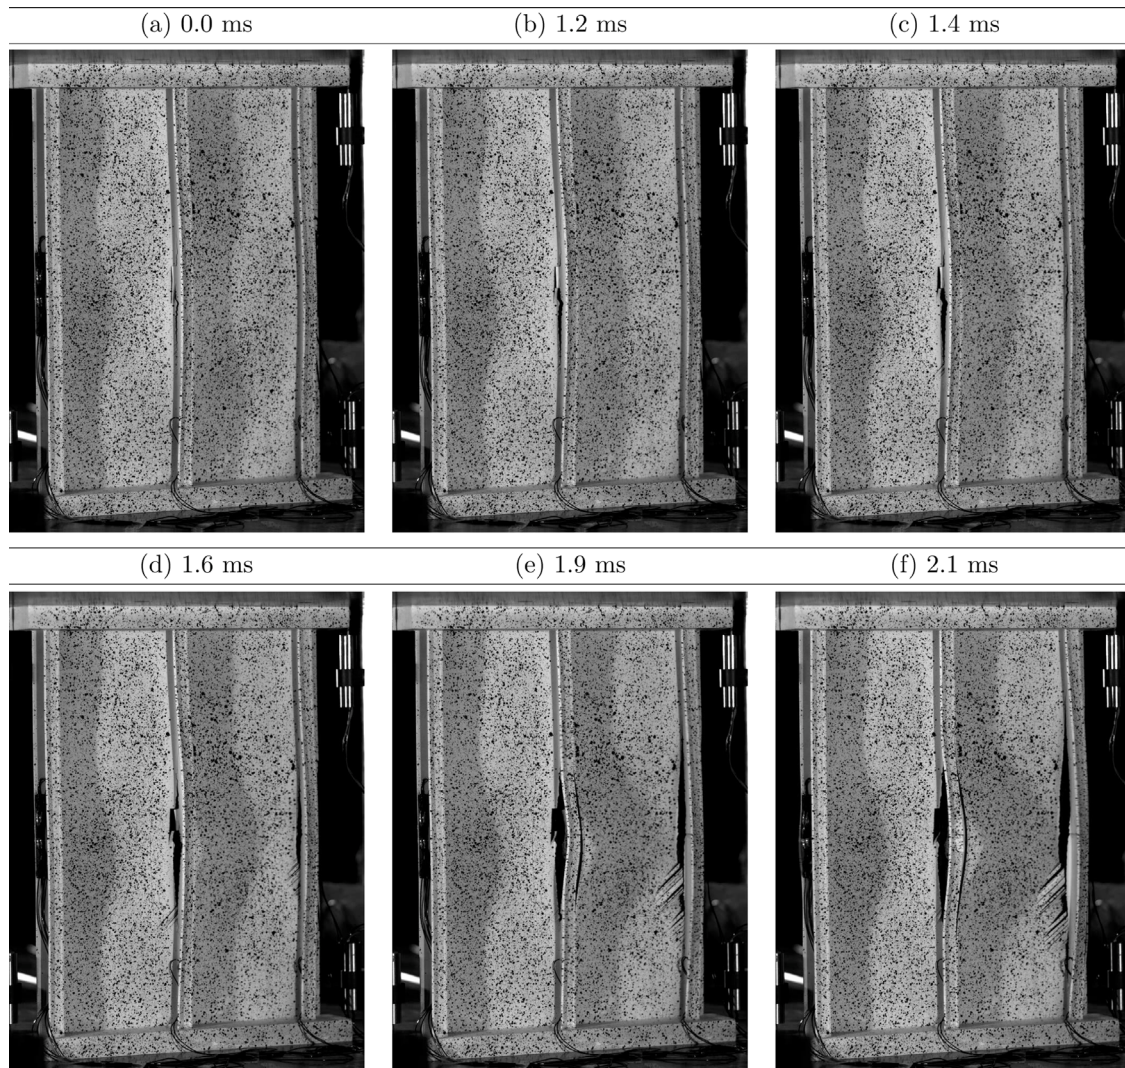
Fig. 21. Sequence of final failure of panel 2 captured by high speed camera: (a) crack opening of middle stringer; (b) crack propagation of middle stringer; (c) separation of right stringer; (d) separation of middle cap; (e) failure of middle cap; (f) separation of left stringer and separation of right cap.

The sequence of the final failure over the full length of panel 2 is captured by the second high speed camera at 10,000 fps, as shown in Fig. 21. Final failure starts with the crack opening (a). Then the crack grows between the web of the middle stringer and the skin (b), after which the separation between the web of the right stringer and the skin occurs (c). This is followed by the separation between cap and web of the middle stringer (d) and failure of the middle cap (e). Then, the web of the left stringer starts to separate from the skin simultaneously with the separation between cap and web of the right stringer (f). This sequence occurs within 2.1 ms, and shows that the skin-stringer separation is the critical failure mode leading to the final failure of the panel.
