FROM DETERIORATION TO REVIVAL

Approaches to the Conservation of Plastic Buildings

Ashal Tyurkay, Uta Pottgiesser

KEYWORDS: Futuro, deterioration, Conservation Management Plan (CMP), comparative analysis, plastics

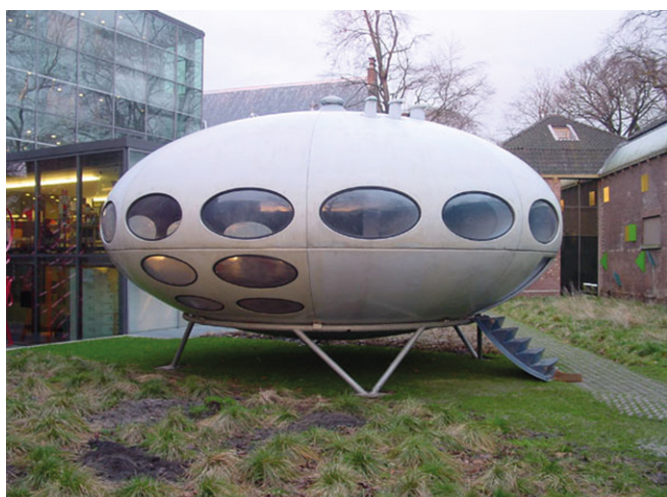
01 *Futuro No. 000* (prototype) before conservation in 2003 exhibited outside in the Centraal Museum in Utrecht. © K. Vermaas, 2003

expression and of experimental construction from post-WWII [FIGURES 01 - 04]. They witness an iterative construction process using innovative forms, materials or joints in connection with traditional building methods and techniques.²

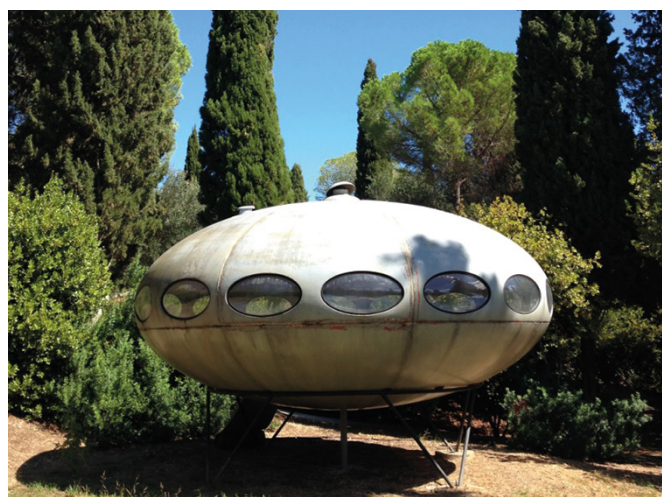
02 The *Corfu-Futuro* house installed in Limni, Corfu island. © D. Joannou, 2014

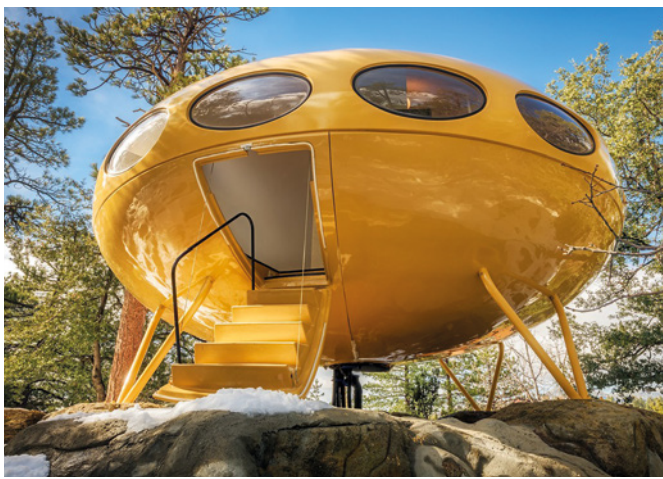
03 The *Donaldson-Futuro* is placed outside and serves as a private guest house. © P. Kozal, 2018

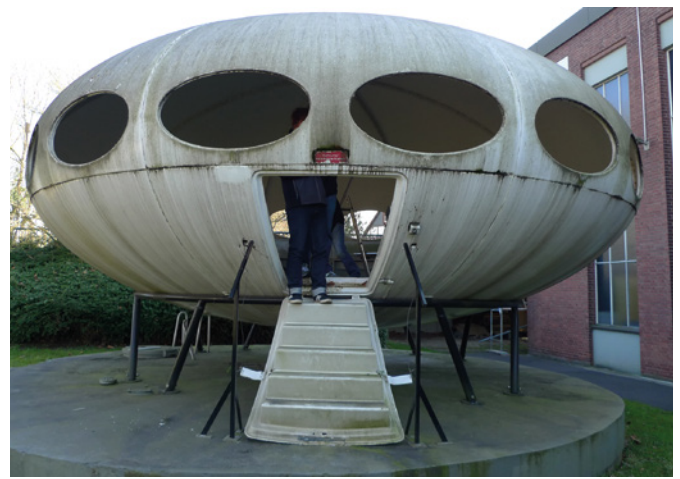
04 The *Munich-Futuro* in Witten (Germany) before transportation to Munich. © BAKU, P. Voigt, 2016.

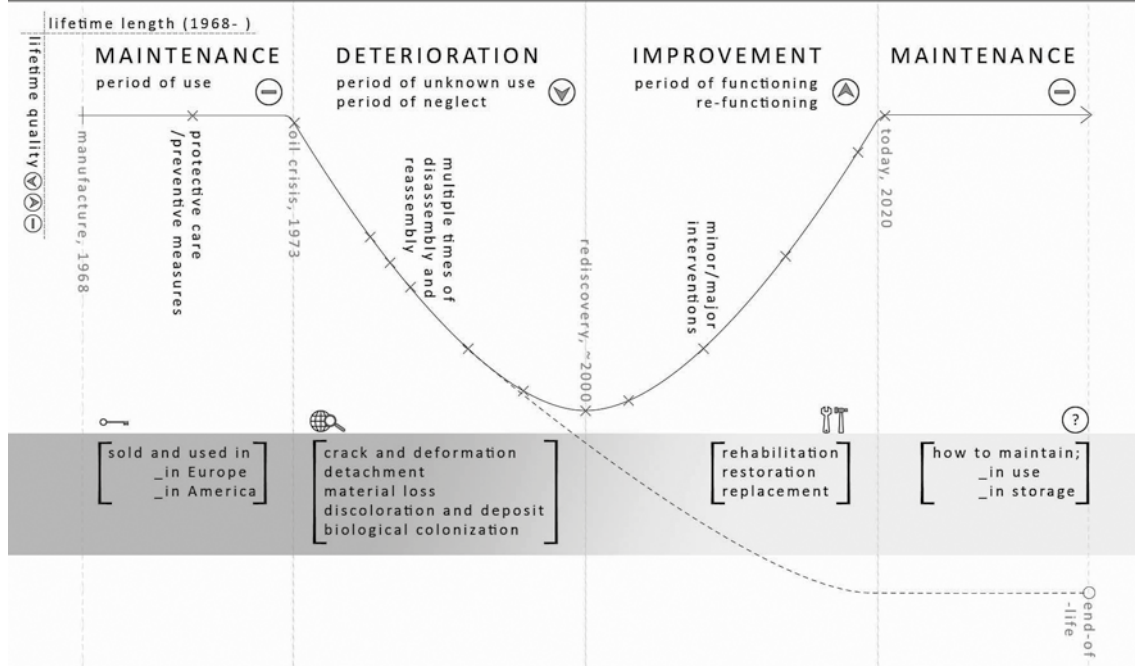
05 The Lifetime Change Curve describes the periods and moments of deterioration and intervention. © Authors

Criteria and processes of conservation could be applied to the lifetime of the Futuros [05]. Taking the manufacture or creation date of the Futuro as the start of its life, the lifetime could be described, including maintenance, deterioration and conservation intervention (improvement).
