Structural integrity assessment of a full-scale adhesively-bonded bi-material joint for maritime applications

Thin-Walled Structures

The present study proposes a comprehensive integrity assessment approach for a full-scale adhesively-bonded bi-material joint for maritime applications. The joint represents a cross-section of the bond-line connection of a ship with a steel hull and a sandwich composite superstructure. The full-scale joint consists of a sandwich composite core adhesively bonded to two U-shaped steel brackets. The joint was subjected to a quasi-static loading profile including 6 load cycles up to the final failure. Each load cycle was followed by a dwell segment holding the joint at the maximum displacement for 30 s and then unloading to 50% of the maximum displacement. Three Structural Health Monitoring (SHM) techniques including Acoustic Emission (AE), Fiber Optic Sensor (FOS), and Digital Image Correlation (DIC) were employed during the test to assess the damage state of the joint. Moreover, a Finite Element Model (FEM) was developed to simulate the evolution behavior of different damage mechanisms in the joint and the FE results were compared against the experime

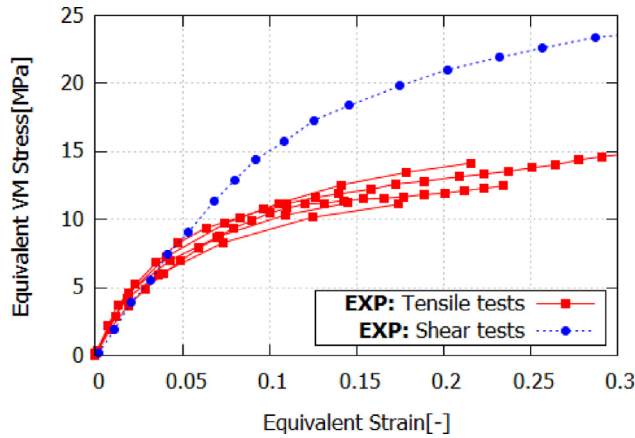
Fig. 5. Comparison between the response of adhesive under shear and tensile loadings. The equivalent stress $\sigma_e = \tau\sqrt{3}$ and equivalent strain $\epsilon_e = \frac{\gamma}{\sqrt{3}}$.

the Von Mises (VM) equivalent stress in Fig. 5. The comparison shows a stronger material response under shear loading compared to the tensile loading using VM equivalent stress. From the modeling point of view, this will forbid the VM criteria to be used as a yielding criterion, requiring instead an anisotropic yielding criterion such as Hill's yielding criterion [20] to describe the adhesive behavior. A reminder of the yielding function expression is given in Table 1.

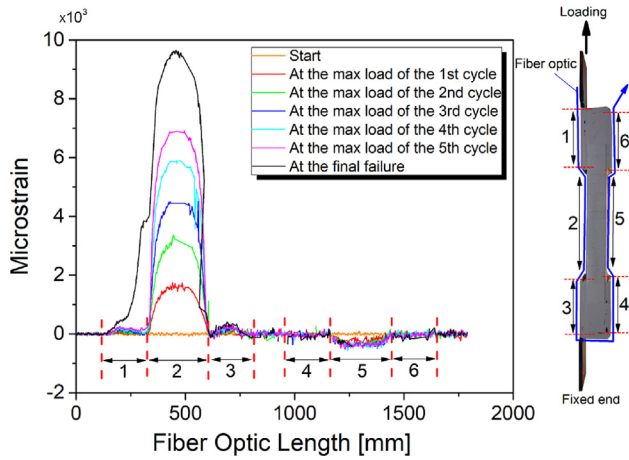
Fig. 9. The FOS longitudinal strain distribution in the joint.

the wooden blocks were auxiliary components in the tested joint. Experimental observations revealed that the joint failed because of the induced bending in the joint, which refers to the asymmetry of the joint under loading conditions to mimic the real-life loading condition of the joint. The measured strain by the FOS clearly indicates the bending induced at the CFRP skin of the joint (see Fig. 9). As it is clear, there is a large tension strain at the left CFRP skin (Section 2), while the right CFRP skin is under a compression strain (Section 5). Finally, the joint failed at the side which is under tension stress (see Fig. 9).

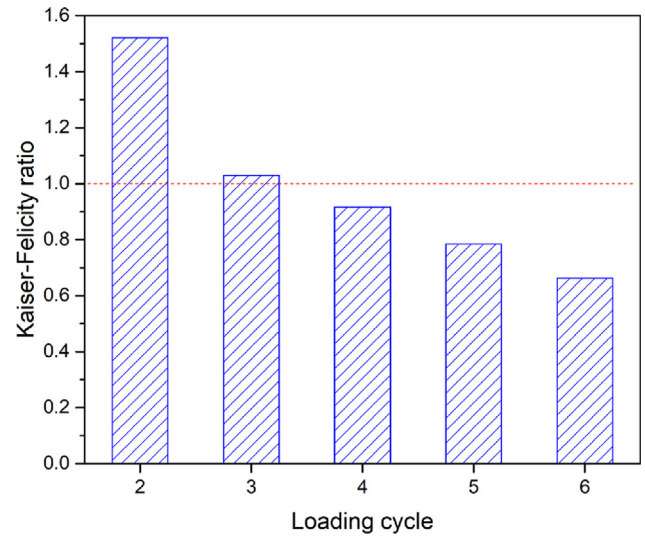
Fig. 11. Kaiser and Felicity ratios for the joint.

the AE profile of the first load cycles, the AE curve is plateau during the unloading phase. In the next reloading phase, as long as the load level is less than the maximum load of the previous load cycle, the AE curve is still plateau, while once the load crosses the maximum load of the previous load cycle, the cumulative number of AE events increases. This phenomenon is called the Kaiser effect that shows the joint is still healthy. During the reloading phase, if the AE activities increase at load levels less than the maximum load of the previous load cycle, it indicates the occurrence of the critical damage in the joint that adversely affected the integrity of the joint. This phenomenon is named Felicity effect [7,22] and it can be seen for the last load cycles. If the load corresponding to the initiation of the new AE activities in the reloading phase is divided by the maximum load of the previous load cycle, it can be used as an indication of Kaiser or Felicity effects [7,22]. The index larger than or equal to 1 indicates the Kaiser effect, while the index smaller than 1 indicates the Felicity effect. This index is depicted in Fig. 11 for the joint. As it is clear, the Felicity effect is obvious at the 4th load cycle. This indicates that the critical damage of the joint started in the 4th load cycle. The load level corresponds to the critical damage detected by the AE is ~65% of the final fracture

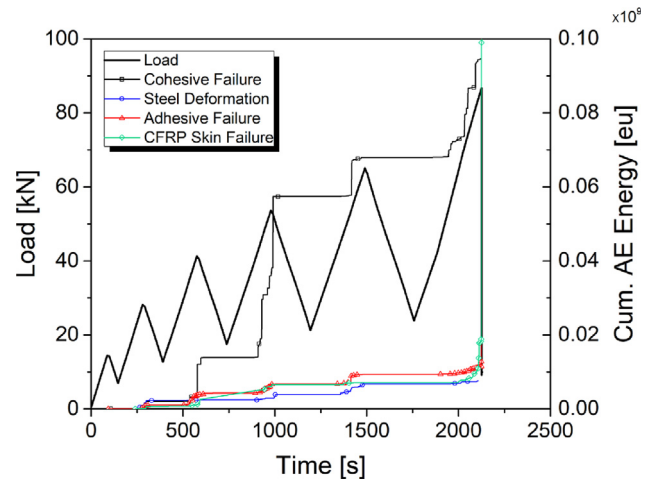
Fig. 12. The cumulative AE energy curve of the different damage mechanisms of the joint.

The cumulative AE energy curves of the classified AE signals are depicted in Fig. 12. From the progressive damage point of view, irrespective of the instantaneous jump at the end of the test (at the final failure moment), the dominant damage mechanisms are CFRP skin failure, which is obvious in Fig. 8, and shear deformation of the adhesive layer, “cohesive failure”, which is obviously visible in the DIC results (see Fig. 13). These two figures indicate the shear stress distribution in the joint at the maximum load of each cycle. As it is obvious, by increasing the load, a considerable plastic shear strain is formed at the adhesive layer of the joint that confirms the presence of a huge amount of cohesive failure signals in the classified AE results (see Fig. 12).

According to the dominant damage modes indicated by the AE results (see Figs. 12 and 14) and the visual inspection and DIC (see Figs. 8 and 13), the failure of the composite skin in contact with the adhesive part, which experiences high shear stress, is the main failure mechanism. The location of the crack initiation was also confirmed by the FE simulations as showed in Fig. 18.

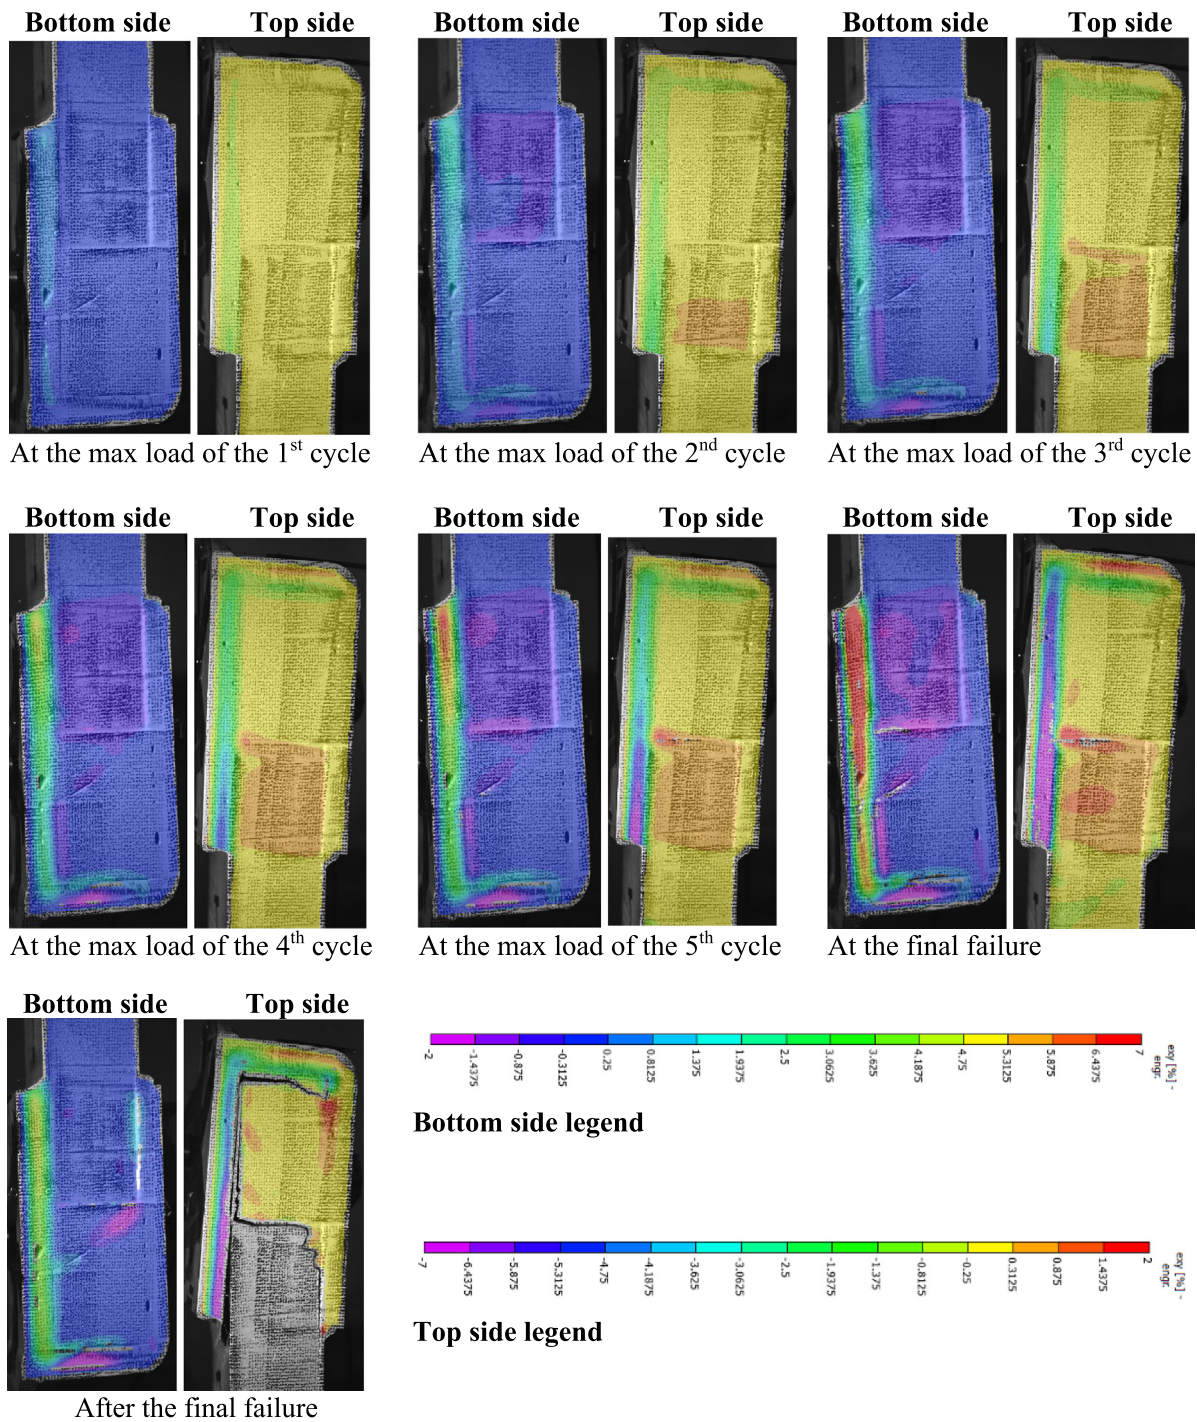
Fig. 13. Shear strain contours of the top and bottom parts of the joint during the tensile loading.

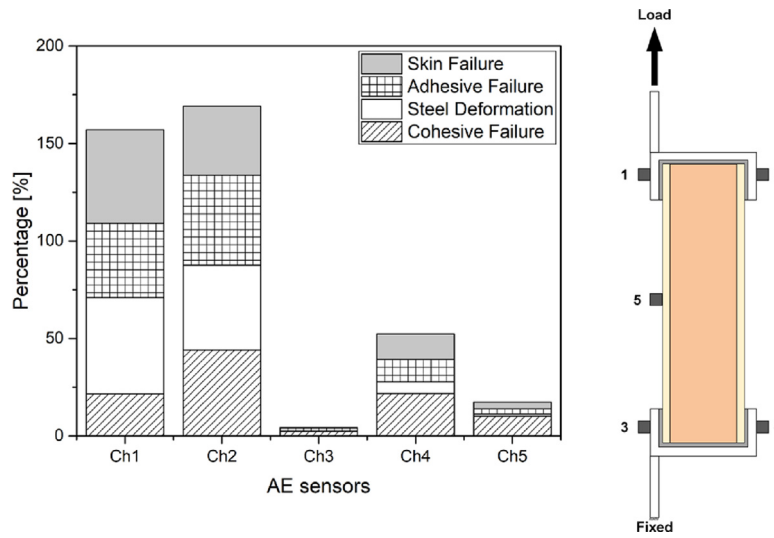
Fig. 14. The contribution of different damage mechanisms per each AE sensor for the joint.

In order to specify the critical regions of the joint where most of the damages occur, the distribution of the recorded AE signals among the five AE sensors is plotted in Fig. 14. The AE sensors Ch1 and

Ch2, which were close to the final failure location (top side), recorded most of the AE signals, while AE sensors Ch3 and Ch4, which were far from the final failure location, recorded a few AE signals. The AE sensor Ch5, which was located at mid-height of the joint, on the CFRP skin, recorded a few AE signals that means the damage zone is far from the middle of the joint and the critical parts of the joint are two adhesively-bonded ends of the sandwich structure.

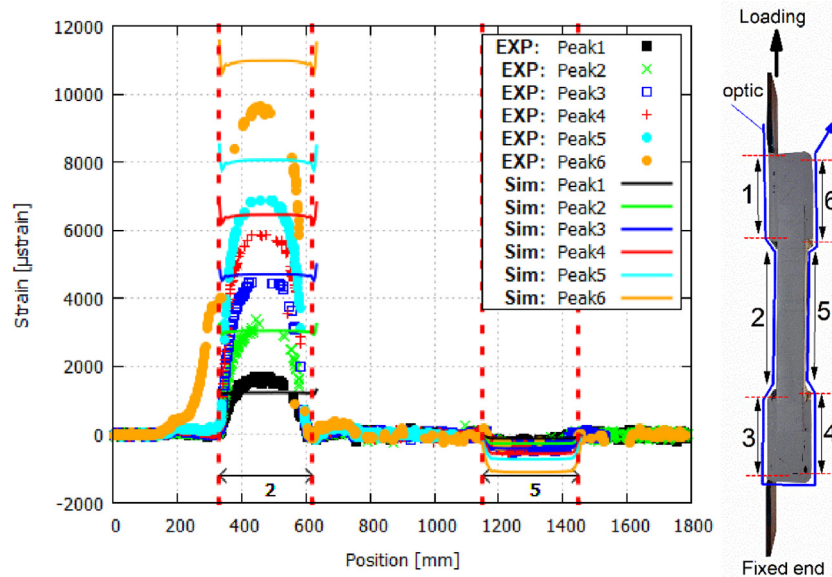
Fig. 16. Comparison between the predicted strains by the FE simulations and the experimental measurements obtained by FOS for the joint.

Fig. 16 shows the longitudinal strain on the lateral sides of the simulated joint in comparison with the true longitudinal strain measured by the FOS during the tests. Again, a good agreement is obtained for low global displacements corresponding to the first cycles, while an overestimation similar to the global response in terms of force is observed. This may also be related to possible damage in the welding between the steel flanges and the U-shaped steel parts.
