**Hydrogen Embrittlement of Inconel 718 Manufactured by Laser Powder Bed Fusion Using Sustainable Feedstock  
Effect of Heat Treatment and Microstructural Anisotropy**

Metals

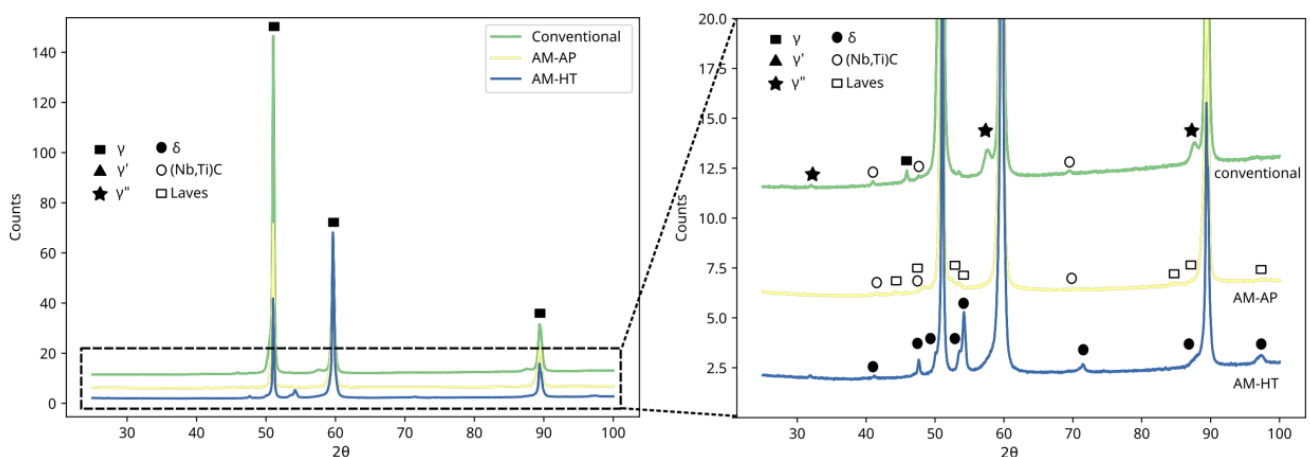
**Figure 8.** XRD measurement results for Conventional, AM-AP and AM-HT Inconel 718.

XRD analysis was performed to confirm the presence of different phases. Figure 8 shows the XRD measurement results for conventional, AM, and AM-HT. For all samples, the primary matrix phase ( $\gamma$ ) shows the strongest peaks. Only qualitative phase analysis is performed, as most of the phases give peaks which overlap with the primary matrix, thus making it hard to distinguish them. In the conventional samples, small peaks identified as  $\gamma''$  are seen close to the  $\gamma$  matrix peaks. Additionally, peaks corresponding to Ti, Nb—carbides are also visible. Even though the microstructure shows the presence of the  $\delta$  phase, corresponding peaks were not identified in the XRD measurement; this is due to the poor resolution of XRD when the phase fractions are less than 5%.

matrix. This leads to the formation of the  $\delta$  phase in these regions during heat treatment [45]. Small peaks corresponding to the  $\delta$  phase are visible for the AM-HT sample in Figure 8, confirming the same.

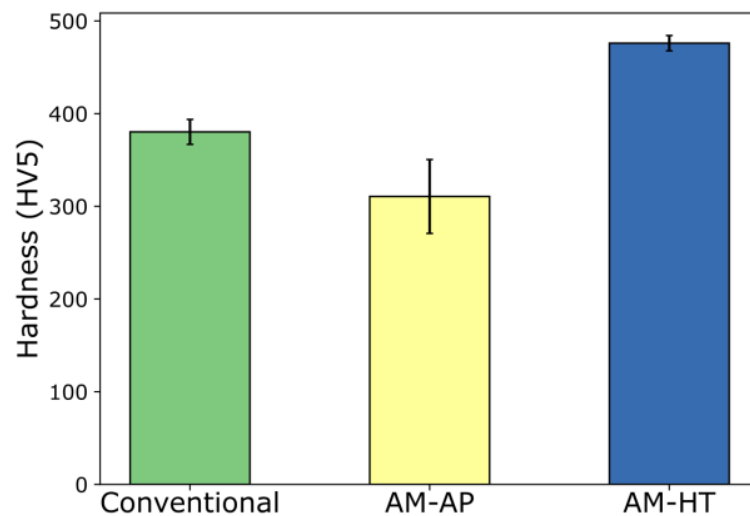
**Figure 9.** Vickers hardness measurements in yz-plane of conventional, AM-AP and AM-HT Inconel 718.

The Vickers hardness measurements of the samples are given in Figure 9. The conventional sample shows a hardness of  $380 \pm 13$  HV<sub>5</sub>, which is in the expected range for the heat-treated wrought alloys [49]. In the case of AM samples, after heat treatment, the sample shows a hardness of  $476 \pm 8$  HV<sub>5</sub>, which is 53% higher than the hardness of the AM-AP sample ( $310 \pm 39$  HV<sub>5</sub>). This is expected, as the heat treatment introduces  $\gamma'$  and  $\gamma''$  strengthening phases, which are absent in the as-processed condition [44]. On the other hand, even after the precipitation of  $\gamma'$  and  $\gamma''$  phases, the conventional sample shows a hardness value lower than AM-HT samples. The difference in the hardness of AM-HT and conventional samples can be attributed to the fine microstructure induced by the L-PBF process. This is evident when comparing Figures 4 and 6, and is in agreement with data reported by Tanja et al. [50]: where the grain size of L-PBF Inconel 718 is reported to be finer than the forged counterpart by a factor of 10. The higher hardness values of AM-HT would correlate to a higher yield and tensile strength [51]. Thus, when considering hydrogen embrittlement, AM-HT is expected to have a higher degree of HE compared to AM-AP and conventional samples.

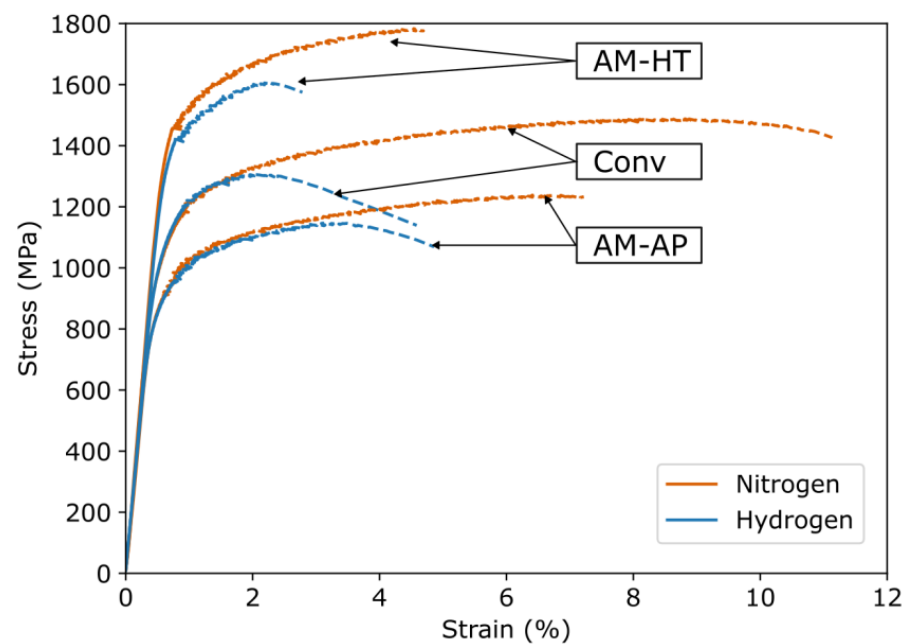
Figure 11. Representative SSRT curves for conventional, AM-AP and AM-HT Inconel 718.

The results of the SSRT test are summarised in Table 4 and representative plots for each testing condition are given in Figure 11. As can be seen, the major difference occurs with the AM heat-treated samples where the double ageing with longer duration is employed. With the precipitation of strengthening phases, an increase of 62% in the yield strength (Y.S.) and a 57% increase in the ultimate tensile strength (UTS) was seen for the AM-HT sample. As accurate quantification of the strengthening phases is not performed in this study, information from the literature is used as reference.

Another observation that needs to be accounted for is the load drop in the SSRT curves (Figure 11). It was found that the drop in load occurred only after a particular stress level is reached. As explained earlier this means a reduction in load-bearing area; here, it signifies the beginning of decohesion. The strain at this point was determined to be 2%. As Inconel 718 has a low stacking fault energy, it is found to show planar deformation [56]. The slip lines visible on the facets could be a consequence of this 2% strain. Further, it could also be possible that the decohesion occurred where the slip lines intersected with the grain boundaries. A cross-section of the fracture surface was analysed to understand it better.
