## Investigating apparent plateau phases in fatigue after impact damage growth in CFRP with ultrasound scan and acoustic emissions

Biagini, Davide; Pascoe, John Alan; Alderliesten, René

International Journal of Fatigue

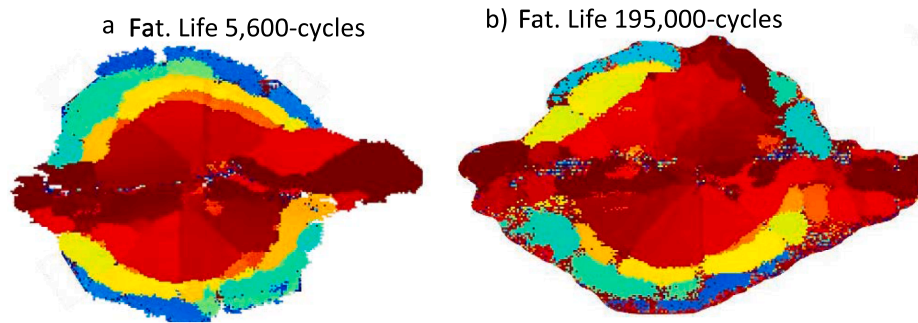
Fig. 6. C-scan of (a) short life (SP-5) and (b) long life (SP-4) specimens compared at >90 % of their respective fatigue lives.

In the second batch of specimens, we used an echo pulse scan system to determine delaminations' depth with high accuracy. The monitoring revealed similar patterns of delamination growth regardless of the applied load level (Fig. 6). In the initial stages of fatigue, all the specimens displayed the growth of a single delamination situated close to the impacted face, propagating perpendicular to loading from impact center towards the lateral edges (Fig. 7). This short delamination grew within the projected delaminated area, hence during the phase that previous studies classified as a plateau phase in delamination growth. This growth was observable since it occurred close to the front face and was not shadowed. However, since impact damage consists of multiple delaminations located in almost every interface, we cannot exclude the possibility that faster growth of short delaminations occurred in the central depths during this phase, but was undetectable. This observation partially confirms the hypothesis formulated by Pascoe [12], suggesting that the apparent no-growth phase could be a consequence of the inability to measure shadowed growth using ultrasound inspection.
