Image analysis for classification of damaged and undamaged areas on composite structures

Shrestha, Pratik; Groves, Roger M.

Nondestructive Characterization and Monitoring of Advanced Materials, Aerospace, Civil Infrastructure, and Transportation XIII

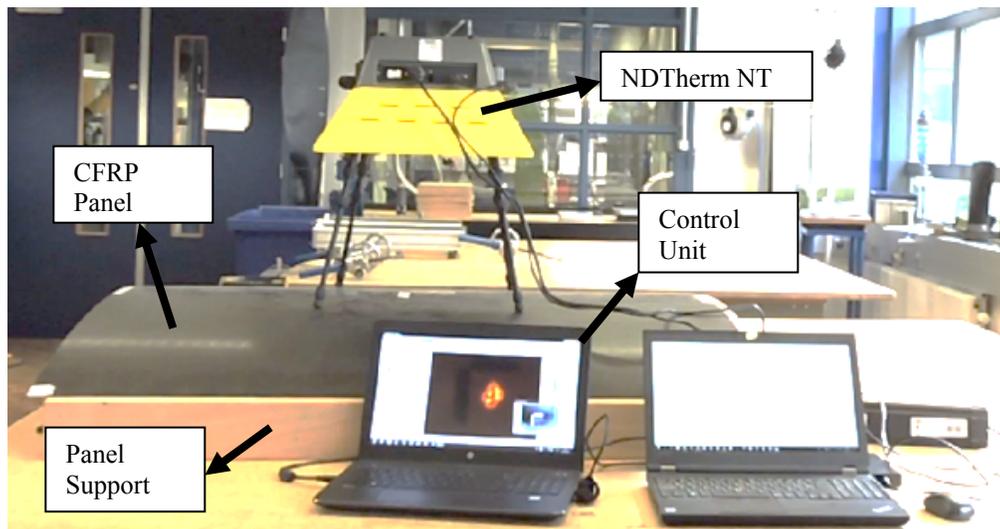
Figure 1. Experimental setup for thermographic inspection of the CFRP panel.

In this section, the experimental setup for acquiring infrared images of a damaged composite panel for training and testing the developed image analysis algorithm is presented. A portable thermographic inspection device, NDTherm NT, was used to detect the BVID on a damaged CFRP panel of Boeing 787's fuselage skin with dimensions of $1.3 \times 1.3 \times 0.0038$ m and a radius of 2 m, by TiaT Europe at TU Delft. The experimental setup is shown in Figure 1. The NDTherm NT consists of a flash lamp for heating the test structure's surface and an infrared camera for acquiring the temperature distribution which is stored as an image file. The image data acquired by the NDTherm NT is used as the input data for the image analysis algorithm developed to detect, localize and quantify the internal damage on the CFRP panel. The overview of the image analysis algorithm is presented in the following section.

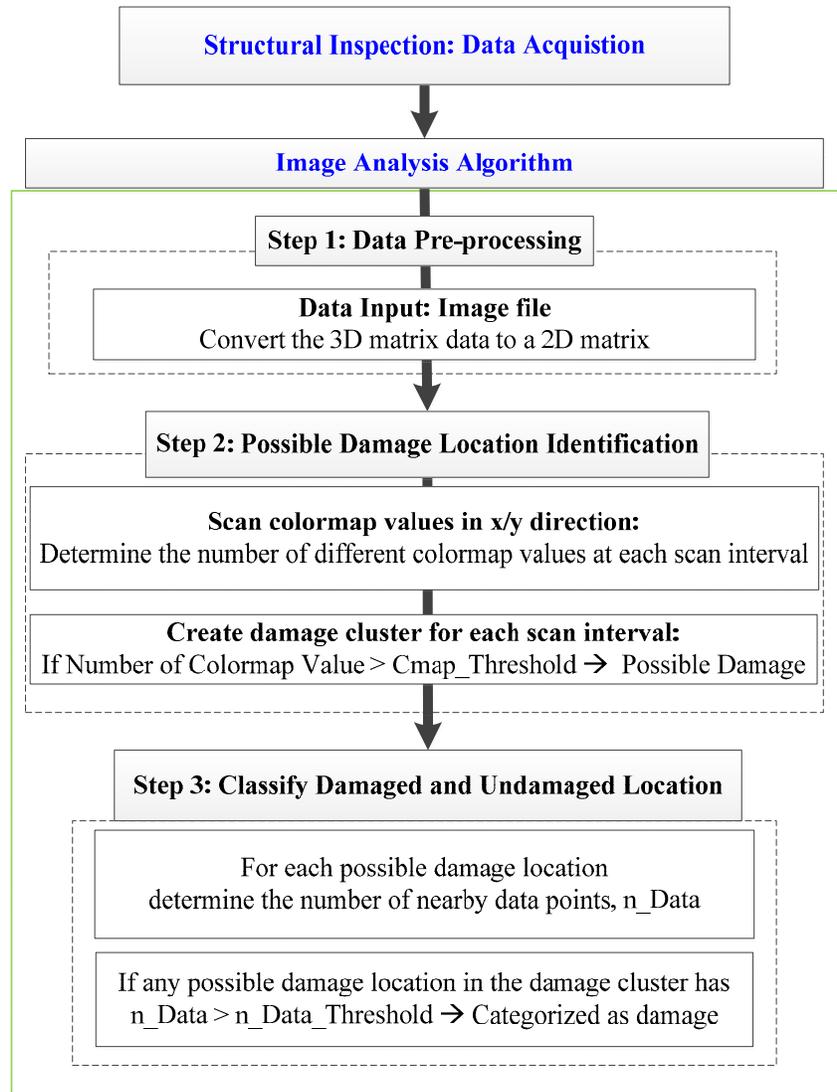
Figure 2. Overview of image processing algorithm for damage analysis.

In this section, an image analysis algorithm that extracts a number of colormap value features from a grayscale image acquired using a portable thermographic inspection for automated damage assessment is presented. In the image analysis algorithm, three key tasks are performed to determine the location and size of the damage on the CFRP panel: a) data pre-processing, b) possible damage location identification and c) classification of the damaged and undamaged region. The overview of the algorithm is presented in Figure 2.

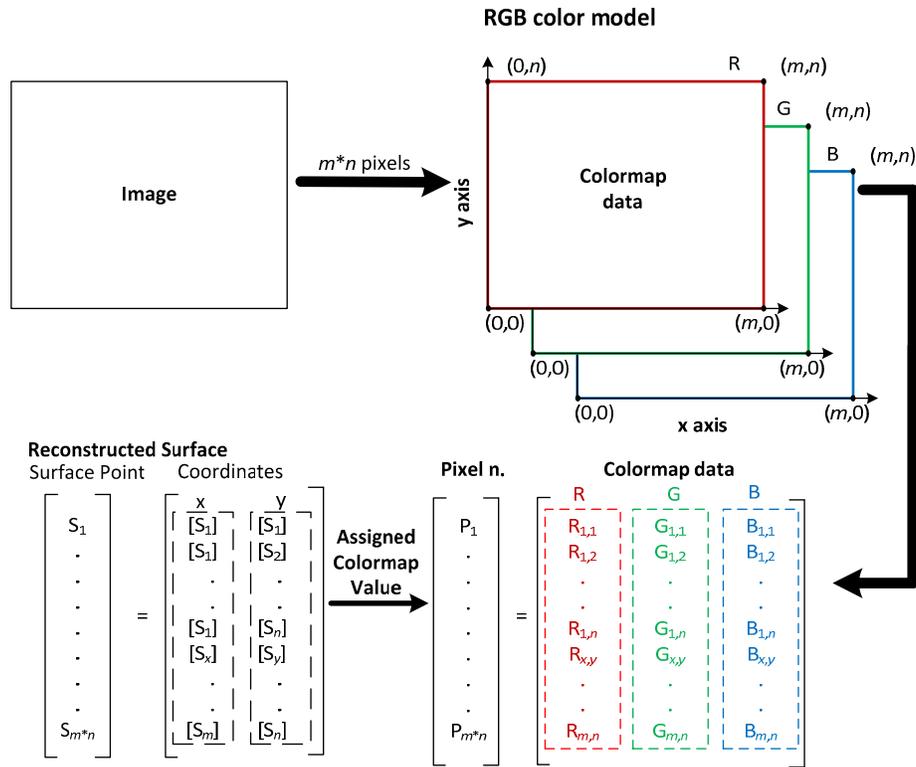
Figure 3. Illustration of data pre-processing procedure.

The first step of the image analysis algorithm involves data pre-processing of the $m \times n \times 3$ matrix. In this step, a new matrix is created that consists of the property of each pixel such as RGB colormap values and the coordinates values. The 2D matrix containing the colormap data, $P[R_{x,y}, G_{x,y}, B_{x,y}]$, is constructed by transforming the image components stored in 3D matrix; where $x = 1$ to m , and $y = 1$ to n . Subsequently, a size marker with a known dimension was used to calculate the size of the test panel in SI units and a matrix containing the x -coordinates and y -coordinates of each pixel is created. Since the image used is 2D the z -component data of each pixel is not known, therefore, in the present algorithm, the z -coordinate of each point is assigned with an equal value. Finally, each surface point, $[S_x, S_y]$, is assigned with the corresponding colormap value, $P[R_{x,y}, G_{x,y}, B_{x,y}]$. The data pre-processing process is illustrated in Figure 3.

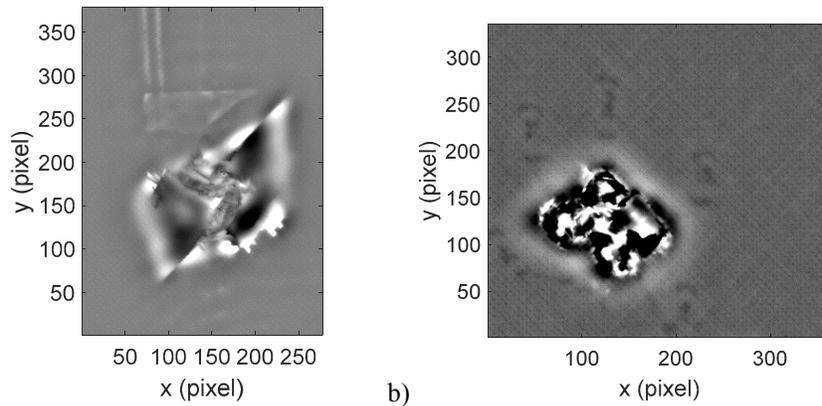
Figure 4. a) Case A: training dataset and b) Case B: test dataset.

In this section, the results of the image analysis algorithm developed for automated damage monitoring are presented. The damaged CFRP panel was inspected using NDTherm NT and the grayscale infrared images were obtained. The infrared images of two datasets with the impact damage are shown in Figure 4. These datasets were used to train and test the damage localization and quantification algorithm.

First, the Case A image data, with 277×378 pixels, was used for training the algorithm to identify the presence of damage visible on the mid-region of the image. The image data was first pre-processed to convert the $277 \times 378 \times 3$ 3D matrix to a 104706×3 2D matrix. A size marker was used to determine the size of the image from pixel to SI unit. The size of Case A was determined to be $103.4 \text{ mm} \times 141.0 \text{ mm}$. Subsequently, the pre-processed data was analyzed to determine the number of different colormap values in the x-direction and y-direction, as shown in Figure 5. This feature extraction process significantly reduced the volume of data required for damage analysis. In total, 664 clusters were created and from each cluster, a single feature, the number of colormap values present in the cluster, were obtained for the damage analysis in the next step of the algorithm.

The image analysis algorithm trained using Case A dataset was used to detect the damaged area for Case B dataset, shown in Figure 4 (b). Case B dataset has 365×335 pixels and dimensions of $136.2 \text{ mm} \times 125.0 \text{ mm}$. The pre-processing of Case B dataset consisting of $365 \times 335 \times 3$ 3D matrix resulted in a 122275×3 2D matrix. Subsequently, the feature extraction process output a total of 691 clusters, 27 clusters more than that of Case A, that consists of colormap data for each scan interval. The detected damage location and size result for Case B is shown in Figure 7. In the infrared image, the damage can be observed on the lower left quadrant. Using the image analysis algorithm, the damage location was also determined to be located in the lower left quadrant of the image. The damage size was determined to be 70.1 mm long in the x-direction and 57.8 mm long in the y-direction.

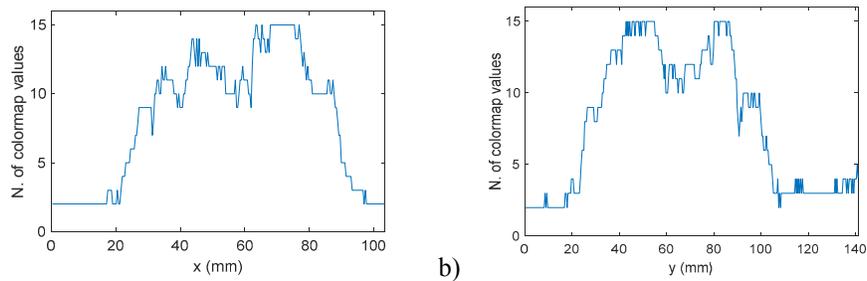
Figure 5. N. of colormap value feature extraction in a) x-direction scan and b) y-direction scan.

In Figure 5, it can be seen that the number of colormap values detected in the 664 clusters ranges from 2 to 15. The lowest number of colormap values corresponds to the undamaged area and the increase in the number of colormap values is a result of the presence of damage observed in the image shown in Figure 4 (a). In order to determine a suitable $C_{map_Threshold}$ for the algorithm, a parametric study was performed by calculating the detected damage area for $C_{map_Threshold}$ values from 1 to 8.

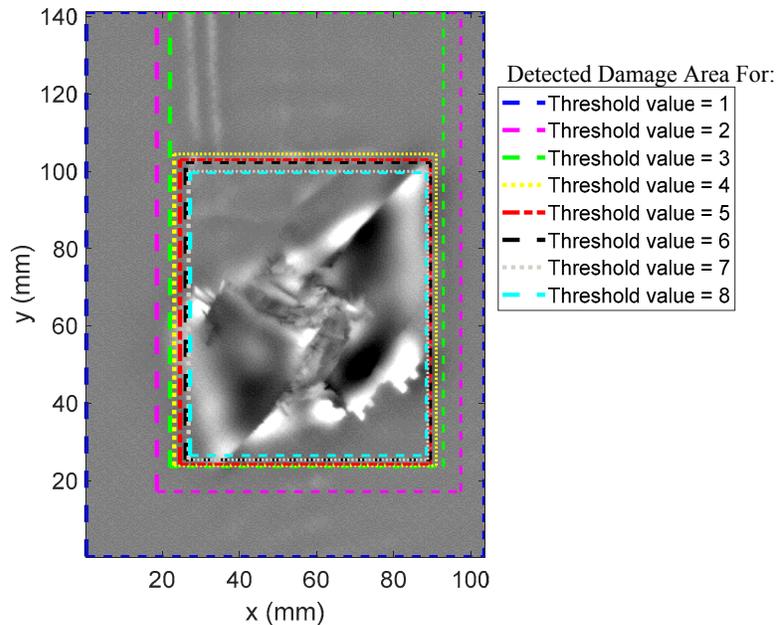
Figure 6. Case A: Damage area detection for Cmap_Threshold value of 1 to 8.

The area detected as damage for $C_{map_Threshold}$ value of 1 to 8 is presented in Figure 6. Since the minimum number of detected colormap value is 2, the lowest threshold value of 1 resulted in the entire panel being classified as damaged. By increasing the threshold value it can be seen that the size of the detected damage area is reduced. $C_{map_Threshold}$ of 2 and 3 resulted in the damage length in x-direction and y-direction to be within the range of 70.0 mm and 124.0 mm, respectively. When the $C_{map_Threshold}$ of 2 or 3 was selected, the damage length in the y-direction is found to be longer in the y-direction due to detection of the two vertical lines located on the upper left quadrant of the image. The vertical lines correspond to visible surface features that are present on the structure. Whereas, with $C_{map_Threshold}$ between 4 and 8 the damage region was correctly identified. The damage area was determined to be $67.9 \text{ mm} \times 80.6 \text{ mm}$ with $C_{map_Threshold} = 4$, and increasing the threshold value resulted in decrease in the size of the detected damage area. Using $C_{map_Threshold} = 8$, the damaged area was determined to be $61.2 \text{ mm} \times 73.1 \text{ mm}$. From the $C_{map_Threshold}$ parametric study, $C_{map_Threshold}$ value higher than 2 was found to be suitable for correct identification of the damage region for Case A dataset. Proper $C_{map_Threshold}$ selection is important for accurate damage size detection; if it is too small then it can result in overestimation of the damage size and if it is too high then it

can lead to underestimation of the damage size. Based on the results obtained from training dataset, the Cmap_Threshold was set to 5.

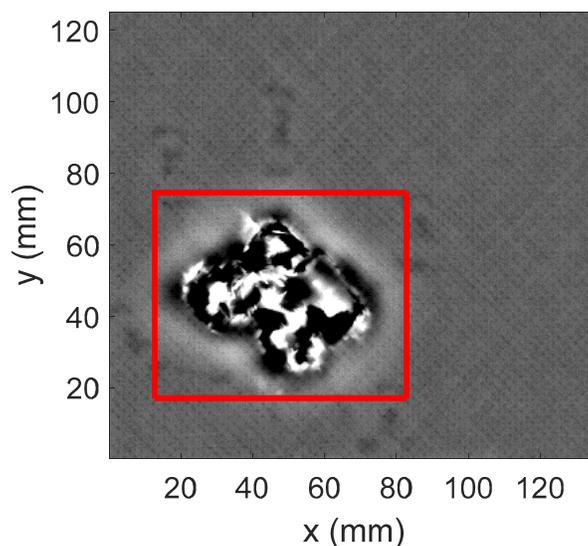
Figure 7. Case B: Damage area detection for Cmap_Threshold value of 5.
