## Deformation and damage evolution of a full-scale adhesive joint between a steel bracket and a sandwich panel for naval application

Jaiswal, Pankaj R; Kumar, R Iyer; Saeedifar, M; Saleh, MN; Luyckx, Geert; Waele, W De

Proceedings of the Institution of Mechanical Engineers, Part C: Journal of Mechanical Engineering Science

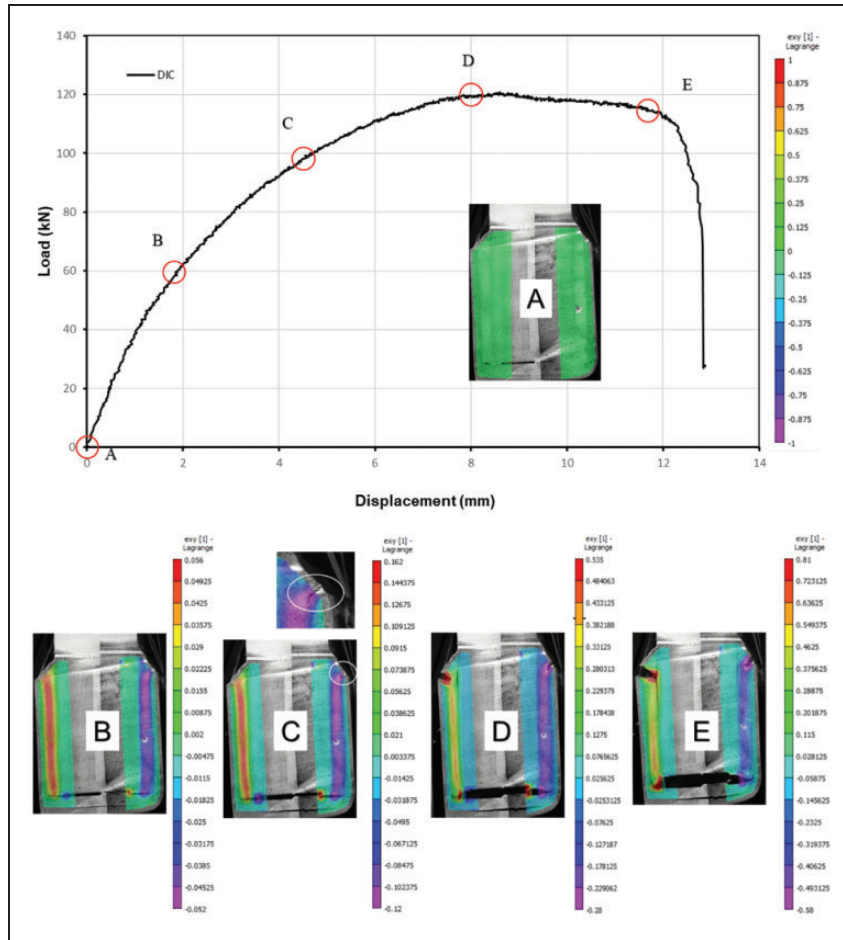
**Figure 7.** Load-displacement curve and shear strain distribution around the bond line of the specimen at different moments during the test.

In image C the damage has initiated by tearing and debonding of the adhesive at the interface of steel and adhesive at the top-right side of the sample. Image D corresponds to ultimate load around 120 kN; tearing and debonding of the adhesive at the top of the steel-adhesive interface at both sides of the joint including debonding of adhesive-composite interface at the left top of the joint were observed. Finally in image E, tearing of the adhesive and debonding at the interface of adhesive and composite were observed at both sides of the specimen, as well as debonding at the steel-adhesive interface at the top right side of the specimen. Near the end of the test the shear strain values start to decrease due to unloading of the joint. It can also be observed that the shear strain pattern on image E is less uniform than the patterns observed in images B-D. This is the result of local damage and increased asymmetry in the loading of

Figure 7. Additionally, six images of the adhesive joint were selected at different loading levels to analyse the change in AE activities presented in Figure 13 (b). As a general trend it was observed that the emission of energy increases with increasing load in terms of a growing gap between the sandwich panel and foam/steel at the bottom of the joint.

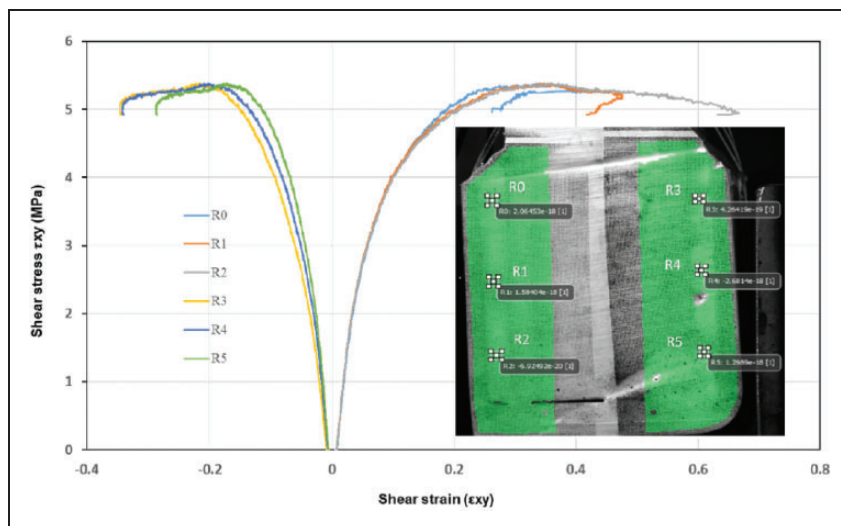
**Figure 8.** Shear stress-shear strain curves for six different locations in the adhesive of the full-scale joint specimen.

In order to evaluate the local shear strain behaviour within the adhesive, individual plots of shear stress versus shear strain for six different regions

(i.e. R0 to R5) at the surface of the adhesive are shown in Figure 8. An inspection block method was used to calculate the local shear strain in the adhesive by means of DIC post-processing. The strain values reported for R0 to R5 are the mean values of the four

corners of each inspection block. The reported shear stress is a global value calculated as the ratio of the applied tensile load to the sheared area of the bond line (i.e. 2 times width multiplied by height). An ultimate shear stress value of 5.4 MPa was calculated.

The shear strain values in the adhesive at the left side of the joint (locations R0, R1, R2) show an identical evolution during most of the test; only close to failure values start to diverge. The failure strains increase from top to bottom of the bond line. This is hypothesized to be due to the closer proximity of R0 to the region of damage and thus partial relaxation of the stresses in the adhesive. The evolution of shear strain values for the regions at the right side of

the joint are again similar, although not identical. This is hypothesized to be caused by bending of the right steel flange during the test since it is not directly in line with the load introduction. The failure strains at the right side (R3, R4, R5) are significantly lower than these at the left side (R0, R1, R2).
