The fatigue failure study of repaired aluminum plates by composite patches using Acoustic Emission

Maleki, Abdullah; Saeedifar, Milad; Ahmadi Najafabadi, Mehdi; Zarouchas, Dimitrios

Engineering Fracture Mechanics

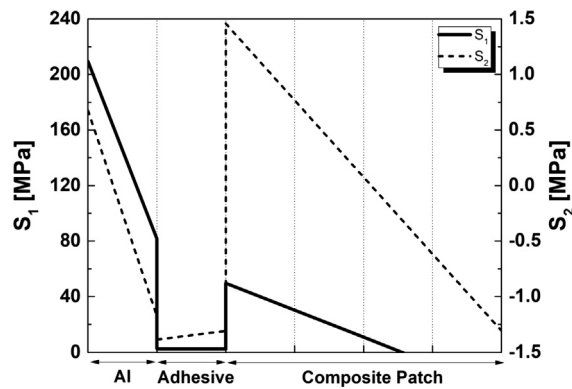
Fig. 5. The effective applied stress at the two sides of the repaired specimen.

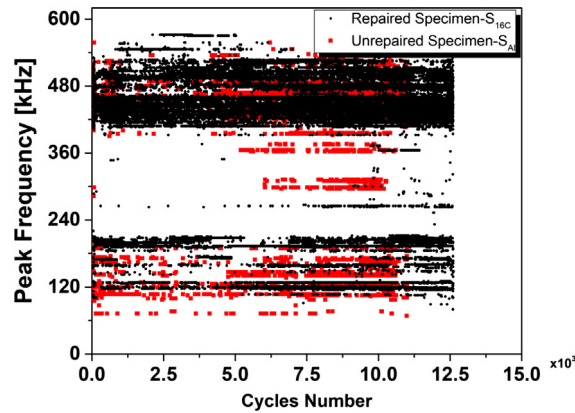
Fig. 8. The frequency distribution of AE signals for the unrepaired and repaired specimens.

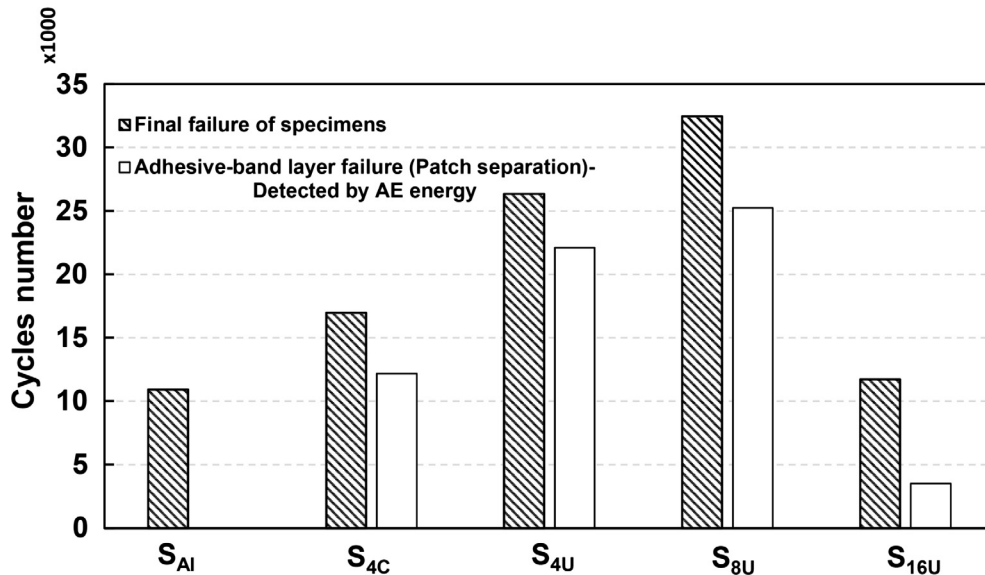
Fig. 11. The cycles number to the final failure of the specimens and the cycles number to the failure of adhesive layer obtained from AE.

Fig. 11 represents the cycles number to the final failure of the specimens and also the cycles number to the failure of the adhesive layer which is detected by the cumulative AE energy curve of adhesive layer failure. It is obvious that at a fixed

patch thickness (4 layers), the unidirectional layup (S_{4U}) has the better performance in comparison with the cross-ply layup (S_{4C}) and it could improve the lifetime of the cracked aluminum with 141% against 55% for the cross-ply layup. However, the remained lifetime after separation of the patch for the S_{4C} is higher than S_{4U} (4790 cycles for S_{4C} against 4223 cycles for S_{4U}). Due to the higher stiffness of the unidirectional patch, it carries more portion of the applied load, thus when it is failed more additional load is applied to the Al specimen. On the other hand, at a fixed layup, the best thickness for the patch is for the 8 layers patch that could improve the fatigue life about 197%. The better functionality of specimen S_{8U} is due to this fact that this specimen has a big stiffness and it does not also induce a big bending moment to the specimen. In contrary, the specimen S_{16U} has the worst functionality. Although the 16 layers patch has a bigger stiffness, but, because of the high thickness of the patch, it induces a big bending moment to the specimen that leads to the separation of the patch from Al at the low cycles number.
