Foulant Identification and Performance Evaluation of Antiscalants in Increasing the Recovery of a Reverse Osmosis System Treating Anaerobic Groundwater

Published in Membranes

Abstract: The objectives of this study are to assess the performance of antiscalants in increasing the recovery (\geq 85%) of a reverse osmosis (RO) plant treating anaerobic groundwater (GW) in Kamerik (the Netherlands), and to identify scalants/foulant that may limit RO recovery. Five different commercially available antiscalants were compared on the basis of their manufacturer-recommended dose. Their ability to increase the recovery from 80% to a target of 85% was evaluated in pilot-scale measurements with anaerobic GW and in once-through lab-scale RO tests with synthetic (artificial) feedwater. A membrane autopsy was performed on the tail element(s) with decreased permeability. X-ray photoelectron spectroscopy (XPS) analysis indicated that calcium phosphate was the primary scalant causing permeability decline at 85% recovery and limiting RO recovery. The addition of antiscalant had no positive effect on RO operation and scaling prevention, since at 85% recovery, permeability of the last stage decreased wi

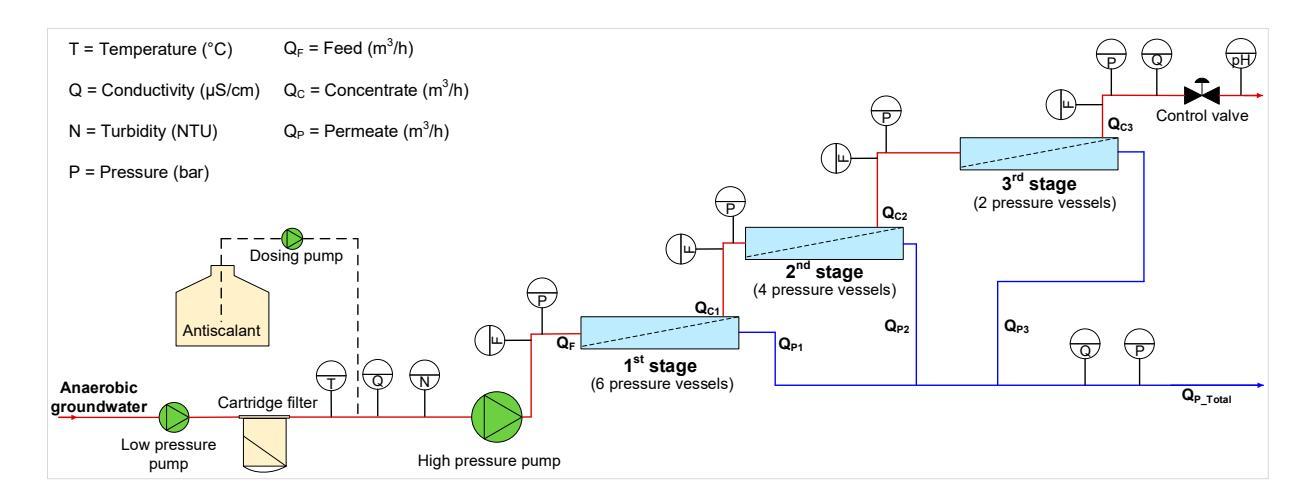
Figure 1. Schematic representation of the RO pilot installation in Kamerik [36].

Figure 1 depicts a schematic representation of the RO pilot plant. The RO installation had three stages where the pressure vessel configuration for each stage could be varied. Each pressure vessel contained three hydranautics membrane elements (ESPA2-LD-4040). The anaerobic GW (feedwater) was passed through a cartridge filter (10 μ m) and then fed to the RO unit. The RO installation was operated at constant permeate water production. To assess the occurrence of scaling, the average normalized (temperature corrected) permeability (K_w, Equation (S1)) of the last stage was monitored.

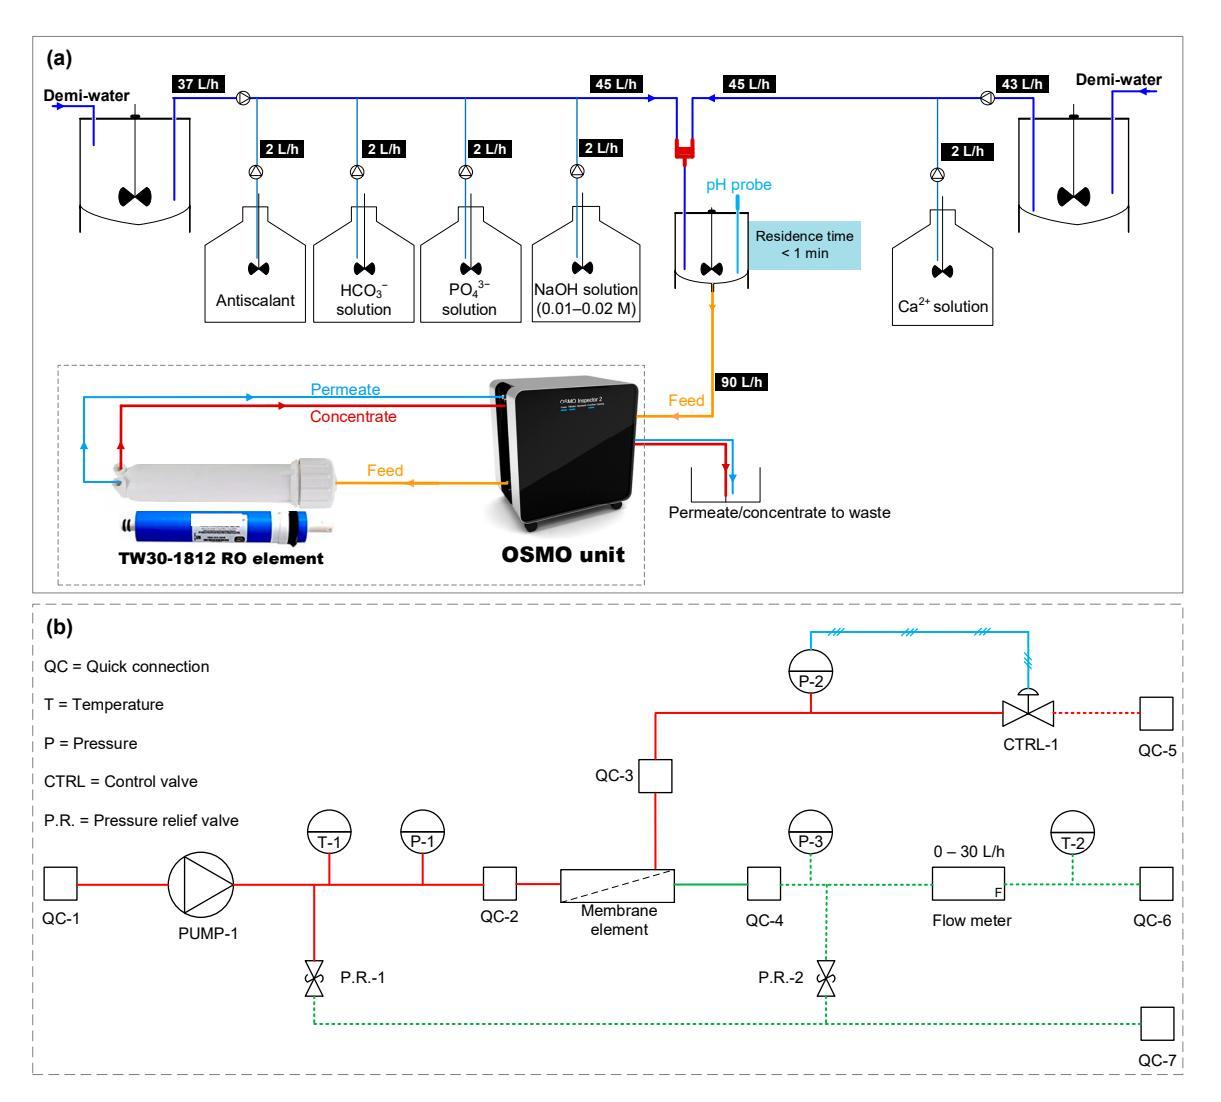
Figure 2. (a) Once-through lab-scale RO setup for testing the performance of antiscalants. (b) Piping and instrumentation diagram of the OSMO unit with the RO element [26].

An OSMO inspector unit (Convergence Industry B.V., the Netherlands) was used to feed the synthetic concentrate solution to a TW30-1812-50 RO element (OsmoPure Water Systems). An Atrato ultrasonic flow meter was installed in the OSMO unit, which could measure permeate flow rates ranging from 0.12 L/h to 30 L/h. A new TW30-1812-50 RO element was used in each experiment.

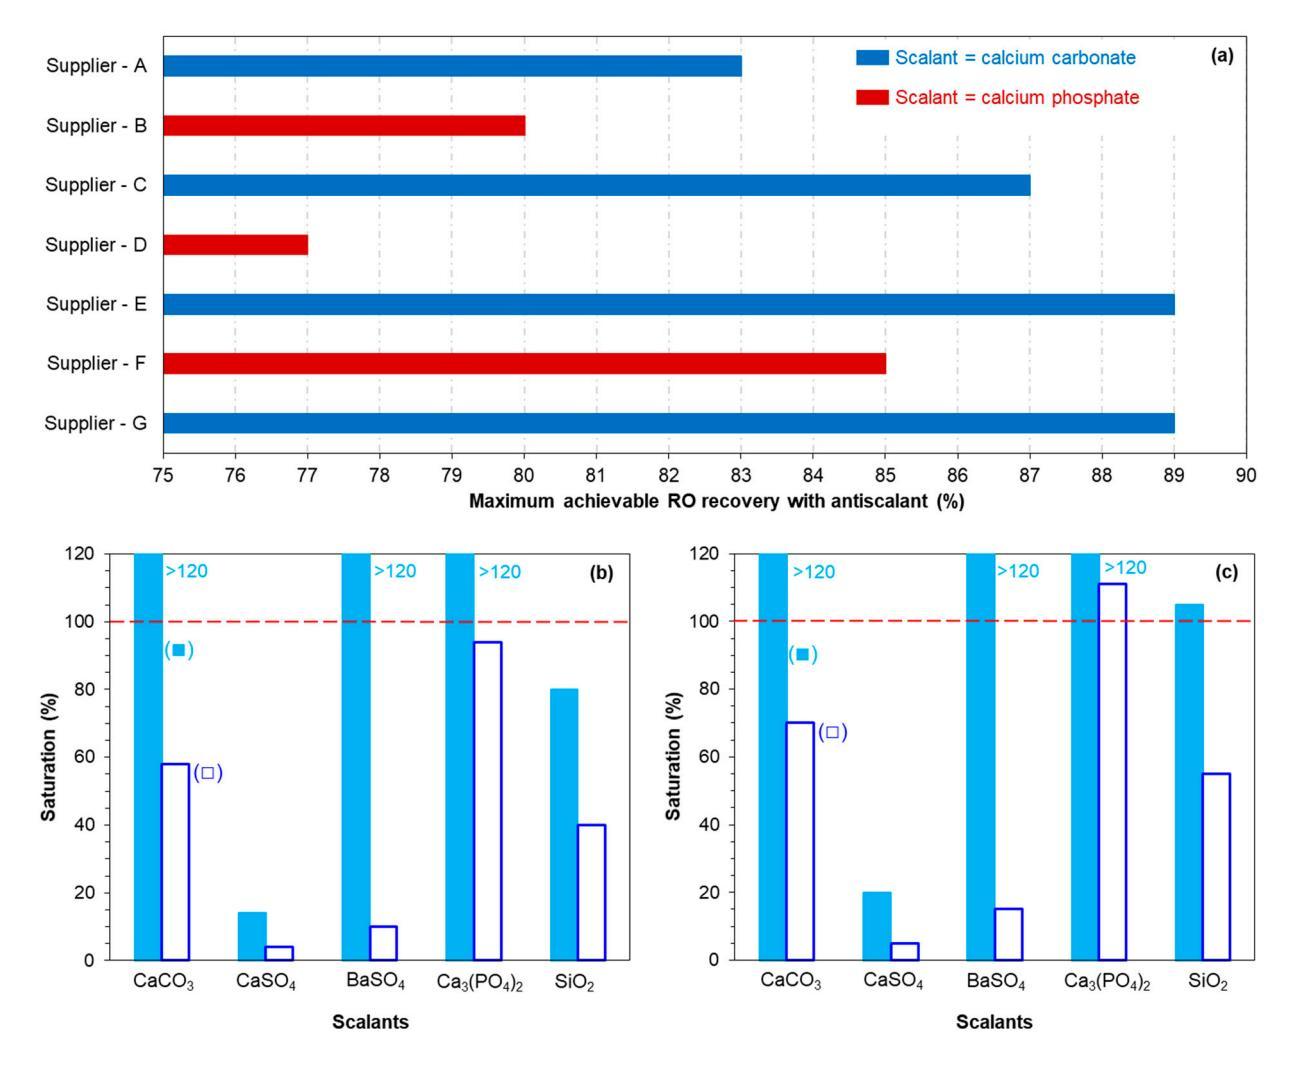
Figure 3. (a) Maximum achievable recovery of the RO unit in the presence of antiscalants determined with the projection programs of various antiscalant suppliers. (b) Scaling potential of commonly encountered scalants at 80% recovery of the RO unit (\blacksquare) in the absence of antiscalant, and (\square) in the presence of antiscalant. (c) Scaling potential of commonly encountered scalants at 85% recovery of the RO unit (\blacksquare) in the absence of antiscalant. (b,c) are determined with the projection program of supplier B.

Figure 3a shows the maximum achievable recoveries in the presence of antiscalants for the RO unit, which were determined by the projection programs of seven different antiscalant suppliers. As can be seen, the recommended maximum achievable RO recovery was different for all the projection programs of the antiscalant suppliers. In addition, the scalant compound, which may limit RO recovery, was not the same, according to the projection programs of different suppliers. For instance, according to the projection programs of suppliers A, E, C, and G, recovery of the RO unit was limited due to calcium carbonate scaling, while calcium phosphate scaling was limiting RO recovery according to suppliers B, D, and F. The maximum achievable RO recovery (limited due to calcium carbonate) was 89% according to suppliers E and G, and 83% and 87% according to suppliers A and C, respectively. The maximum achievable RO recovery (limited due to calcium phosphate) was 77%, 80%, and 85% according to suppliers B, D, and F, respectively. From Figure 2a, one can clearly recognise that the projection programs of the antiscalant suppliers are not consistent in identifying the maximum RO recovery.

Figure 3b,c present the scaling tendency (performed with the projection program of supplier B) of some commonly encountered scalants in the RO concentrate at 80 and 85% recovery, respectively. The scaling tendency of the RO concentrates at 80 and 85% recoveries is presented because the RO pilot, in this study, was operated initially at 80% recovery and then at 85% recovery. The scaling tendency is shown both with and without the addition of antiscalant to the RO feed.

The projection program of supplier B advised that at 80% recovery without antiscalant, the RO unit may experience calcium carbonate, barium sulphate, and calcium phosphate scaling, while with the addition of antiscalant to the RO feed, none of the mentioned scalants will precipitate in the RO unit. Furthermore, at 85% recovery with no antiscalant, the program indicated that silica may also precipitate together with calcium carbonate, barium sulphate, and calcium phosphate. The program suggested that, with the addition of antiscalant, calcium carbonate, barium sulphate, and silica may not precipitate in the RO unit at 85% recovery, while calcium phosphate may precipitate even with the addition of antiscalant.

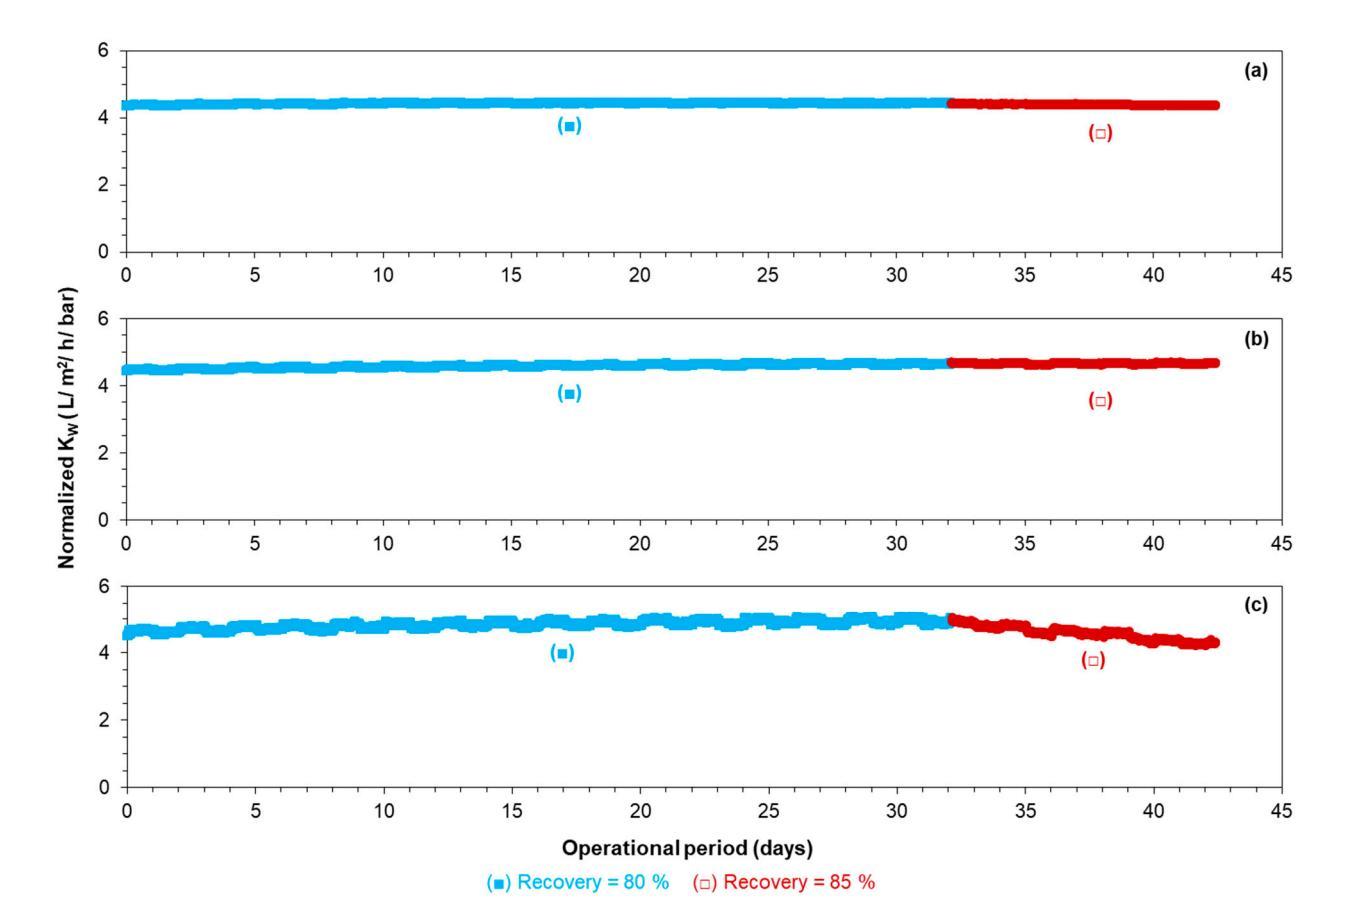
Figure 4. Average normalized permeability of the (**a**) first stage, (**b**) second stage, and (**c**) third stage of the RO unit at 80 and 85% recoveries without antiscalant addition.

Figure 4 presents the average normalized permeability of the first, second, and third stages of the RO unit at 80–85% recoveries when no antiscalant was added to the RO feed.

At 80% recovery without antiscalant, the normalized permeability remained constant, where calcium carbonate, barium sulphate, and calcium phosphate had the tendency to scale the RO unit, according to the projection program of supplier B. On the other hand, at 85% recovery, the normalized permeability of the last stage decreased in the absence of antiscalants. At 85% recovery, the normalized permeability of the second stage remained constant, where the total recovery of the first and second stages was approximately 77%. As no decrease in membrane permeability of the last stage at 80% recovery without antiscalant was observed, it was expected that permeability would remain constant at 77% recovery.

Surprisingly, the average normalized permeability of the first stage with a recovery of 52% had a slight decreasing trend (with a—0.005 slope). The slight decrease in the first stage may not be due to the deposition/precipitation of newly formed particles/crystals. It could be that the RO feed contained particles that were deposited in the first stage and caused permeability decline. To understand what compounds caused permeability decline in the third stage and in the first stage, the tail elements of the mentioned stages were taken out for autopsy.

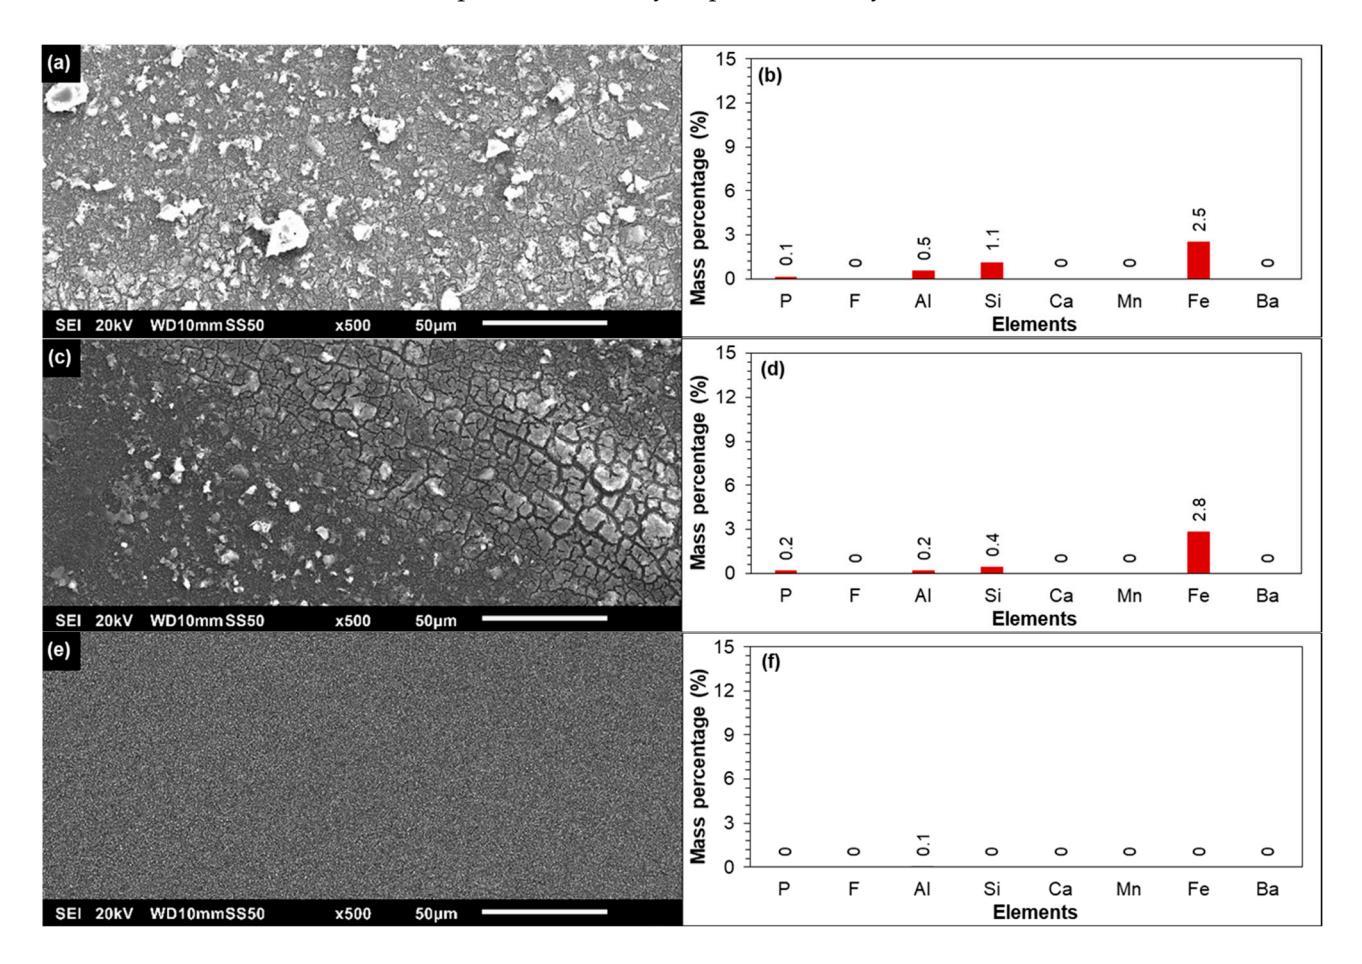
Figure 5. (a) SEM and (b) EDX analyses of the tail element of the first stage with decreased permeability. (c) SEM and (d) EDX analyses of the tail element of the first stage cleaned with a 0.05 M NaOH solution. (e) SEM and (f) EDX analyses of the tail element of the first stage cleaned with a 0.05 M HCl solution.

The SEM and EDX analyses of the tail element of the first stage (with decreased permeability) are presented in Figure 5a,b, respectively. The SEM picture showed that the membrane surface was covered by deposits. The EDX results in Figure 5b indicated that the deposited material on the membrane surface consisted of aluminium, silicon, and iron. In the EDX analysis (Figure 5b), only those elements that are not part of the membrane surface could be attributed to clay particles that might be present in the RO feedwater that were not retained by the 10 μ m cartridge filter. The presence of iron may be related to the deposited clay particles, as iron may be present in the composition of the clay particles, and/or to the iron oxide particles that may be present in very low concentrations in the RO feed.

Figure 5c,d present the SEM image and the EDX of the membrane cleaned with 0.05 M NaOH solution, respectively. It was observed that the NaOH solution was unable to remove the deposited particles from the membrane surface, and the layer (after cleaning) still consisted of aluminium, silicon, and iron. On the other hand, the deposited particles disappeared when the membrane was stirred in 0.05 M HCl solution (Figure 5e). In the EDX analysis (Figure 5f), no aluminium, silicon, and iron were detected. This showed that the deposited layer was removed with HCl solution. At this point, it was not clear if the deposited particles were dissolved in the HCl solution and/or were detached from the membrane surface due to mechanical forces.

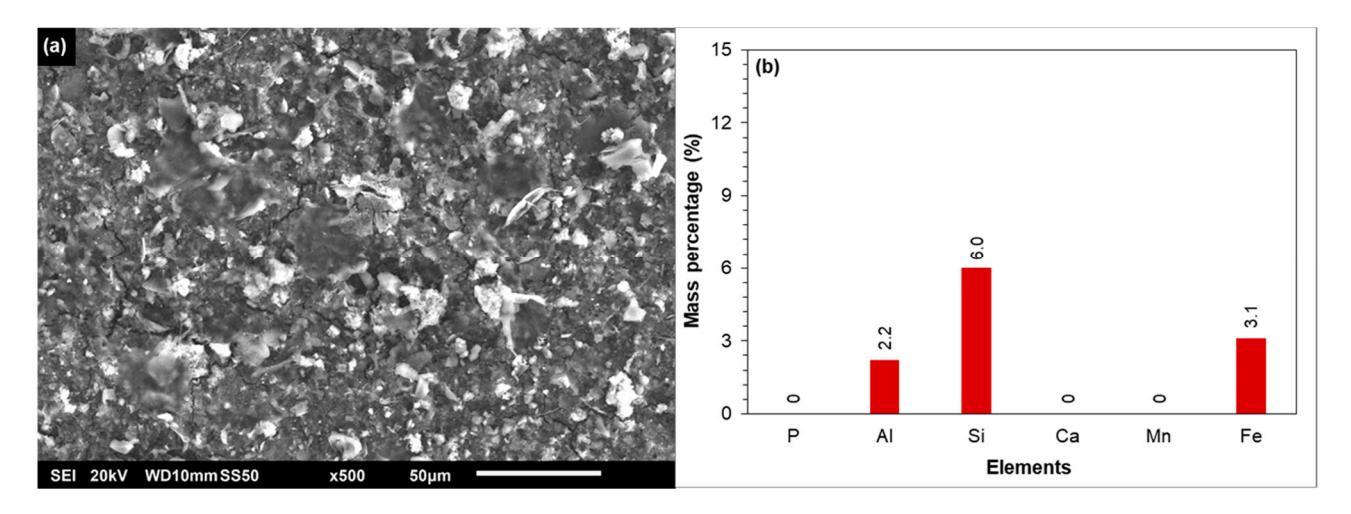
Figure 6. (a) SEM image and (b) EDX analysis of the 0.45 μ m filter after filtration of the 0.05 M HCl solution (of the tail element of the first stage).

In Figure 6, the SEM-EDX analysis of the retained deposits on the 0.45 μ m filter (after filtering the 0.05 M HCl cleaning solution) is shown. As can be seen, the retained deposits consisted of aluminium, silicon, and iron suggesting that clay particles from the membrane surface were not dissolved in the HCl solution, but actually were detached from the membrane surface. Figure 6b also indicated that a part of the iron on the membrane surface of the tail element of the first stage (Figure 5a,b) could be linked to clay particles, since if all iron was present as iron oxides, then it should have been dissolved in 0.05 M HCl solution. In Figure 6b, the mass percentage of iron (on the filter surface) was approximately half the mass percentage of silicon. However, in Figure 5b, the mass percentage of iron on the membrane surface of the tail element of the first stage was higher than silicon. This may indicate that the additional mass percentage of iron in Figure 5b could be due to the iron oxide particles.

In brief, based on the SEM-EDX results of Figures 5 and 6, it may be concluded that the deposition of clay and iron oxide particles (present in the RO feed) were contributing to the slight permeability decline of the first stage.

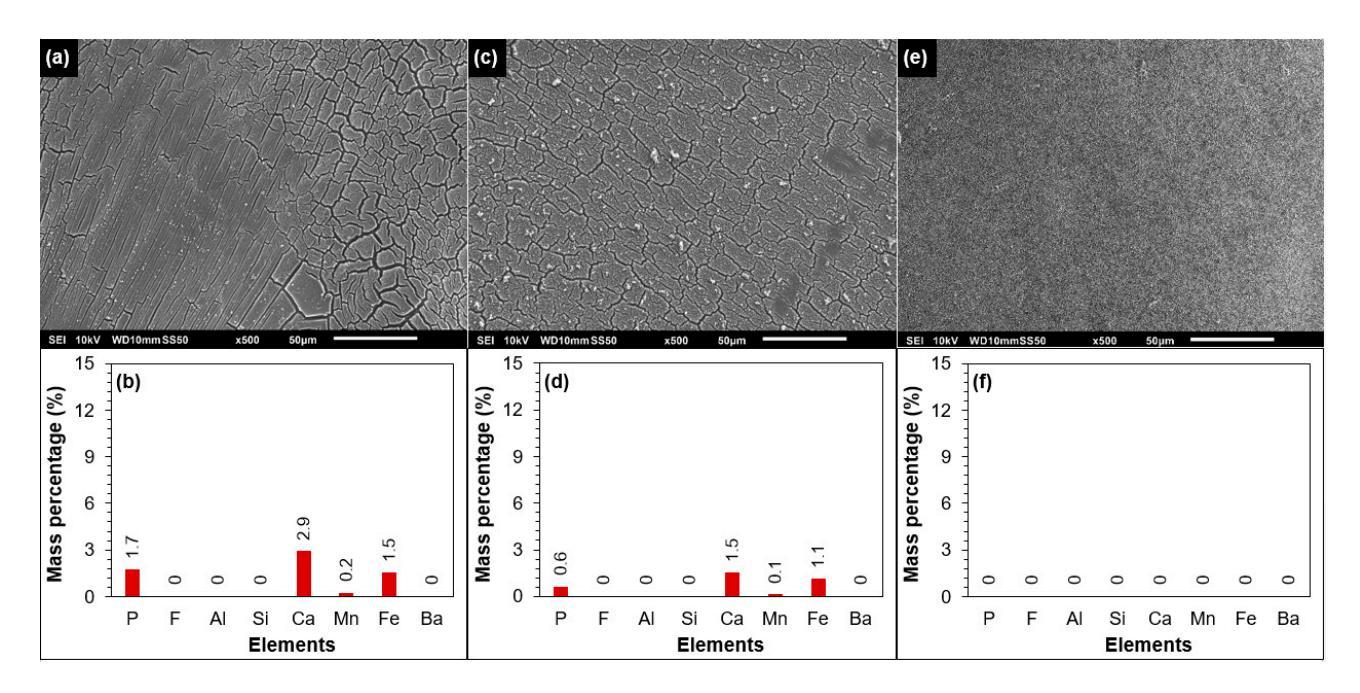
Figure 7. (a) SEM and (b) EDX analyses of the fouled tail element of the third stage. (c) SEM and (d) EDX analyses of the tail element of the third stage cleaned with 0.05 M NaOH solution. (e) SEM and (f) EDX analyses of the tail element of the third stage cleaned with 0.05 M HCl solution.

In Figure 7a,b, SEM-EDX analysis of the fouled/scaled RO membrane of the tail element of the third stage is shown. As can be seen, the membrane surface apparently was covered with an amorphous layer. According to the EDX analysis, the foulant was composed of calcium, phosphorous, and iron. A small mass percentage of manganese could also be observed. In the EDX analysis, aluminium and silicon were not observed on the membrane surface, which suggested that clay particles did not contribute to the permeability decline of the third stage at 85% recovery. According to the antiscalant projection program of supplier B (Figure 3c), calcium carbonate, barium sulphate, calcium phosphate, and silica have the potential to scale the RO at 85% recovery in the absence of antiscalant. As silica was not observed on the membrane surface in the EDX analysis

(Figure 7b), it can be concluded that silica scaling did not occur in the RO unit at 85% recovery without antiscalant.

Furthermore, barium sulphate scaling did not occur at 85% recovery, as barium was not present on the fouled membrane surface (Figure 7b). Based on a study by Boerlage, et al. [37] where they reported that barium sulphate has very slow precipitation kinetics and its precipitation is hindered by humic substances (HS), it was expected that the barium sulphate scale would not occur in the RO unit in Kamerik. In the anaerobic groundwater of Kamerik (RO feed), the concentration of HS was approximately 5.3 mg/L (Table 1), which might inhibit barium sulphate scaling in the RO unit. Several researchers [38–42] have reported that HS significantly hinder the formation of calcium carbonate. Also, in a study by the current authors [36], it was demonstrated that HS, as well as the phosphate present in the GW, were able to inhibit calcium carbonate scaling in the RO unit in Kamerik. We showed that due to the presence of HS and phosphate, the induction time of the real RO concentrate at 80% recovery was longer than 7 days, whereas at the same supersaturation level in the absence of phosphate and HS, the induction time of the synthetic RO concentrate of 80% recovery was around 1 h. Due to the long induction time (>168 h) of the RO concentrate of 85% recovery in the absence of antiscalants (Figure S1), it is also expected that calcium carbonate scaling would not occur at 85% recovery when antiscalants are not added to the RO feed. In the XRD analysis (Figure S2), calcium carbonate crystals were not detected, which also indicates that calcium carbonate scaling was not the reason for the permeability decline in the last stage, as seen in Figure 4c.

In Figure 7b, the mass percentage of calcium and phosphorous on the membrane surface could be attributed to (amorphous) calcium phosphate scaling, which was also predicted by the projection programs of suppliers B, D, and F (Figure 3a). However, the presence of iron on the fouled membrane is not clear. As aluminium and silicon were not observed on the fouled membrane of the third stage (Figure 7a), the presence of iron could not be due to clay particles. One may suggest that the presence of iron on the membrane could be due to the presence of iron oxide particles in the RO feed. The presence of iron (and also of calcium and phosphorous) on the fouled membrane is elucidated via XPS analysis later.

Figure 7c,d presents the SEM-EDX analysis of the fouled membrane which was cleaned with 0.05 M NaOH solution. As can be seen, the alkaline solution (0.05 M NaOH) was unable to remove the foulant from the membrane surface. After cleaning at high pH, calcium, phosphorous, and iron were still present on the membrane surface. On the other hand, the acidic solution (0.05 M HCl) was able to remove the foulant from the membrane surface, as can be seen from the SEM image (Figure 7e) and the EDX analysis (Figure 7f). As calcium, phosphorous, and iron were not detected on the membrane surface (Figure 7e), the acidic solution was filtered through a 0.45 μ m filter and then the filter was examined by SEM-EDX. It was found that the foulant (composed of calcium, phosphorous, and iron) on the tail element of the third stage was dissolved in the acidic solution (Figure S3).

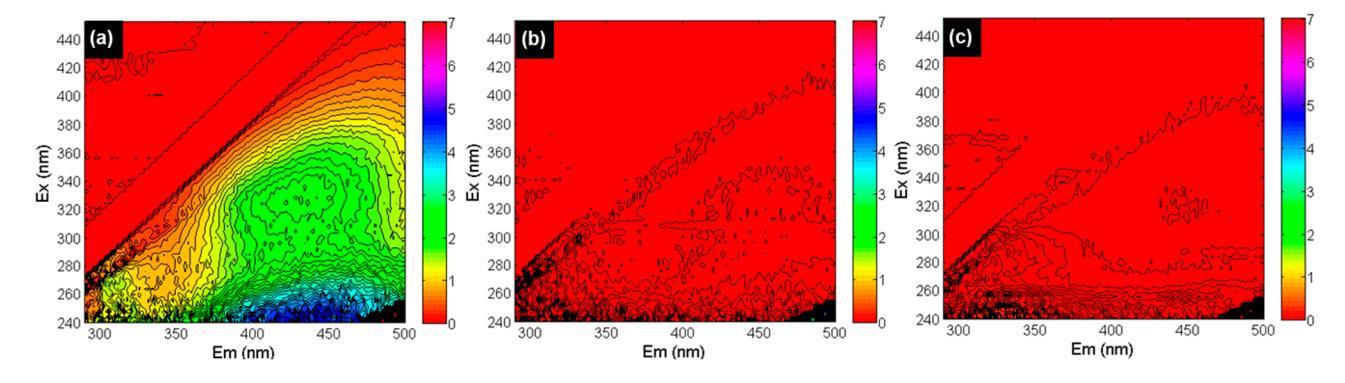
Figure 8. FEEM analysis of the (**a**) RO concentrate at 85% recovery, (**b**) 0.05 M NaOH cleaning solution, and (**c**) 0.05 M HCl cleaning solution (Ex and Em represent excitation and emission wavelengths).

In Figure 8, fluorescence excitation-emission matrix (FEEM) analysis of the RO concentrate (at 85% recovery) and the HCl and NaOH cleaning solutions of the tail elements of the third stage are shown. In this study, the locations of the EEM peaks of humic acid (HA) and fulvic acid (FA) were based on the EEM regions reported by Chen et al. [48]. The HA peaks were observed in the 380–500 and 250–400 nm emission and excitation wavelength ranges, respectively, while the 380–400 and 200–250 nm emission and excitation wavelength ranges, respectively, were attributed to FA [48].

As illustrated in Figure 8a, peaks for both HA and FA (with high intensity) were observed in the RO concentrate, which verifies the presence of HS in the anaerobic GW. However, HA and FA peaks were not visible in the cleaning solutions of the tail element of the third stage, as shown in Figure 8b (NaOH solution) and Figure 8c (HCl solution). The absence of HA and FA peaks in the HCl and NaOH solutions suggests that HS were likely not responsible for the permeability decline of the third stage of the RO unit in Figure 4c.

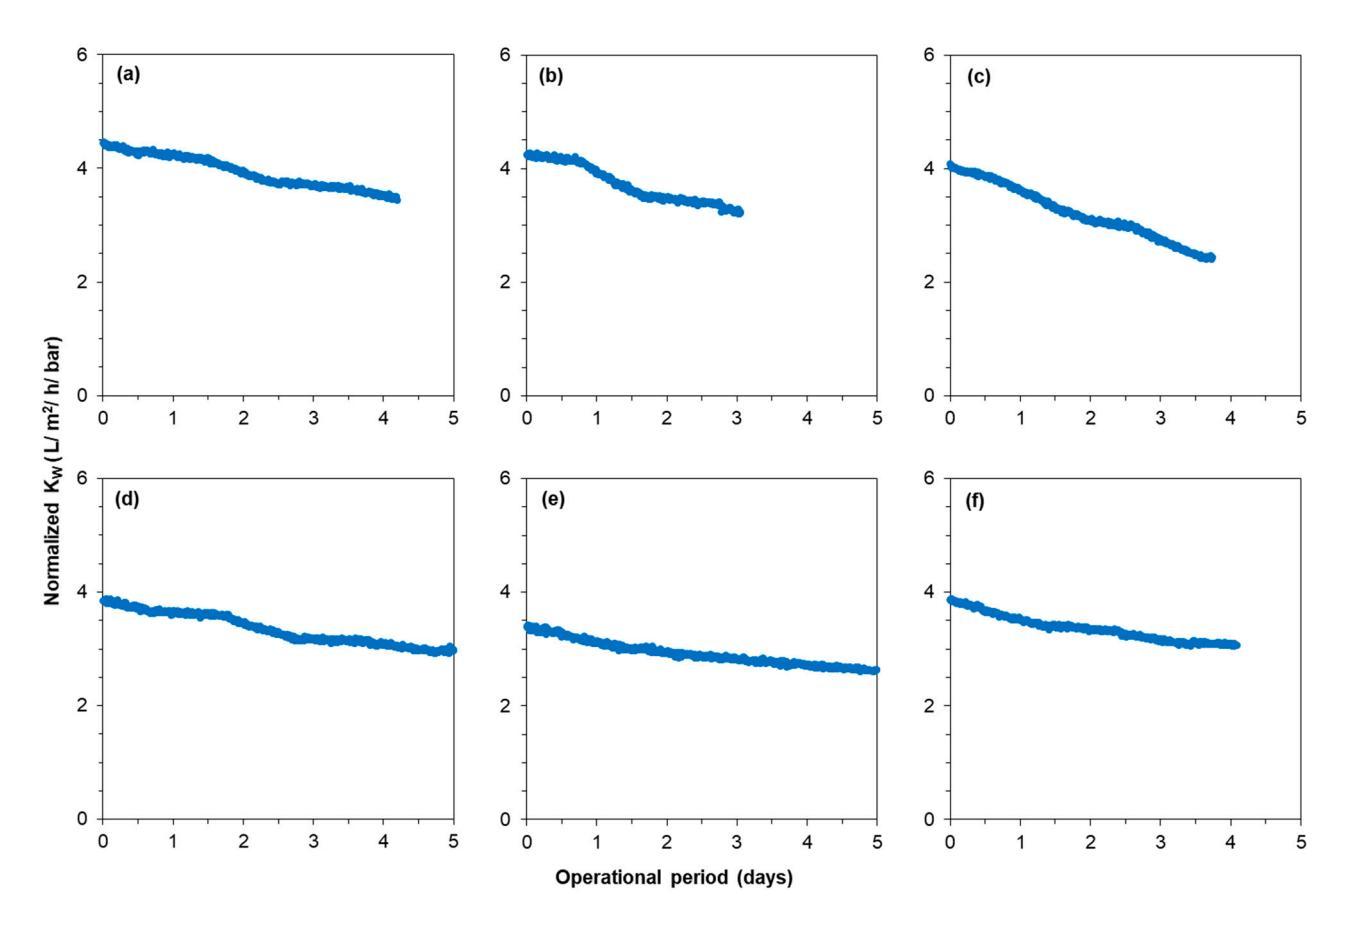
Figure 9. Average normalized permeability of the last stage of the RO unit at 85% recovery (a) without antiscalant, (b) with 2.5 mg/L AS–1, (c) with 2.5 mg/L AS–2, (d) with 2.5 mg/L AS–3, (e) with 5 mg/L AS–4, and (f) with 5 mg/L AS–5.

Figure 9 shows the average normalized permeability of the third stage of the RO unit at 85% recovery in the absence and presence of the five tested antiscalants. As can be seen, none of the antiscalants could prevent the permeability decline of the third stage. After operating the RO unit with antiscalant (AS–5), the tail element of the third stage was examined with SEM-EDX, and the results were similar to those shown in Figure 7. It is worth mentioning that the permeability of the third stage also decreased at 83% recovery in the presence of antiscalants (Figure S5). The RO operation at 81 and 82% recovery was not investigated.

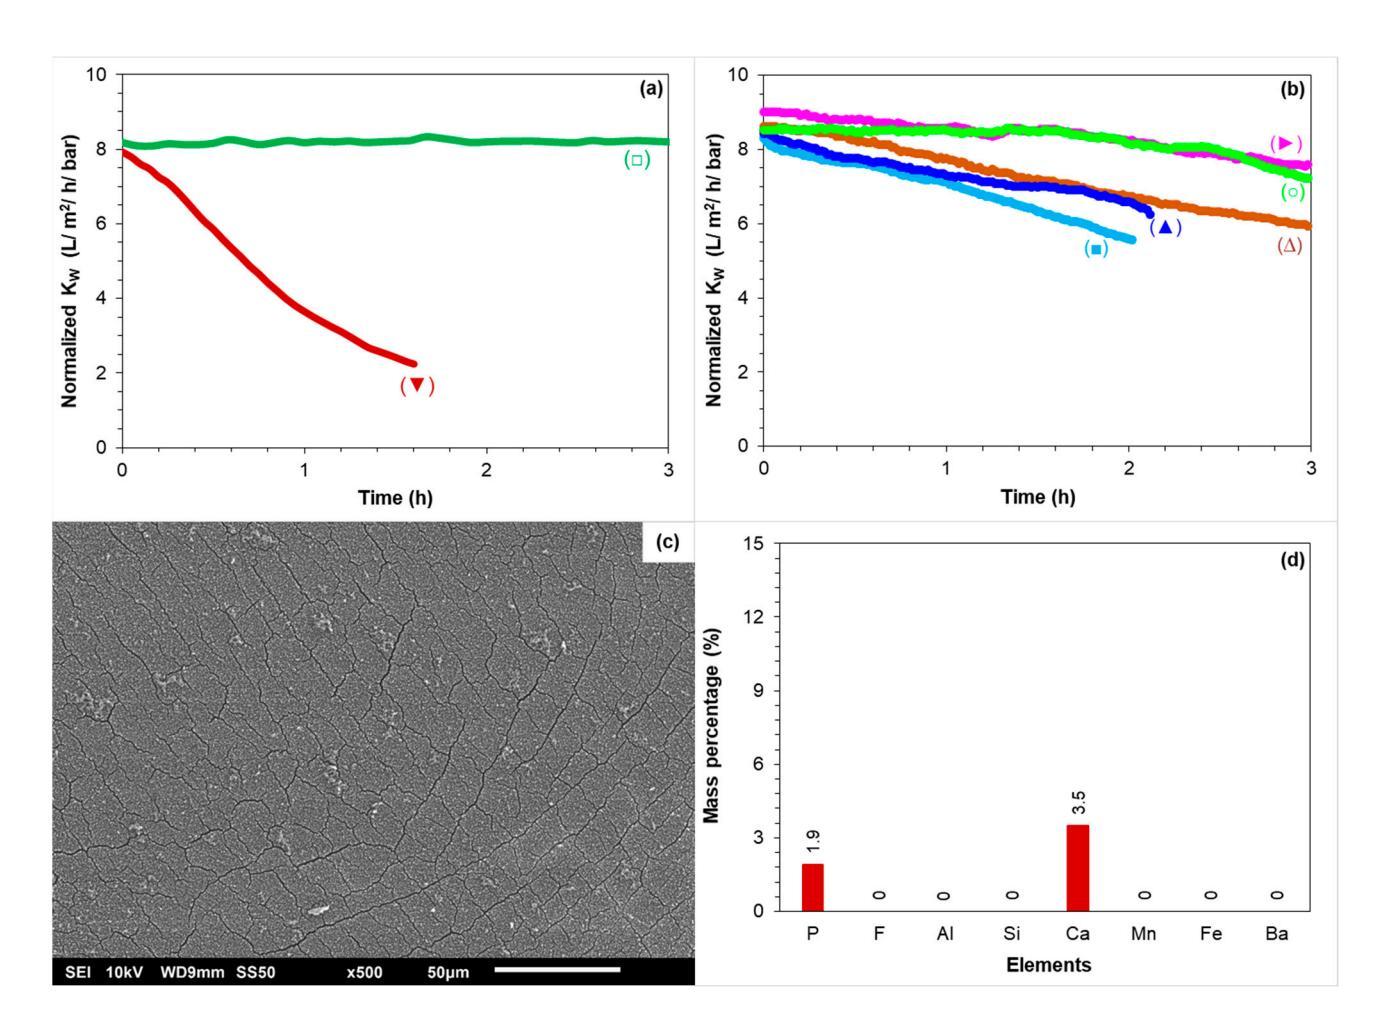
Figure 10. (a) Normalized K_w of the small RO element when fed with the synthetic concentrates of (\Box) 80% recovery without antiscalant and (\triangledown) 85% recovery without antiscalant. (b) Normalized K_w of the small RO element when fed with the synthetic concentrates of 85% recovery with 33.3 mg/L of (\blacksquare) AS–1, (\blacktriangle) AS–2, (\bigcirc) AS–3, (\triangle) AS–4, and (\triangleright) AS–5. (c) SEM image of the membrane surface fouled with calcium phosphate without antiscalant addition. (d) EDX analysis of the membrane fouled with calcium phosphate without antiscalant addition.

Figure 10a shows the normalized permeability of the TW30-1812-50 membrane element when fed with the synthetic concentrates of 80 and 85% recoveries in the absence of antiscalants (see Table 4 for the testing conditions). As can be seen, the normalized permeability of the membrane remained constant when fed with the synthetic concentrate of 80% recovery. This result is consistent with the RO pilot results (Figure 4c), where the normalized permeability in the third stage remained constant at 80% recovery without antiscalant. On the other hand, when the membrane element was fed with the synthetic concentrate of 85% recovery, the normalized permeability decreased sharply, as illustrated in Figure 10a. This result also verifies that calcium phosphate was one of the scalants that caused permeability decline of the third stage of the RO pilot in Figure 4c. A SEM image and an EDX analysis of the membrane with decreased permeability (Figure 10a) are given in Figure 10c,d, respectively. As can be seen, the membrane surface was covered with an amorphous layer (verified with XRD analysis (Figure S6)) of calcium phosphate particles. In the EDX analysis, the mass percentage of fluoride, aluminium, silicon, manganese, iron, and barium was zero, which was because they were not present in the synthetic concentrate of 85% recovery.

Figure 10b shows the normalized permeability of the RO when fed with the synthetic concentrate of 85% recovery in the presence of 33 mg/L (equivalent to 5 mg/L dose in the RO feed) of various antiscalants. The normalized permeability decreased by at least 10% with each antiscalant in a 3 h experimental period, indicating that none of the antiscalants could prevent calcium phosphate scaling. From Figure 10b, one can also observe that the poor performance of the antiscalants in preventing the permeability decline of the third stage of the RO unit in Figure 9 was not (mainly) due to the presence of a high concentration of iron (II). The permeability of the small RO element in Figure 10b decreased more sharply than the permeability of the third stage of the RO unit in Figure 9. One possible explanation is that the supersaturation level of calcium phosphate in the synthetic RO concentrate was slightly higher than that of the real RO concentrate because the once-through lab-scale RO experiments were performed at room temperature (approximately 22 °C), whereas the RO concentrate was at around 12 °C. Furthermore, Figure 9 shows the average permeability of the RO unit could be sharper than the ones of third stage shown in Figure 9.
