Reliability of a Damaged RC Slab Structure using Model Code 2010 Safety Formats for NLFEA

De Boer, Ane; Lantsoght, E.O.L.; Yang, Y.

Publication date 2020

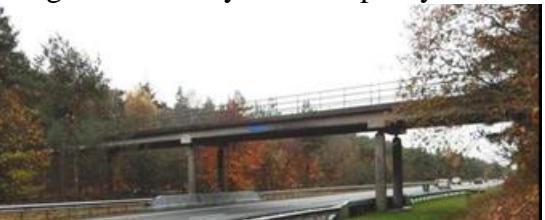
Figure 1: Photograph Watergoorschesteeg viaduct.

Viaduct Watergoorschesteeg (see Figure 1) is a fourspan reinforced slab in the central region of the Netherlands, which was designed and built in 1963. The viaduct is a slab on a beam grid. The viaduct has been inspected every six years.

The length of the central spans is 14.5 m and the outermost spans are 10.5 m in length. The overall width of the bridge deck is 5.7 m; the carriageway width is only 3.8 m. The central spans are divided into three parts with two intermediate cross-beams. The outermost spans are divided into two parts with only one intermediate cross beam. The bridge deck slab has a thickness of 0.30-0.36 m, the cross beams at the support lines have a width of 1.0 m and a height of 0.95 m. The intermediate cross beams have a width of 0.5 m and a height of 0.65 m. These divisions can be seen in Figure 2.

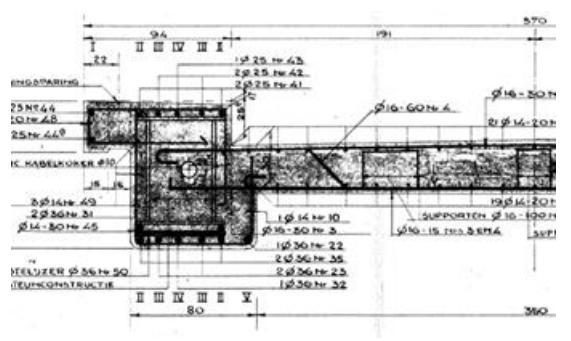
Figure 3: Half of the cross section of the bridge deck.

The main capacity is coming from the two edge beams, which are heavily reinforced. The traffic forces of the wheel prints will be transferred by the slab panels to the intermediate cross beams and finally to the edge beams. The cross section of the bridge deck can be seen in Figure 3. The reinforcement in the cross beam of Figure 3 shows some bent up reinforcement. The Dutch Concrete recommendation before the Eurocode(NEN 6720 1995) assigns no extra capacity to the bent up reinforcement, so a nonlinear analysis where this reinforcement layout is incorporated will bring automatically extra capacity.

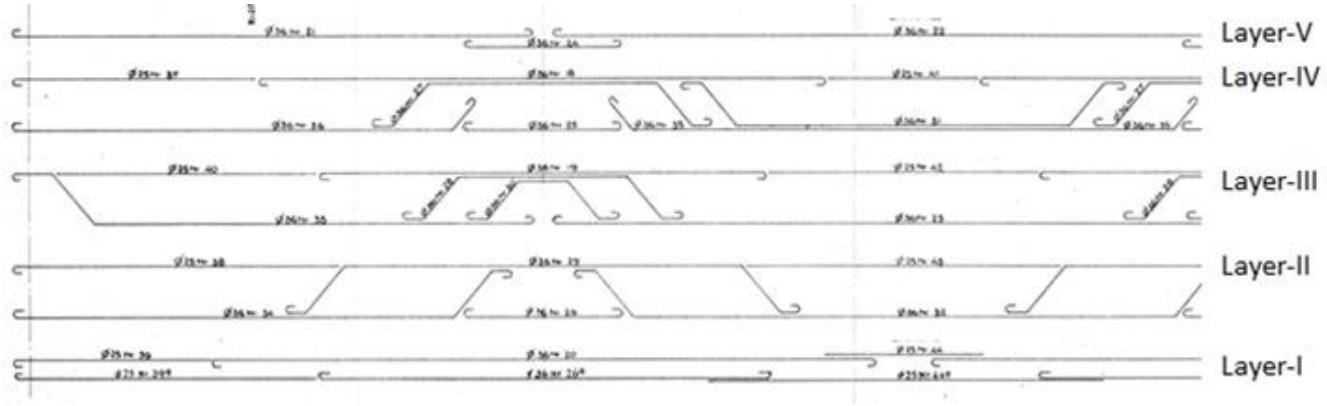
Figure 4. Side view of reinforcement layers of the edge beams.

The longitudinal reinforcement of the edge beams contains a lot of bent up bars, so also here there is extra capacity expected by running a nonlinear analysis. 4 shows an impression of the amount of bent up bars in the edge beams. Figure 4 shows also the side view of the reinforcement layout in longitudinal direction of a side span and a main span. Error! Reference source not found.4 shows on the right side of the figure the five different layers of the reinforcement, which can be found also in Figure 3 under the edge beams. In Figure 3 the order of the layers starts with II followed by III, IV, III and II. The outside of the edge beam shows a layer I at the top, where the inside of the edge beams shows a layer V at the bottom. The diameter of the reinforcement bars is 36 and 25 mm, which is rather heavy for the time period of design (1963).

Both figures show clearly the differences in dimensions of the crossbeams and the intermediate crossbeams. The NLFEA model contains only quadratic hexa solid elements with a maximum element side length of 100 mm. The dimension of 100 mm (3 stress points over the element side length) is related to the face to face dimension (150mm) of the different layers in the edge beam reinforcement. The reinforcement has been modelled as shown in Figures 4.

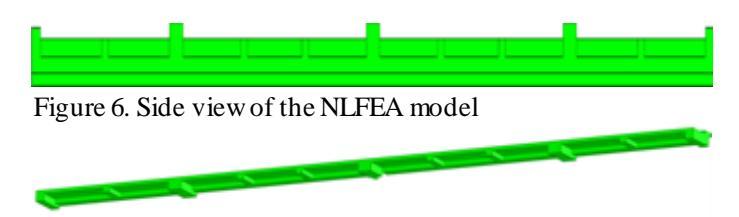
This means a reduction of input, especially for amount of the reinforcement bars. A side view can be seen in Figure 6 and an iso view of the bottom side of the concrete structure is shown in Figure 7.

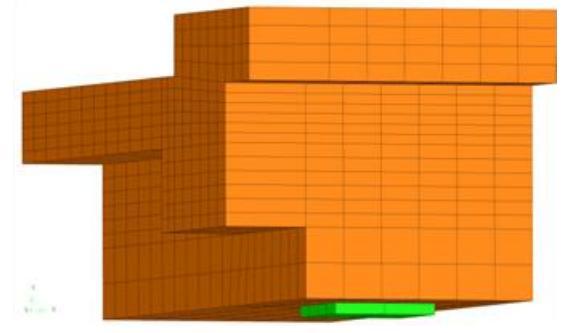
Figure 8. Element distribution at the support crossbeam

Figure 8 shows the element distribution over the height of the bridge deck and the edge beam at the location of the intermediate support cross beam.

Figure 8 shows the concrete part and one bearing. The thickness of the bridge deck on the left side is divided over six elements, the edge of the bridge deck on the right side shows four elements over the height. The edge beam itself counts six elements on longitudinal direction and 14 elements over the height. The bearing part consists of $2 \times 2 \times 1$ elements.

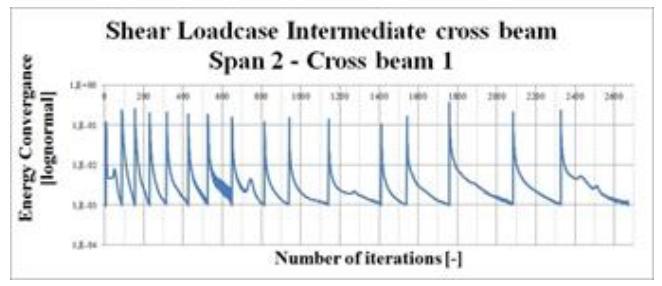
Figure 9. Energy convergence development versus total number of iterations

This process can be visualized by Figure 9, where all iterations of the different load steps converge below this limit of 1.E-03.

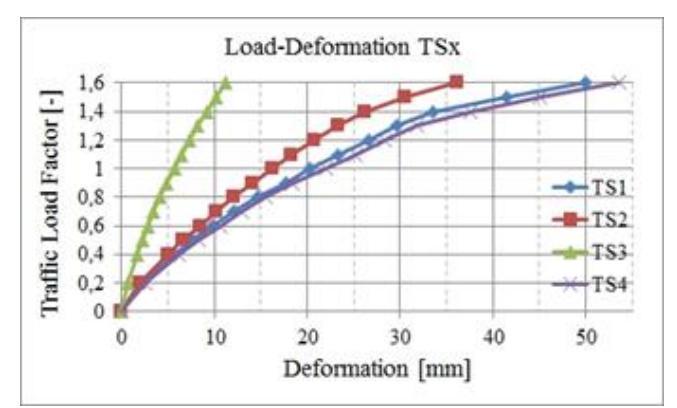
The first usual result of a nonlinear analysis is the load deflection curve. Here, Figure 10 shows the results for the four different wheel print load cases. Figure 10 shows that the difference in deformation between load cases TS1 (shear force) and TS4 (bending moment) is very small, where the shear force load case TS3, near the support cross beam, isn't relevant. Further important results are given in Table 2.

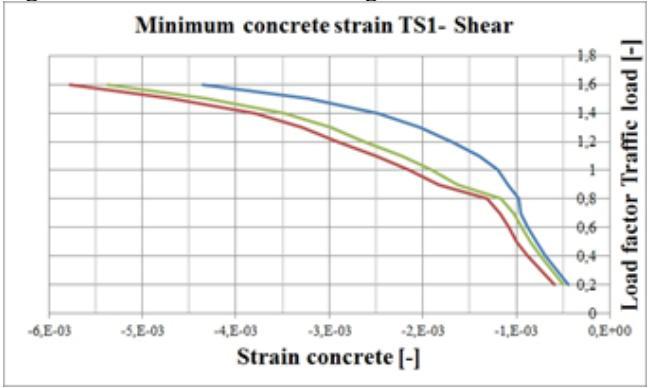
Figure 11. Concrete strain elements below the -3.5‰

(1.25). The maximum value of the reinforcement strains at a load factor of 1.6 shows 1.83%, which is far below the limit strain of 5%. However, the value for the concrete is -5.8‰, which is below the limit of -3.5‰. These concrete elements in the structure are located at the support cross beam and are very local at the edge, which is indicated in Figure 11.

Figure 12 shows that the concrete strain of -3.5‰ is reached at the level of load factor 1.18. Conclusion from Figures 11 and 12 is that the minimum strain of the concrete is only localized in some stress points of three elements, which can be seen as a local aspect.

Figure 17 counts five elements with a lower minimum strain, where Figure 11 shows only three elements with a lower minimum strain. However two elements (the most left and right element) in Figure 17 have a very small nodal area, where the minimum strain is reached.

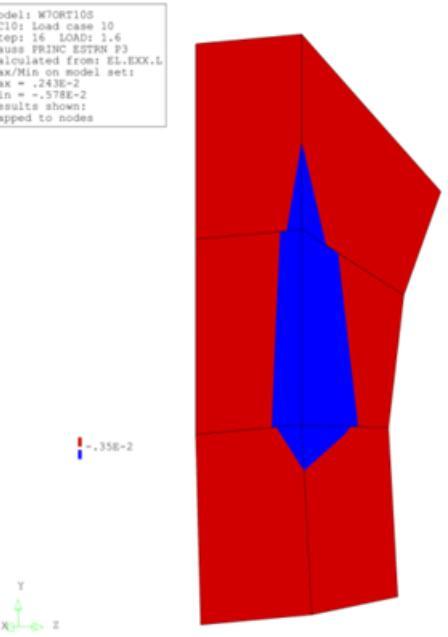
Figure 12. Development of the critical concrete strains

Important to know is the fact when this crushing behaviour of the concrete starts. This development is

shown in Figure 12 for load case TS1 for the three finite elements.

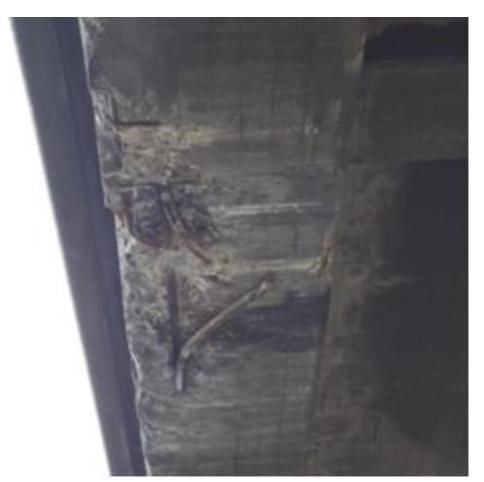
Figure 13. Photograph of the edge beam damage

The damage of the edge beam can be seen on the photograph of Figure 13. Two reinforcement bars are broken over a length of 1 meter and also some concrete cover is missing.

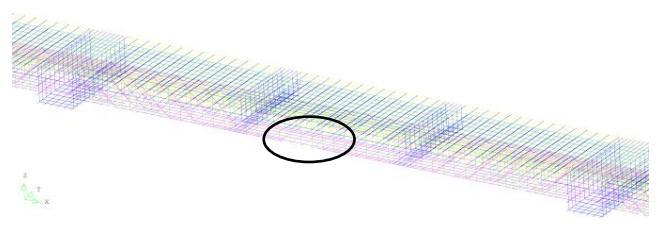
Figure 14. Excluded reinforcement edge beam mid span 2

The damage results in a modification of the reinforcement bars of the edge beams, which is done by splitting two bottom level longitudinal reinforcement bars into two separate bars. This can be seen in Figure 14. The nonlinear analysis of the three traffic load cases belonging to mid part of span 2 are relevant.

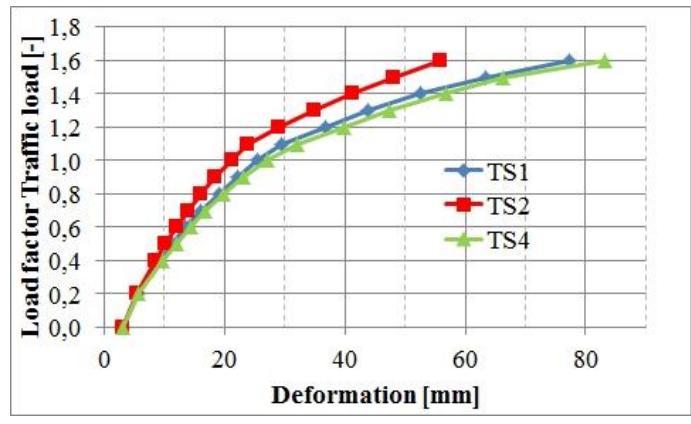
Figure 15. Load-deformation wheel print load cases

Again also here the most usual output is the load deformation of the structure can be given, now for the three relevant load cases TS1, TS2 and TS4. This is shown in Figure 15.

Figure 15 shows that the deformation results of the load case TS1 and TS4 are close to each other, where TS4 has still the maximum deformation. However, the increase of the deformation is rather large, changing from 53 mm to 83 mm!

The maximum deformations are increasing from 53 to 83 mm, which is rather high, because the ratio to the span length becomes 1:175.

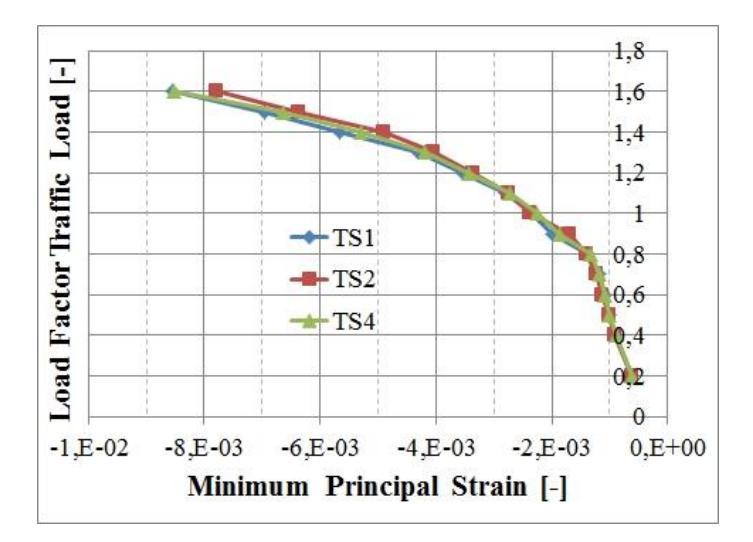
Figure 17. Development of the critical concrete strains

This means that the location is shifted from the edge of the crossbeam to the region above the bearing plate of the same crossbeam. The edge side got a redistribution of strains, where the minimum value is coming below the limit of -3.5‰. Inspection of this edge side location didn't show any damage (crushing) of the concrete. The development of the concrete strain is shown in Figure 17.

The critical principal concrete strains (Figure 17) shows still a load factor of 1.18, when the minimum limit of -3.5% is reached. The change from the edge of the crossbeam to the bearing plate region doesn't have effect on the load factor for the wheel print load.

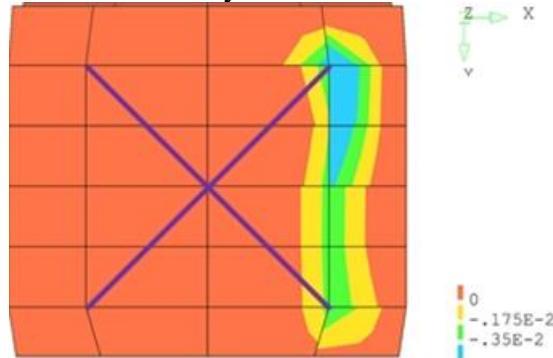
Figure 18. Concrete strain values around the bearing area

To identify the principal concrete strain in the bottom fibre of the supporting cross beam, the strain is plotted at the area of the bearing and the surrounded row of elements of load case TS4. This plot is shown in Figure 18.

Figure 18 shows at the edge of the bearing area only low strain, where most of the area at the bottom fibre has a tensile strain. This behavior is rather overestimated by the way of modelling no pylons in this calculation. When the pylons have a normal length in the model and automatically also the belonging stiffness the strains would be presented in a more smooth way without extreme values.

Figure 18 shows a principal concrete strain over half of the right side of the bearing area, which is indicated by the purple cross, with a value below -3.5%. The other half of the right side has values between -1.75 and -3.5%.
