## Design, Engineering and Experimental Testing of Tubular Glass Columns

Veenstra, C.R.A.; Noteboom, C.; Oikonomopoulou, F.; Overend, M.

Challenging Glass Conference Proceedings

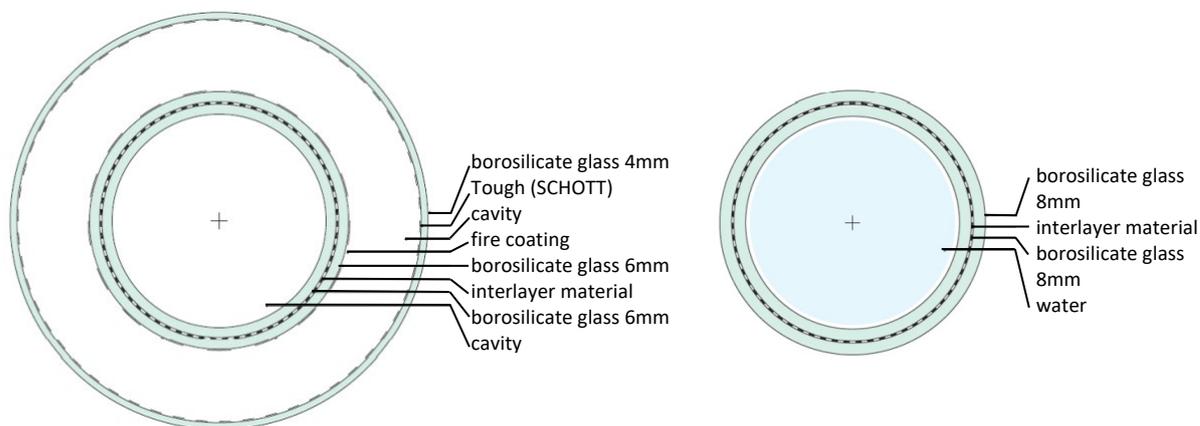
Figure 1 shows a characteristic cross-section of the two concepts.

Fig 1. Left: cross-section of the MLA. Right: cross-section of the SLW.

The MLA column (figure 1, left) consist of an outer, non-load bearing tube and two inner load-bearing borosilicate glass tubes. The outer glass tube has a polymer coating on its inner surface and its primary purpose is to protect the inner glass layers. The two inner, load-bearing, tubes are bonded together by a transparent interlayer material. In this project, Ködistrukt LG, LOCA material from H.B.Fuller Kömmerling is used. This is a thermoset liquid resin, formed with cross-linked polymers. The first component is polyol and the second is isocyanate. This interlayer material cures at room temperature. Due to this, no sudden cooling takes place, whereby no extreme stresses occur. Furthermore, this interlayer material has a low shrinkage value (3.5%) resulting in smaller quantities of entrapped air (e.g. bubbles) and low residual stresses within the adhesive layer. The outer surface of the middle layer will be coated with a transparent fire resistance coating (e.g. HCA-TR)<sup>1</sup>. This coating is protected from scratches by the outer glass tube. It is further advisable to use sprinklers in the building, in order to reduce the temperature of the glass for a prescribed duration in the event of a fire.

The SLW glass column (figure 1, right) comprises two glass tubes bonded together by an interlayer material (the same liquid resin as used for the MLA). In this concept, the tube is filled with water to keep the glass cool in the event of a fire. The water will be pumped through the column. As in the MLA variant, it is advisable to also use sprinklers in the building to further reduce the temperature of glass if needed. The 3D-view of SLW is shown in figure 2 (right).

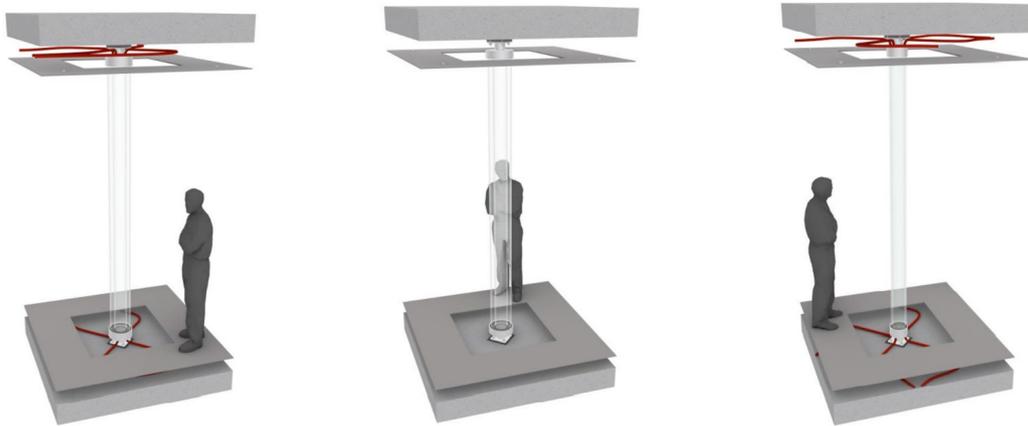
Fig 2. 3D-view of the MLA with (left) and without (middle) a ventilation system. Right: 3D-view of the SLW.

As mentioned before, temperature differences between the closed glass tube cavity and the exterior could result in air pressure that in turn can result in condensation and stresses. If the glass column cannot resist these stresses, the air pressure can be regulated by a ventilation system. Nevertheless, condensation could still occur. Therefore, silica desiccant grains are included in the design, in a similar manner to desiccant commonly used in insulating glazing units. Figure 2 (left and middle) shows the MLA with and without a ventilation system.

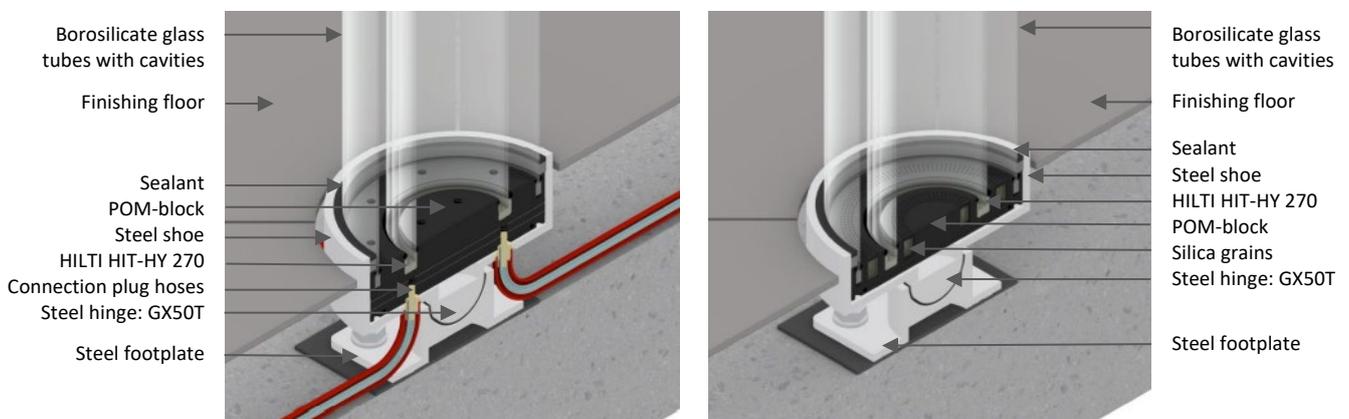
In both designs, hinged connections are used, to ensure that only axial compression forces are transmitted to the glass column. A POM-block is placed in between the steel shoe and the glass tubes, because it has a lower Young's modulus than glass. Hilti mortar will be injected under the glass tubes into the groove of the POM-block to distribute the compression loads from the connection into the glass tubes. The POM-block can accommodate several variants of the glass columns e.g. the application: water, air or silica grains. Figure 3 shows two different 3D cross-sections of the end connection from the MLA.

Fig 3. 3D cross-section of the MLA end connections  
left: connected to a ventilation system, right: without connection to a ventilation system.

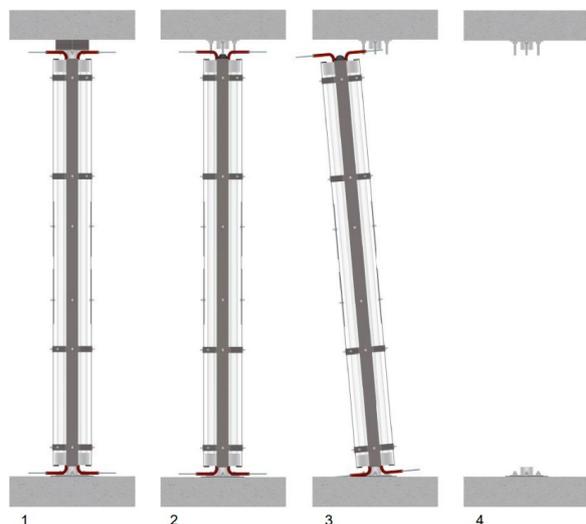
Fig 4. Replacement strategy (of the MLA connected to a ventilation system).

A few steps of the assembly sequence are shown in figure 5. Environmental sustainability is considered by designing for demountability. The glass column can be removed from the building in one piece. To achieve this, dry connections are used, so all components can be reused as well<sup>2</sup>. In this way, it is also possible to replace the column when broken (figure 4). Temporary struts need to be placed on either side of the broken column, and the column can be removed and replaced.

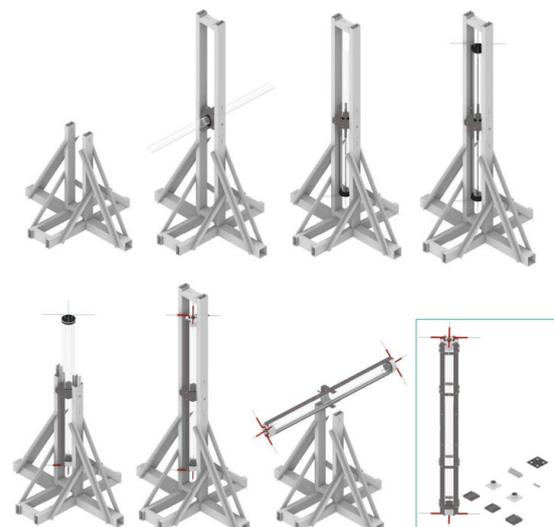
Fig 5. A few steps shown on the assembly of the MLA (with air hoses). The last picture is an overview of all the components ready for installation on-site.

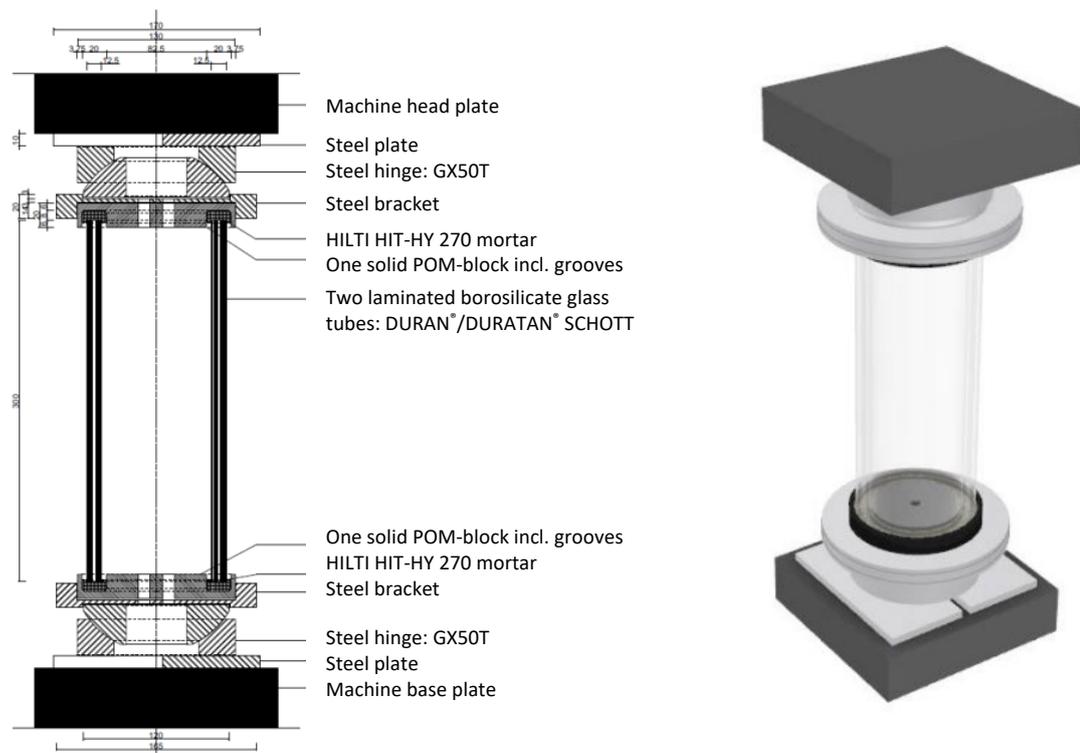
Fig 6. Illustrations of the sample (left: cross-section, right: 3D-view).

Each sample consists of two glass tubes. The diameter of the outer tube is 115 mm, the wall thickness is 5 mm, and the length is 300 mm. The diameter of the inner tube is 100 mm, the wall thickness is 5 mm, and the length is 300 mm. This gives a cavity of circa 2.5 mm between the two glass tubes. Figure 6 shows an illustration of the samples. From the 6 samples, the first three samples are made of DURAN® (annealed) glass tubes, and the other three samples using DURATAN® (heat-strengthened) glass tubes.

- POM-block, t=20 mm,  $\phi$ =130 mm (with grooves to put in the glass tubes)
- HILTI HIT-HY 270 mortar (Hilti mortar), t=8mm (under the glass tubes)
- Steel bracket: S355 cutting plate, t=20 mm,  $\phi$ =165 mm (CNC-milling to create cambers to keep the POM-block and the hinge at its place)
- Steel hinge: standard product GX50T

<sup>3</sup> Since the head plate of the testing machine had holes for the wires, the steel plates, shown in figure 6, are left out during testing.

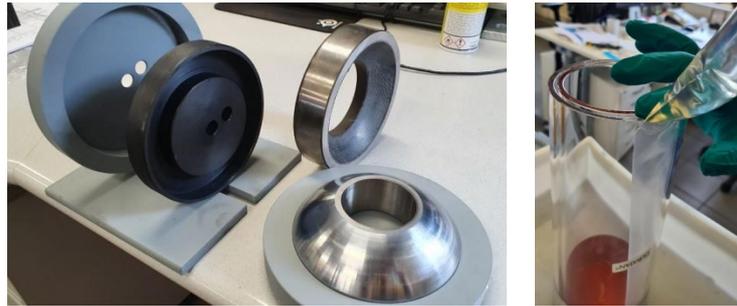
Fig 7. Left: steel and POM components, right: lamination process of one of the samples.

laminated in a vertical position. The end-connections, steel and POM components are designed and developed with the aid of Octatube. The steel shoes are made from CNC-milled steel rods in order to create the designed chambers. In these chambers, the POM-block and the steel hinges (Techniparts) are placed. The POM-blocks are milled from solid POM-rods to obtain the desired grooves. During assembly, strain gauges are glued to the inner and the outer glass tubes. Lastly, the HILTI HIT-HY 270 mortar is injected into the grooves of the POM-blocks, and the laminated glass tubes are placed on top. The mortar was well-distributed into the grooves and it was possible to inject it properly, whereby the glass stayed clean. In figure 7, the steel and POM components are shown, as well as the lamination process.

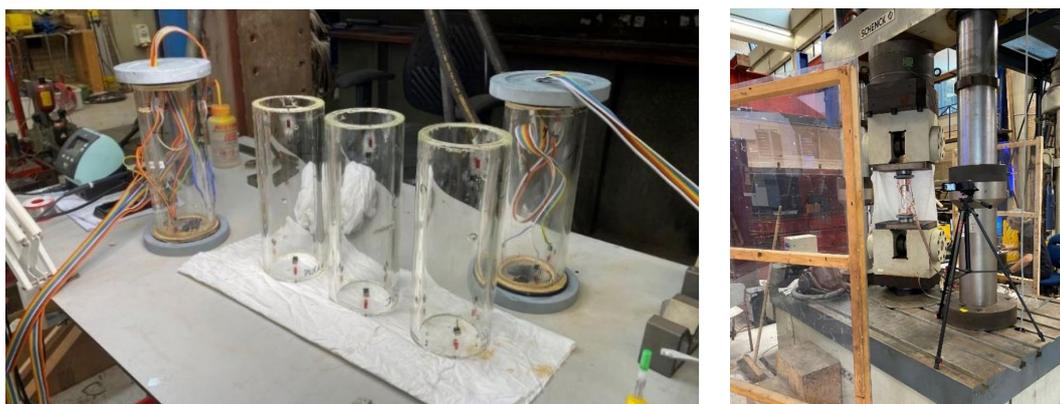
Fig 8. Left: samples ready for testing, right: one of the samples placed in the compression machine.

Prior to testing, the aforementioned strain gauges, glued to the glass tubes, are soldered to the connectors. Twelve strain gauges are glued to each sample, 6 on the outside and 6 on the inside. The glass is abraded lightly, at the locations where the strain gauges are glued, to make sure that the strain gauges are not falling off. After that, the wires could be soldered to the connectors as well. Timber pieces are glued inside the grooves of the POM-blocks to hold the glass at the right height. Then the HILTI HIT-HY 270 mortar could be injected, which requires approximately 5 minutes to harden. Within these 5 minutes, the mortar needed to be injected, smoothed out, and the glass needed to be placed on top of the mortar and the timber pieces at the right height. Afterwards, the wires needed to be set to zero and then the samples were ready for testing. Figure 8 shows the samples ready for testing.

A hydraulic displacement-controlled universal testing machine is used for the testing of the samples in compression with a cross-head displacement rate of 1mm/min. The samples are clamped between a head and a base plate (figure 8, right).

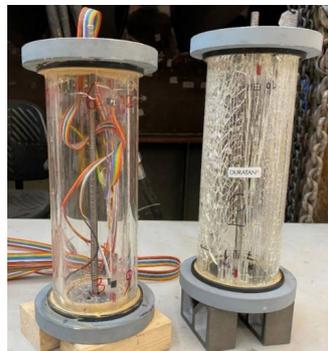
Fig 10. Left: one cracked annealed sample, right: one cracked heat-strengthened sample.

In figure 10 (left), one cracked annealed sample is shown after testing. The annealed samples (AN1-3) presented a few straight, vertical cracks parallel to the length of the tube. The cracks had a slow propagation. The first cracks appeared between 95-160 kN compression load, but complete failure only happened between 700-750 kN. Upon final release of the force, additional small perpendicular cracks appeared. Cracks appeared in both tubes, indicating a good degree of a cooperation between them.

In figure 10 (right), one cracked heat-strengthened sample is shown after testing. The heat-strengthened glass samples (HS3-4) presented considerably more cracks, again vertical and parallel to the length of the tube. The first cracks appeared at 120-160 kN. In contradiction to the annealed glass samples, cracks appeared first in the outer tube. The cracks propagated quickly with a lot of speed. When the tests are ended, due to shattering of the glass (at circa 390-490 kN), the inner tube exploded into small pieces at once. This means that the cooperation from the heat-strengthened samples is less than from the annealed samples. The overview of the differences between annealed versus heat-strengthened samples is given in table 1.

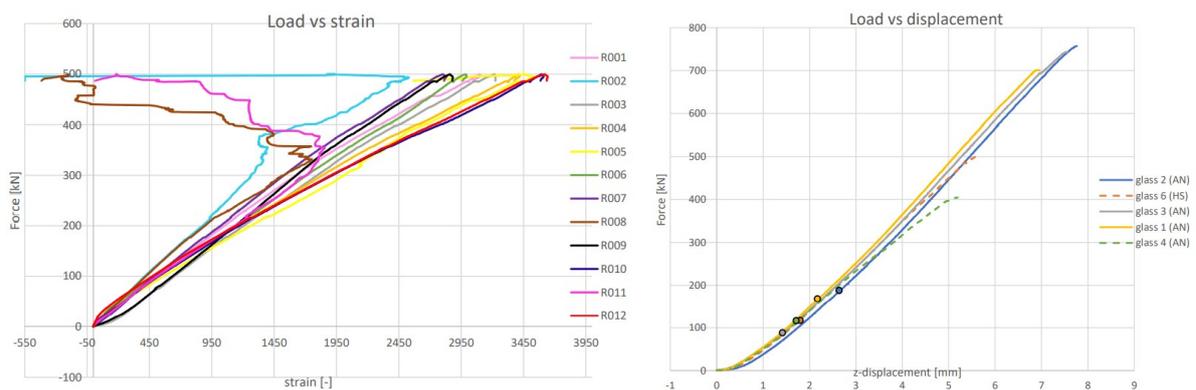
Fig 9. Left: strain versus load curve of sample 6, right: load versus displacement curve of samples 1, 2, 3, 4 and 6.

The even force distribution is checked by the strain gauges. If the forces are equal in the glass tubes, then the strains are equal. Figure 9 (left) shows a typical strain versus load curve from one of the samples. R001-R012 are the twelve strain gauges. R001-R006 are the strain gauges placed on the outside of the glass tubes, and R007-R012 are the strain gauges on the inside of the glass tubes. As shown in figure 9, in the beginning the strains are almost equal. After that, the stress field changes, whereby some strain gauges are deviating. There are a few possible reasons regarding the latter:

The connections and the HILTI HIT-HY 270 mortar remained intact. Only the glass fractured. The test was ended when the glass column experienced a combination of multiple fractures and a significant drop in the load versus displacement curve. This can therefore be considered the ultimate compression capacity of the glass columns. Figure 9 (right), shows the load versus displacement curves for all the samples, except sample 5. The curve of sample 5 is not reliable, because the machine failed to record some of the data during testing. The bullets in the graph represent the load at which the first crack appeared in the samples (the failure load). The cracks appeared between 95-160 kN. This corresponds to a compression stress of 29.5-49.5 MPa, with corresponding tensile stresses of 5.9-9.9 MPa. Based on equation 6 and 7 of NEN 2608 (2014), the allowable tensile stress for annealed glass is 15.5 MPa and for heat-strengthened glass is 36.3 MPa; which would in turn imply that in theory, the first cracks should occur at around 250 kN of compressive load with a corresponding nominal compression strength of 78 MPa with the given set-up.
