## Dielectric Coatings for High Voltage Gas Insulated Switchgear

van der Born, Dennis

2017

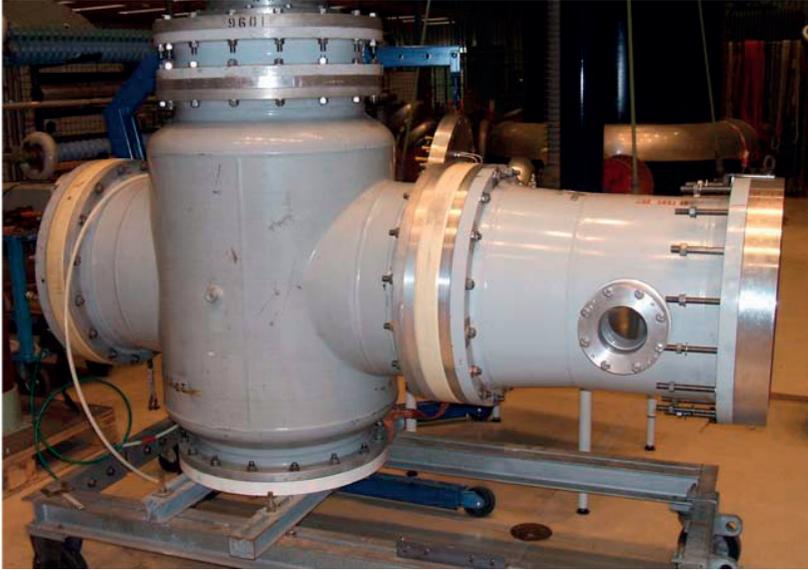
Figure 3.1: Picture of test setup GIS enclosure

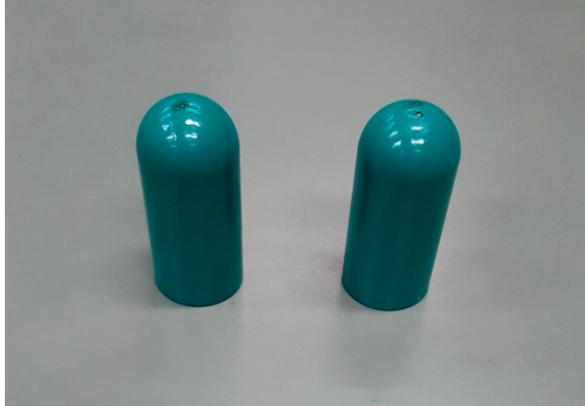
**Figure 3.7:** EP-I coated small size electrodes.

EP-I is a thermoset polymer based on epoxy resin and has a green colour as shown in Figure 3.7. For the application of the material on the rod electrodes the electrodes are

first degreased and sandblasted. Next, the coating is applied by dipping the electrodes in a bath containing the liquid resin. The resin is then polymerized at a temperature between 180 °C and 230 °C.

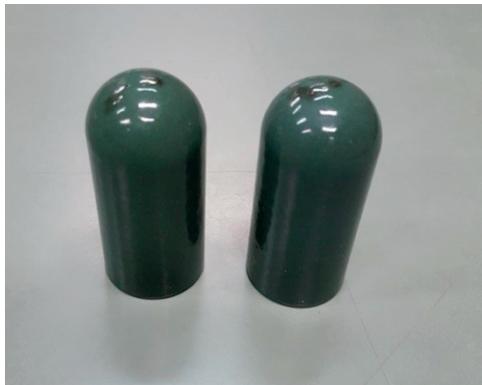
**Figure 3.8:** FP-I coated small size electrodes

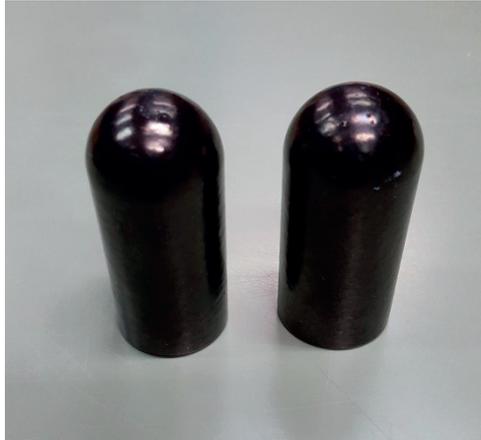
**Figure 3.9:** FP-II coated small size electrodes.

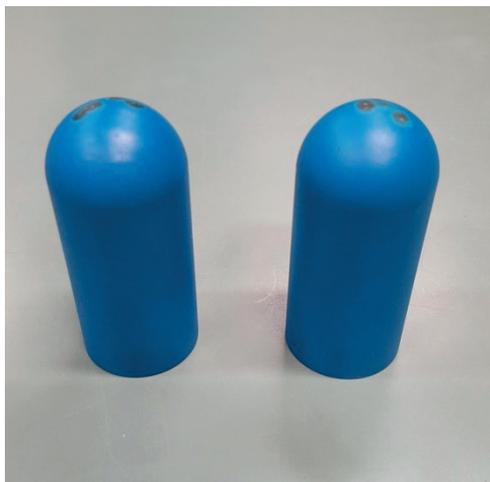
**Figure 3.10:** FP-III coated small size electrodes.

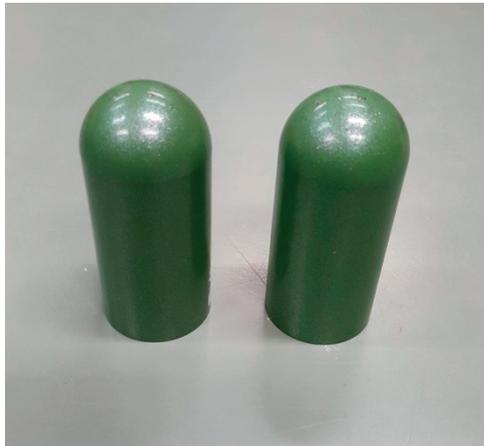
**Figure 3.11:** FP-IV coated small size electrodes.

FP-IV consists of a bottom adhesion layer and one or more topcoat layers which consist of FEP (Fluorinated Ethylene Propylene) reinforced with mica particles. This material is anti-adhesive and non-wetting and is suitable for food contact. The colour of the material is in this case olive green as shown in Figure 3.11. The production process consists of pneumatic spraying after which the material cures at a temperature of 400 °C. Electrode pre-treatment consists of degreasing and micro-abrasive blasting.

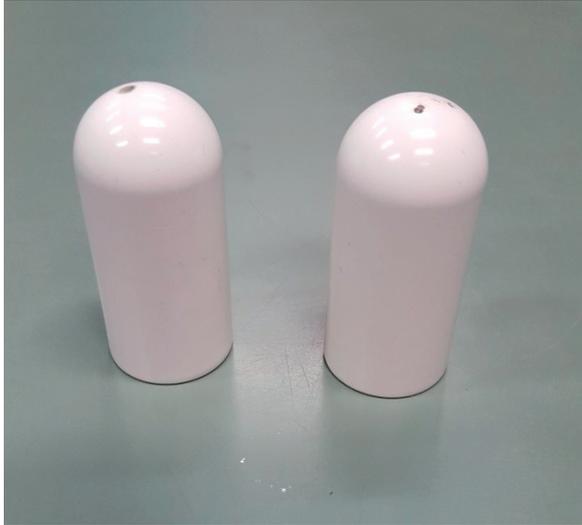
**Figure 3.12:** PA11 coated small size electrodes.

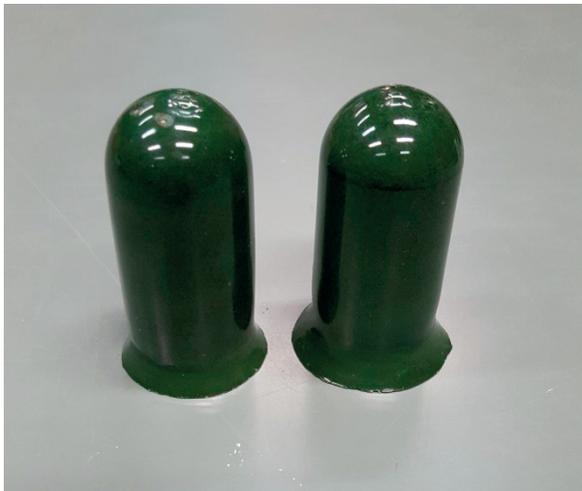
**Figure 3.13:** Semiconductor A coated small size electrodes.

Unfortunately, the contents of this material are classified. However it is disclosed that this material has semiconductive properties. The colour of the material is green as shown in Figure 3.13.

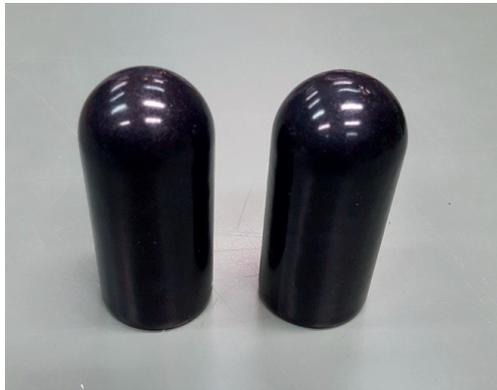
**Figure 3.14:** FP-II + FP-I coated small size electrodes.

As can be seen from the table, for both materials the base layer consists of FP-II which can be seen as a semiconductor. For the top layer either PA11 or FP-I is used as shown in Figure 3.14 and Figure 3.15 respectively. The reason to test these coating types was to

reduce the influence of the electrode surface roughness underneath the coating on the breakdown initiation voltage. This method can be compared with the application of a semiconductor layer between the conductor and the insulation of a power cable.

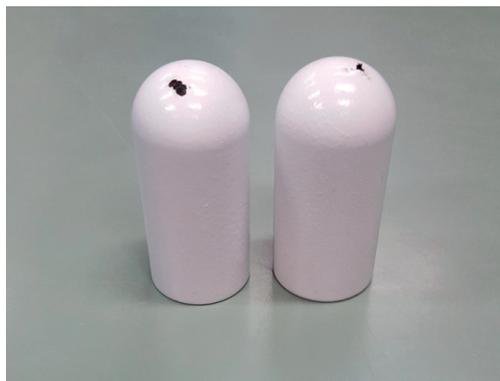
**Figure 3.15:** FP-II + PA11 coated small size electrodes.

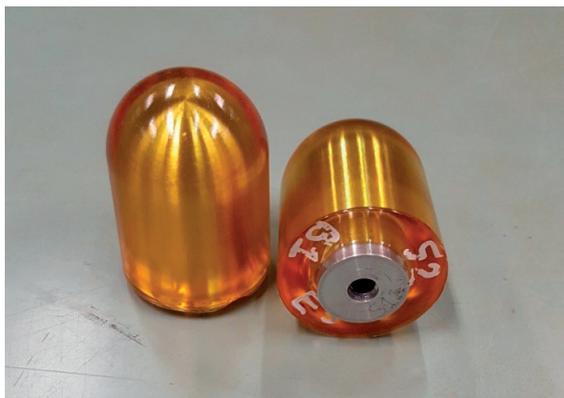
**Figure 3.16:** Neat epoxy coated small size electrodes.

mesocomposite [48]. The volume concentration of cBN particles in nanocomposite B is 0.2%. Figure 3.16 shows two samples of small size electrodes coated with neat epoxy. Electrodes coated with nanocomposite B and C are shown in Figure 3.16 and Figure 3.17 respectively. Nanocomposite A has the same appearance as nanocomposite C. The reason to choose nanocomposites is the fact that it is possible to decrease the relative permittivity of epoxy with the addition of low concentrations of BN nanoparticles [48]. Decreasing the relative permittivity of epoxy would be favourable in terms of breakdown voltage as explained in section 2.3. Furthermore, at Delft University of Technology extensive research was conducted on nanocomposites for high voltage applications and this

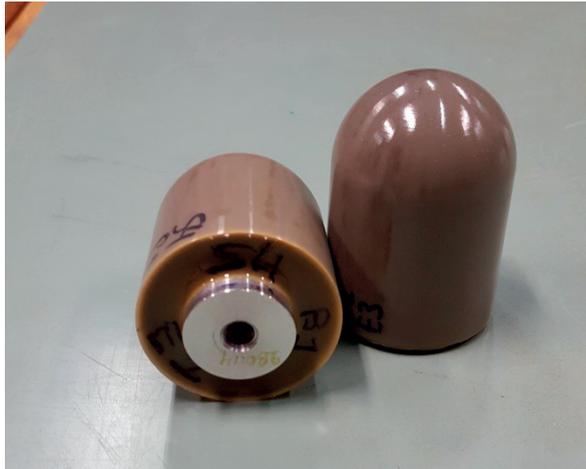
**Figure 3.17:** Nanocomposite B coated small size electrodes.

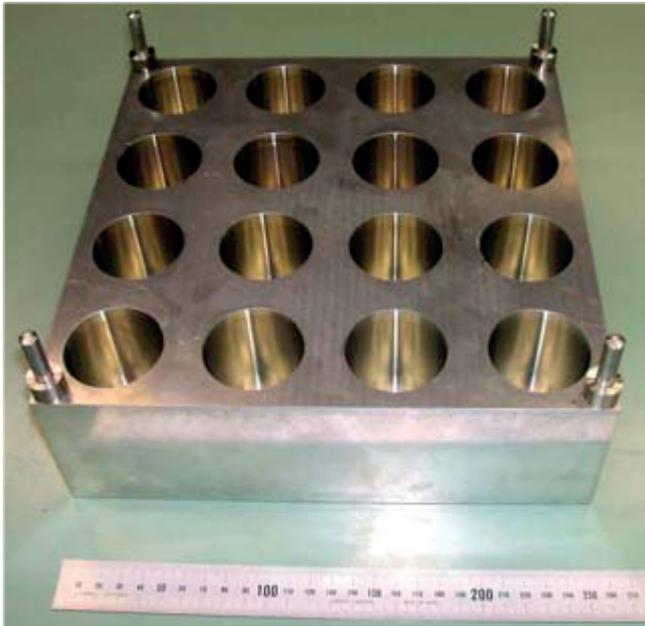
**Figure 3.19:** Mould for small size electrodes, bottom part.

In the case of small size electrodes, the degassed epoxy is poured into the mould shown in Figure 3.19 and Figure 3.20. With this mould it is possible to produce 16 coated small size electrodes in one batch. The correct volume of epoxy is calculated and poured into the cavities in the bottom part of the mould, which is displayed in Figure 3.19. Before pouring the epoxy, silicone release agent is sprayed on the cavity surface to ensure a successful release of the coated electrodes. Furthermore, the mould is preheated to 75

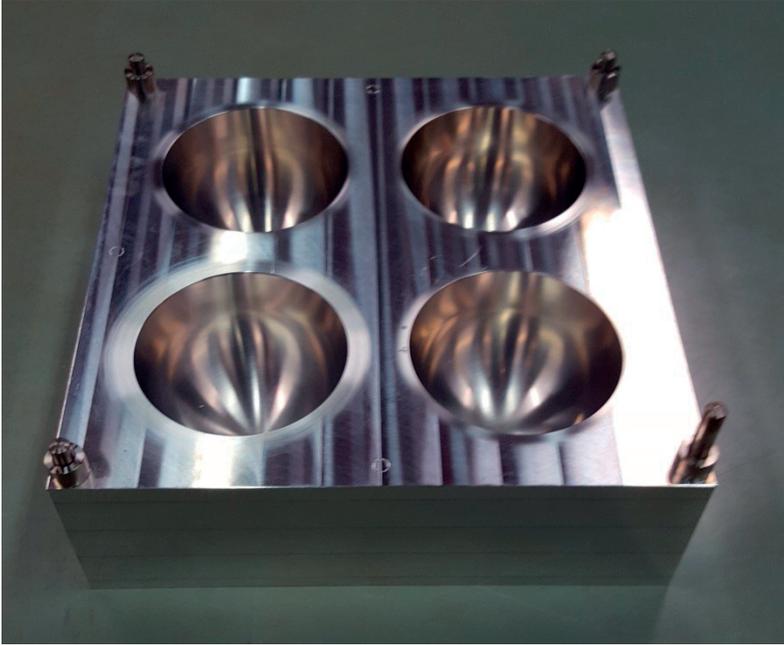
**Figure 3.21:** Mould for large size electrodes, bottom part.

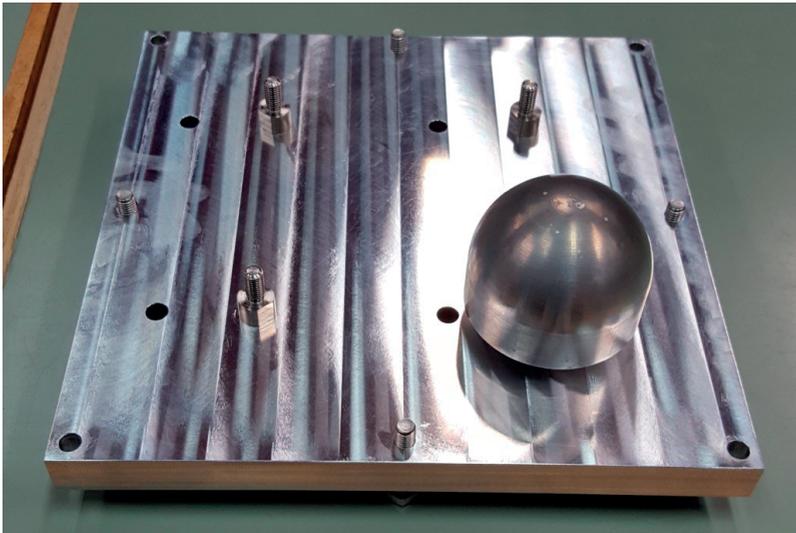
**Figure 3.22:** Mould for large size electrodes, top part, one electrode mounted.

For the medium and large size electrodes comparable moulds are used which can provide up to 4 coated electrodes per batch. The bottom and top part of the large size mould are shown in Figure 3.21 and Figure 3.22 respectively.

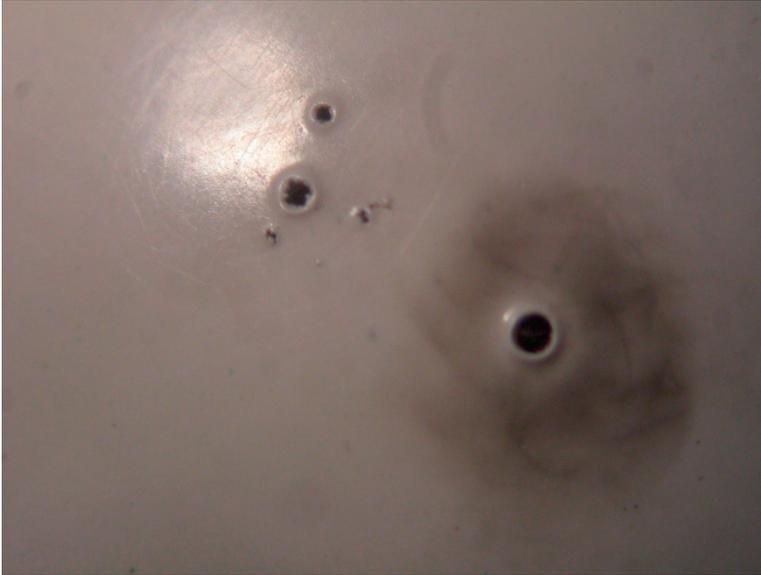
**Figure 5.38:** Microscopic view of the surface of a PA11 coated electrode after a breakdown test.

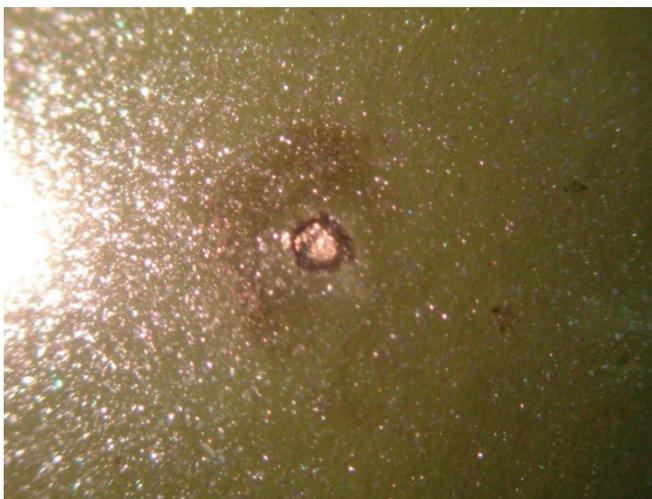
**Figure 5.40:** Microscopic view of the surface of a FP-IV coated electrode after a breakdown test.

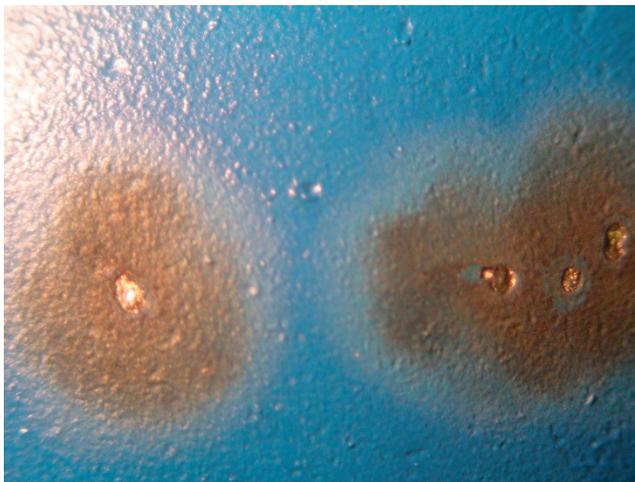
**Figure 5.41:** Microscopic view of the surface of a FP-III coated electrode after a breakdown test.

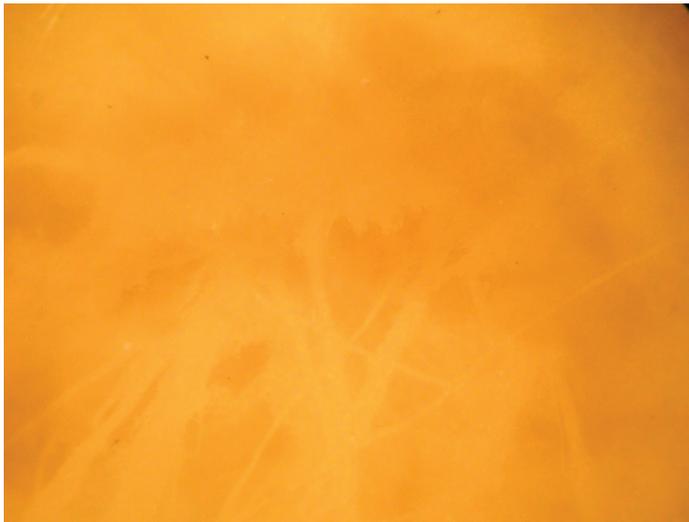
**Figure 5.45:** Microscopic view of the surface of a thick nanocomposite coated electrode after a breakdown test.
