Reinforced glass: Structural potential of cast glass beams with embedded metal reinforcement

T. Bristogianni & F. Oikonomopoulou

Department of Architectural Engineering + Technology, Faculty of Architecture, TU Delft, Delft, The Netherlands

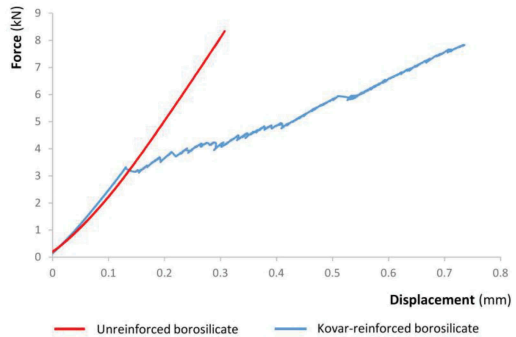
Figure 7. Force-displacement graph of an unreinforced soda borosilicate beam and the Kovar reinforced alkali borosilicate beam. Both beams exhibit an elastic behaviour, only in the case of the unreinforced beam, this is followed by a brittle response and sudden failure. The reinforced beam enters the cracked stage at a much lower load, yet endures the increasing load for 1.4 times more, before complete failure. The displacement in this graph is measured by the LVDT sensor.

The mono-material beams (eight Soda Borosilicate specimens kiln-cast at 1120°C) fail at a range of 30-50.6MPa, exhibiting an average flexural strength of 43.3MPa. The specimens show an elastic behaviour followed by sudden catastrophic fracture (Figure 6-7). One high-velocity propagating crack starts from the maximum tensile zone at the bottom of the beams, splits in 2 or more branches according to the stored energy and reaches the top surface with a characteristic compressive curl. Thus, upon failure, the beam separates in two or more distinct pieces without any post-fracture load-bearing capacity.

The reinforced beam, on the other hand, fails progressively. Nielsen and Olesen (2007) report a three-stage mechanism for laminated, steel reinforced glass beams: the elastic, cracked and yield stage. Between each stage, a change in the stiffness of the system is observed. As seen in Figure 7, the tested reinforced beam, prior to cracking, presents an elastic behaviour of almost identical stiffness to the unreinforced beam. Once the first crack appears (at

3.17kN), the system enters the cracked stage and presents a decrease in stiffness. The yield stage is not reached in this experiment, given that the test is discontinued upon complete glass failure, and at that point the metal bar exhibits only elastic deformation. The reinforced beam exhibits the first crack at approximately one third of the strength (16.6MPa) when compared to the 43.4MPa average strength of pure beams. The emerging cracks at an early loading stage are speculated to be linked to peak shear stresses developing at the metal-glass interface, due to their distinct reaction to the imposed deformation. This can be anticipated, given the significant difference in stiffness of the two materials, with the employed glass exhibiting a 64GPa Young's modulus, while the Kovar bar 138GPa. Nonetheless, the reinforced beam continues to perform upon the first crack, sustaining up to 1.44 times more load prior to failure. Failure occurs at a similar stress (40.8MPa) to the pure beams' average value (43.4MPa). Yet, the progressive failure offers a valuable warning mechanism, and allows the use of a lower safety factor, provided that the design strength used corresponds to the elastic stage of the reinforced beam.

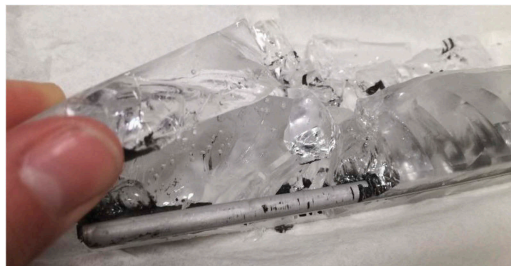
Figure 8. Upon glass failure, the separation of the two materials can be mechanically achieved.

In terms of material separation and retrieval after the end of life of the hybrid component, it seems that the glass can be easily separated by mechanical crushing (Figure 8) and recycled as pure cullet -if not contaminated by colour streaks- while the metal can be reused or recycled. This separation mechanism is advantageous in comparison to the case of laminated or adhesively bonded metallic reinforcements, where the glass interface is contaminated by the bonding medium.
