## THE 'SHELTER' ALMOST SAVED BY HENDRICK DE KEYSER

The 'Shelter' was at risk of demolition: a fascinating story by the architect, Kor Aldershoff, and the restoration architect, Ann-Katrin Adolph.

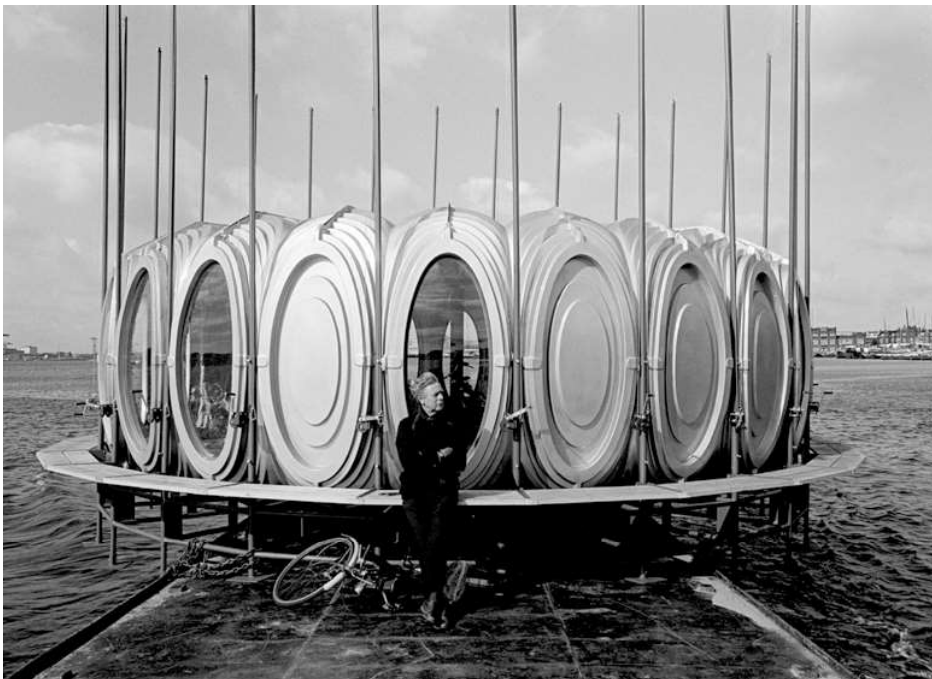
01 The 'Shelter' and architect Kor Aldershoff. © Roos Aldershoff, daughter of architect

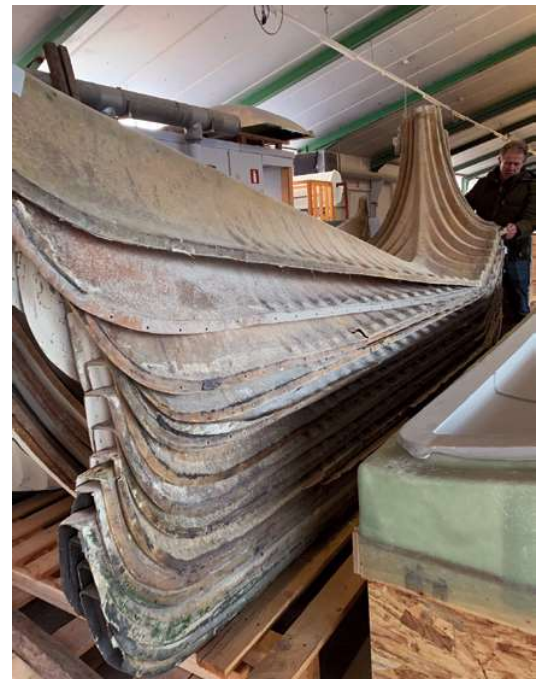
02 The 'Shelter' dismantled, under restoration. © Ann-Katrin Adolph

The restoration architect of the Association Hendrick de Keyser, Ann-Katrin Adolph, explains in an interview that they wanted to retain and restore the original materials in line with the aims of the Association. A specific difficulty in planning the works was related to the fact that the prototype was unfinished, and new problems and dilemmas

in conservation arose due to the unfamiliar material, GRP. The exposed outer surface of the elements could no longer be remediated, and a new layer of GRP had to be added. In some cases, substitutions were necessary.

Also, within the original shells were large voids/pockets which had to be filled. Left unattended, the ingress of moisture to these voids would eventually lead to the detachment of the glass-fiber and polyester. This was a complex but necessary intervention to ensure the conservation of the 'Shelter' prototype.
