Acoustic Emission-Based Analysis of Damage Mechanisms in Filament Wound Fiber Reinforced Composite Tubes

Abstract: This study investigates the mechanical behavior and damage mechanisms of thin-walled glass/epoxy filament wound tubes under quasi-static lateral loads. The novelty is that the tubes are reinforced in critical areas using strip composite patches to provide a topology-optimized tube, and their damage mechanisms and mechanical performance are compared to that of un-reinforced (reference) tubes. To detect the types of damage mechanisms and their progression, the Acoustic Emission (AE) method is employed, accompanied by data clustering analysis. The loading conditions are simulated using the finite element method, and the results are validated through experimental testing. The findings confirm that the inclusion of reinforcing patches improves the stress distribution, leading to enhanced load carrying capacity, stiffness, and energy absorption. Compared to the reference tubes, the reinforced tubes exhibit a remarkable increase of 23.25% in the load carrying capacity, 33.46% in the tube's stiffness, and 23.67% in energy absorption. The analysis of the AE results reveals tha

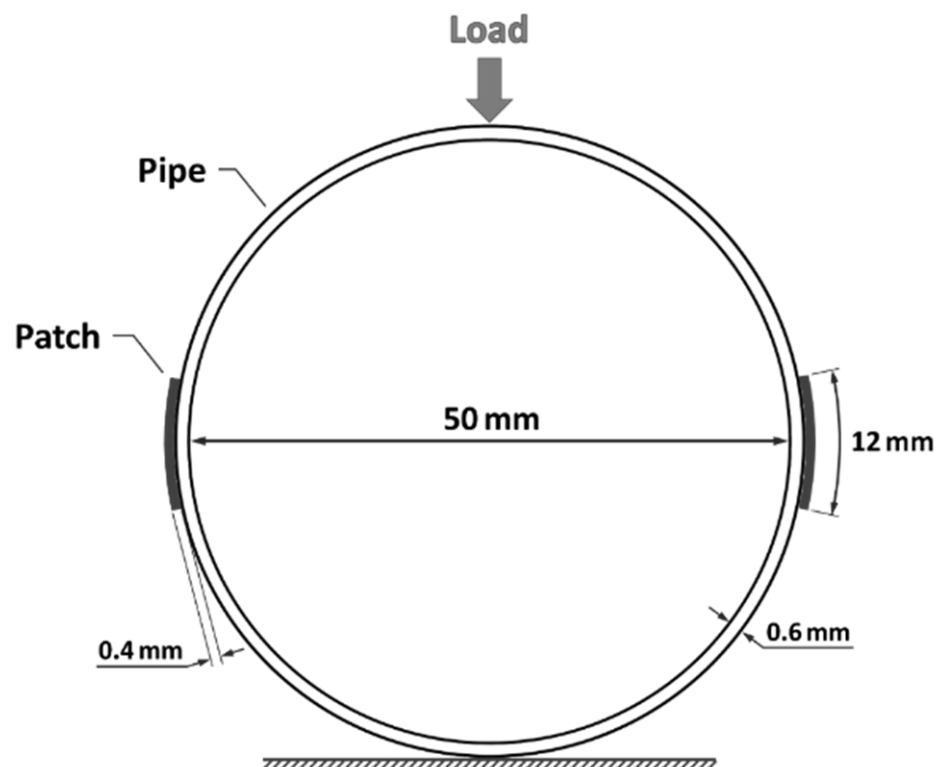
is often used for the external patch as the fabric used in making the main laminate [23]. A 400 g glass fiber woven fabric was used as the patch, similar to the main fiber material. The efficiency and durability of the patch also depend on several parameters, including the thickness of both the main plate and the patch itself [28]. To prevent excessive bending and early separation due to the flexural anchor, the stiffness ratio (thickness to patch length ratio) should be selected carefully, considering the patch thickness. According to reports, the optimal patch thickness is around 60% of the main plate thickness [22]. In this study, as the thickness of the filament-wound tube wall is around 0.6 mm, the patch thickness was selected as 0.36 mm. Additionally, according to the standard, the most appropriate patch length is between 30 and 50 times the thickness. Therefore, the strip width in the circumferential direction of the cylinder was selected as 12 mm. Figure 1 depicts a schematic of the dimensions of the cylinder and the location of the patches.

Figure 1. A schematic of the test setup and the location of the reinforcing patches.

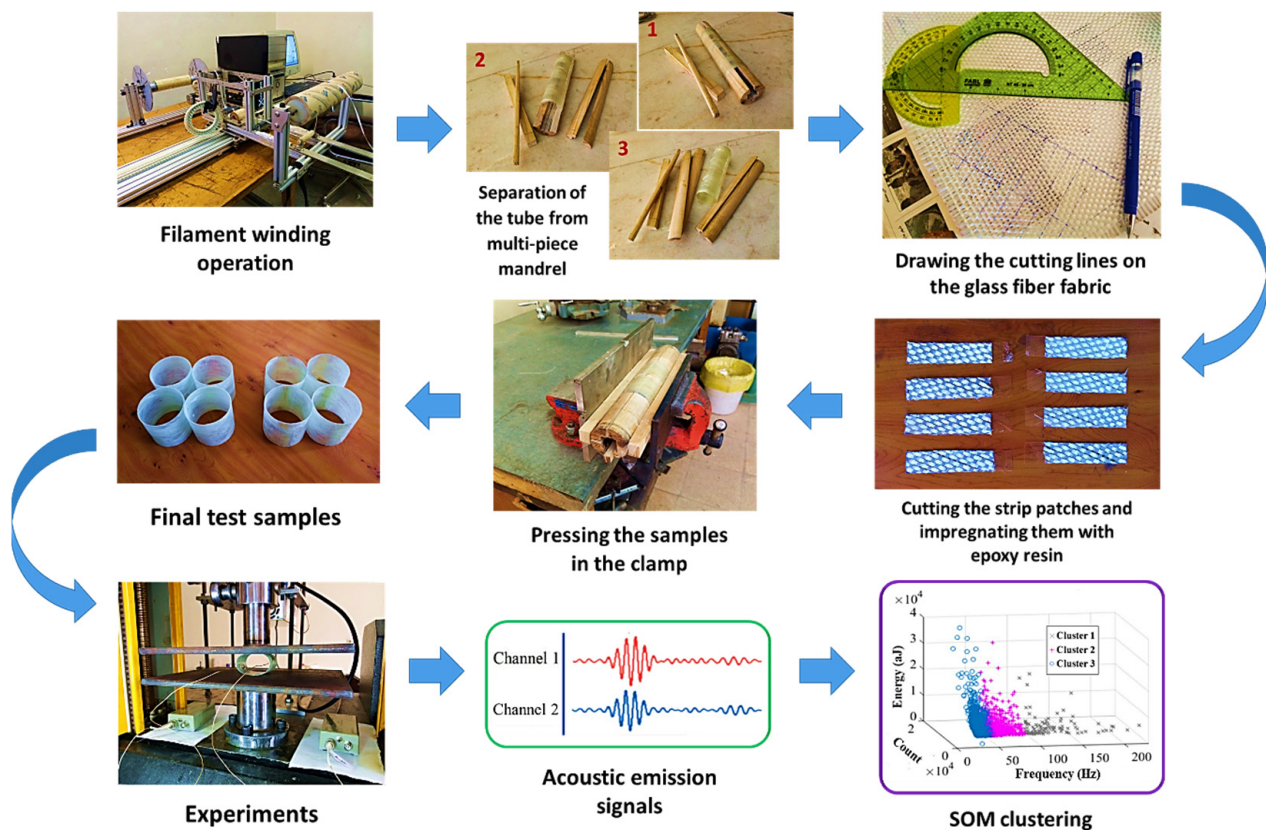
According to previous studies, due to the lower stress discontinuity between layers with the same orientation, the occurrence of delamination is less likely in off-axis laminates compared to laminates with different ply orientations [29]. As a result, the patches were placed in a manner that the threads of the fabric were aligned with the winding angle, which is 65 degrees. The strips were first soaked in resin and then placed on both sides of the samples, followed by clamping the samples for one day. Finally, the samples were cured at a temperature of 80 degrees Celsius for four hours. Figure 2 illustrates the various stages of sample fabrication and testing.

Figure 2. Different steps of the sample preparation and characterization.

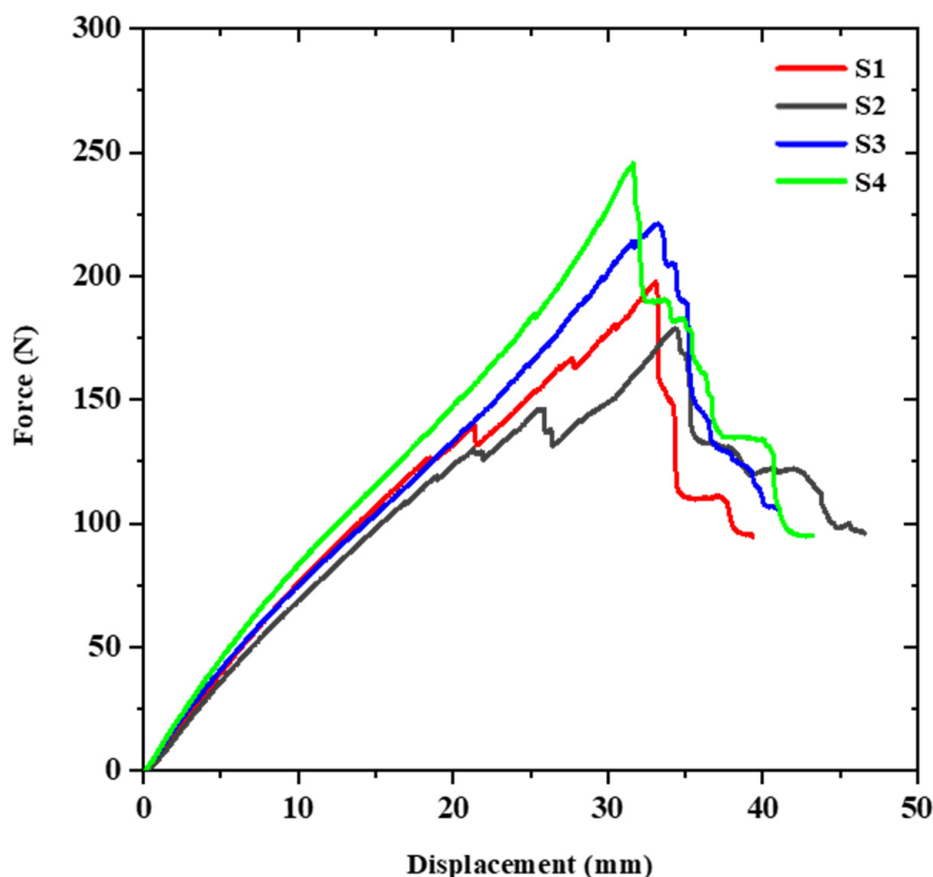
The force-displacement diagram can be used to study the mechanical response of materials or structures subjected to specific loading conditions. Figure 3 presents the diagram for the reference samples, where the letter “S” denotes these samples. In contrast, “P” represents the samples reinforced with patches. The curves in the diagram exhibit relatively good conformity between them, but there are some differences in their behavior, which are attributed to defects and issues that occurred during the filament winding manufacturing process.

Figure 3. Force-displacement curves of the reference samples.

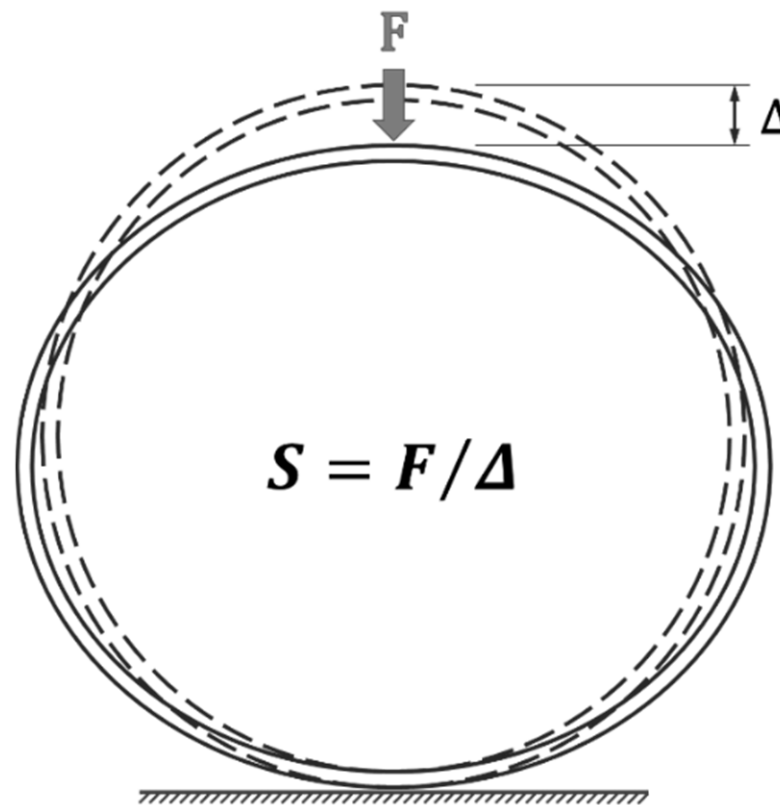
The maximum load-bearing capacity and stiffness are important parameters to consider in studying the mechanical behavior of pipes under lateral loads. The flexural stiffness is an indicator of the deformation that can be tolerated under transverse loading without structural damage [15]. In this study, to calculate the stiffness of the composite tube, the force value at a displacement equal to 5% of its initial diameter is used, as shown in Figure 4. Moreover, to calculate the absorbed energy during loading, the area under the force-displacement curves is used. For a better comparison of the results, the area under all of the curves up to a displacement equal to 70% of the sample’s initial diameter (35 mm) is considered. Table 4 shows the mechanical parameter values for the samples without patches.

Figure 4. Schematic of how to calculate the bending stiffness of the composite tube.

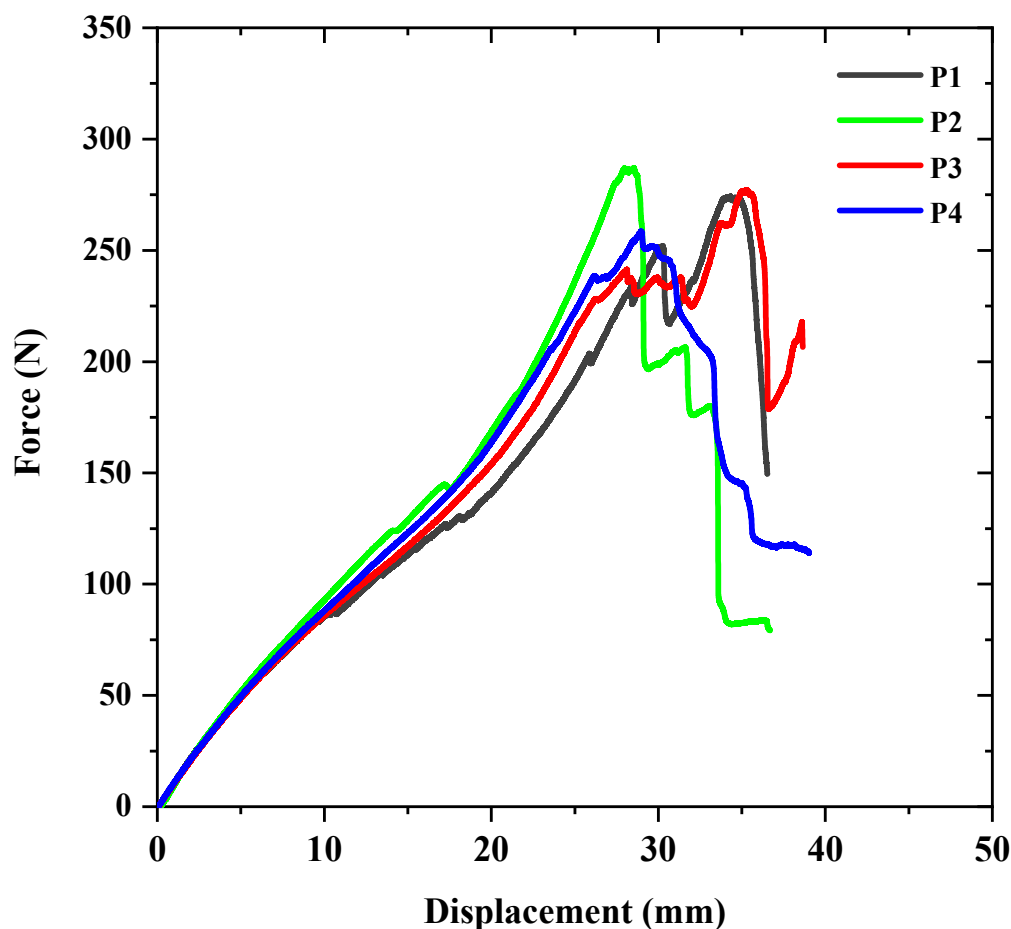
The force-displacement curves and mechanical parameters related to the reinforced samples are depicted in Figure 5 and Table 5, respectively. As shown in the curves, the behavior of similar samples is almost identical, although some differences in the force values can be observed in some samples. For instance, samples P2 and P4 show similar behavior to one another, whereas samples P1 and P3 show similar behavior to each other, especially between loads 125–150 N and displacement 15–20 mm. These differences are mainly attributed to defects and issues that occurred during the manufacturing process and hand-layup process for the reinforcement. One of the significant factors is the distance between the glass fiber roving during winding, resulting in weakness in some parts of the composite sample due to the substantial difference in the width of the roving used. Another factor is the inappropriate distribution of resin in some parts of the sample, which reduces the fiber volume fraction and affects the damage mechanism.

Figure 5. Force-displacement curves of the reinforced samples.

After comparing the behavior of different samples, it was concluded that the reinforced samples exhibited more conformity in the elastic region. This was observed through a comparison of the force-displacement curves and their standard deviation values. The reason for this similarity is that the patches cover weaknesses and structural defects in the critical areas of the tubes. It is re-distributing the stress more uniformly and avoids stress concentration. The investigation of the mechanical behavior of both types of samples indicates that reinforcing the critical areas of the structure with a patch increases the maximum load capacity by an average of 23.25%, the tube's stiffness by 33.46%, and the absorbed energy by 23.67%. The weight of the reinforced samples is only approximately 1.5% higher than that of the reference samples.

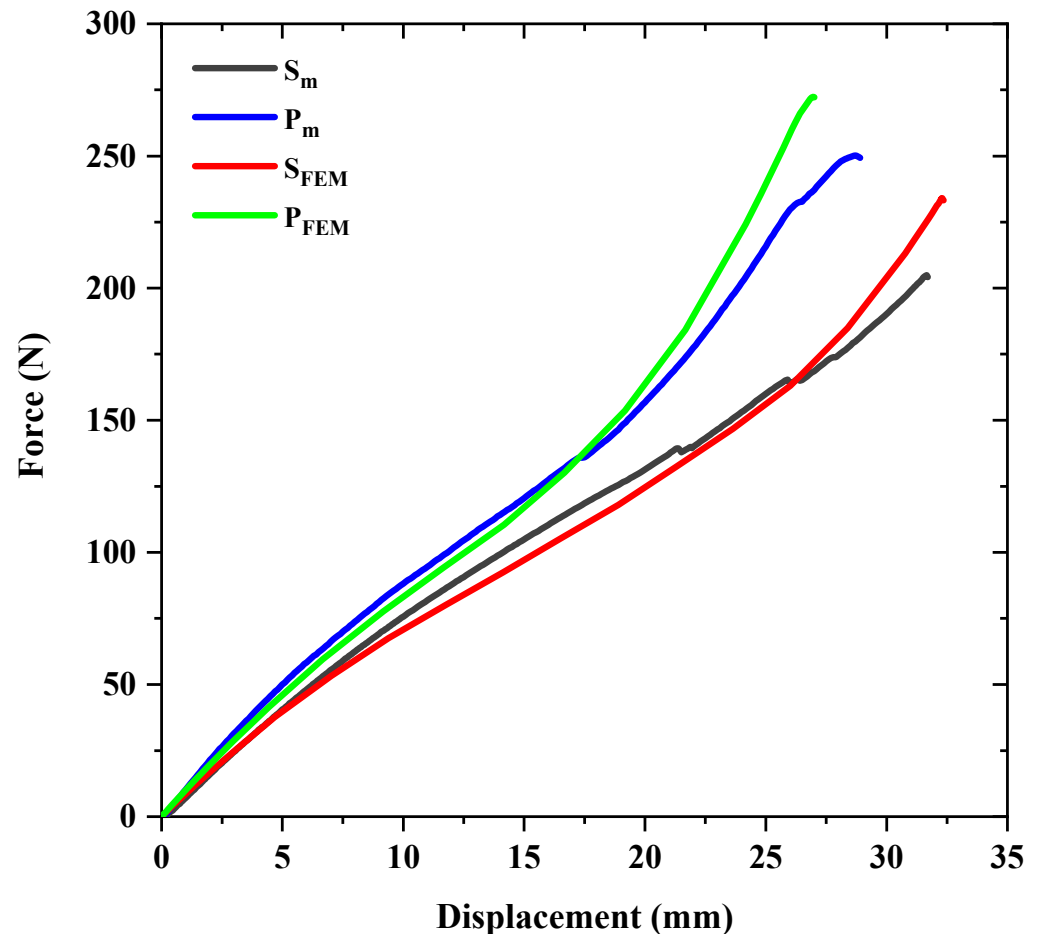
In this section, we compare the behavior of the reference and reinforced tubes using FEM. The average force-displacement curves for both the reference and reinforced samples from the experimental tests are shown in Figure 6, represented by S_m and P_m , respectively. The S_{FEM} symbol corresponds to the reference tube, while the P_{FEM} symbol corresponds to the reinforced tube that resulted from the FEM.

Figure 6. Comparison of the experimental and numerical force-displacement curves for the reference and reinforced samples.

The force-displacement curves' shape, despite the linear behavior of the material, is noteworthy, and is directly related to the structural geometry and type of loading. Similar studies conducted on metal pipes also observed the same trend for the force-displacement curves [36,37]. The increase in slope and the change in curvature during the experiment is due to the deformation of the tube, causing the areas in contact with the load-applying plates to flatten and to increase the contact area of the structure with the plates. As the pressure is almost constant, the force value increases. The experimental and simulated curves have a relatively good agreement, especially in the elastic region. However, as the deformation of the rings increases and damage initiates, the difference between the experimental and numerical data becomes greater. For both types of samples, the maximum load obtained from the numerical solution method is higher due to structural defects and irregularities in the experimental results, causing the structure not to reach its maximum load-bearing capacity. Nonetheless, the difference between the mechanical properties entered into the software and the actual material properties, as well as the use of a laminate model for designing filament wound tubes, should not be overlooked. Table 6 presents

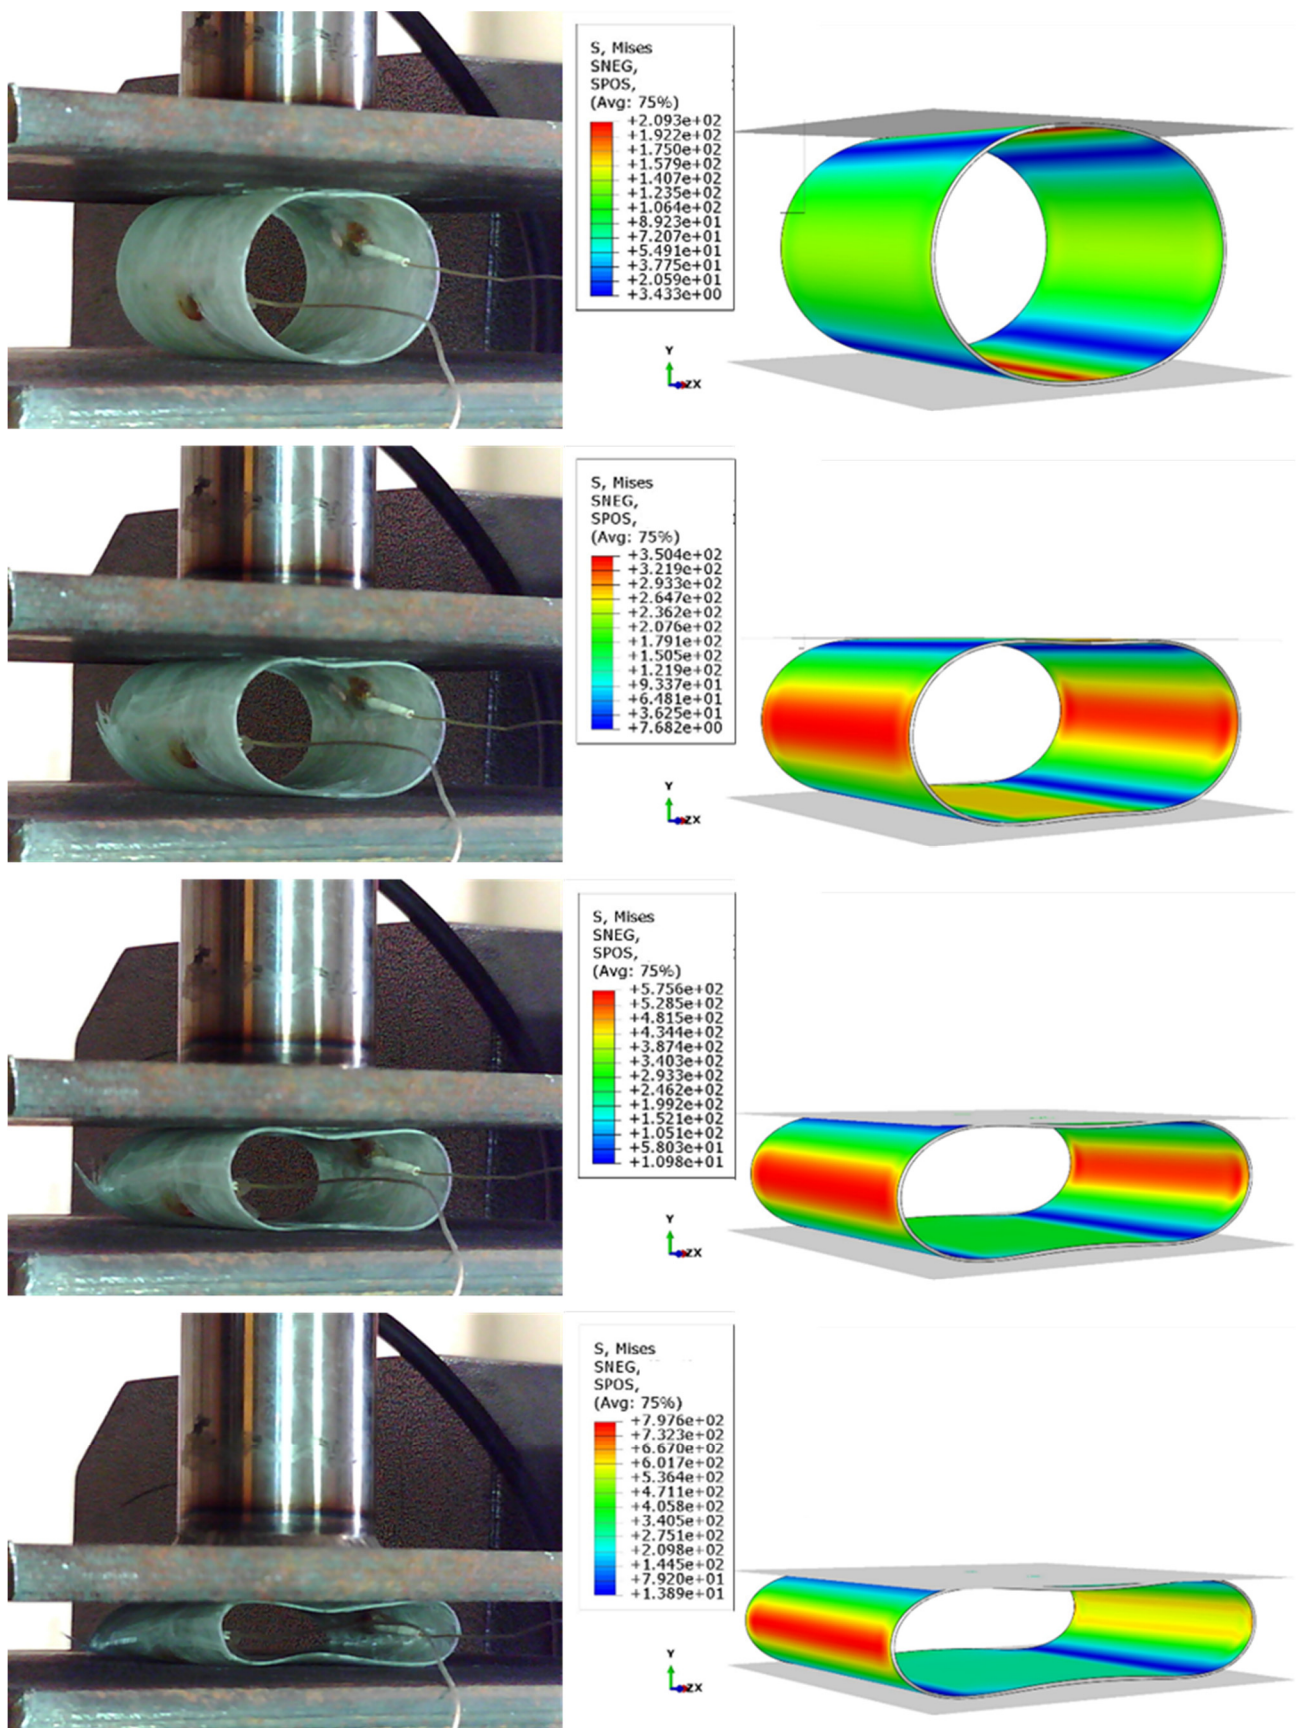
To justify the mechanical behavior of a structure, it is important to study its deformation process and identify the macroscopic damage growth and damage mechanisms. The deformation history of the tube during the experimental tests and the distribution of Mises stress obtained from the numerical simulation of the reference and reinforced samples can be seen in Figures 7 and 8. The figures reveal that after the start of loading, the circular cross-sectional area of the tube turns into an elliptical shape, increasing the length of the torque arm and the stress due to bending in critical areas. It should be noted that the simulated model behaves similarly to the experiments in terms of deformation, with minor differences arising from manufacturing errors and simplified assumptions in the model. Upon examining the stress contours of both samples, it is evident that at the beginning of the experiment, the stress values at the points where the tube contacts the load-applying plates are higher than the other areas. However, with an increase in the moment of bending, the stress values in the critical areas become much higher than those in the areas in contact with the plates.

Figure 7. Comparing the deformation process of a reference sample with the FE simulation results.

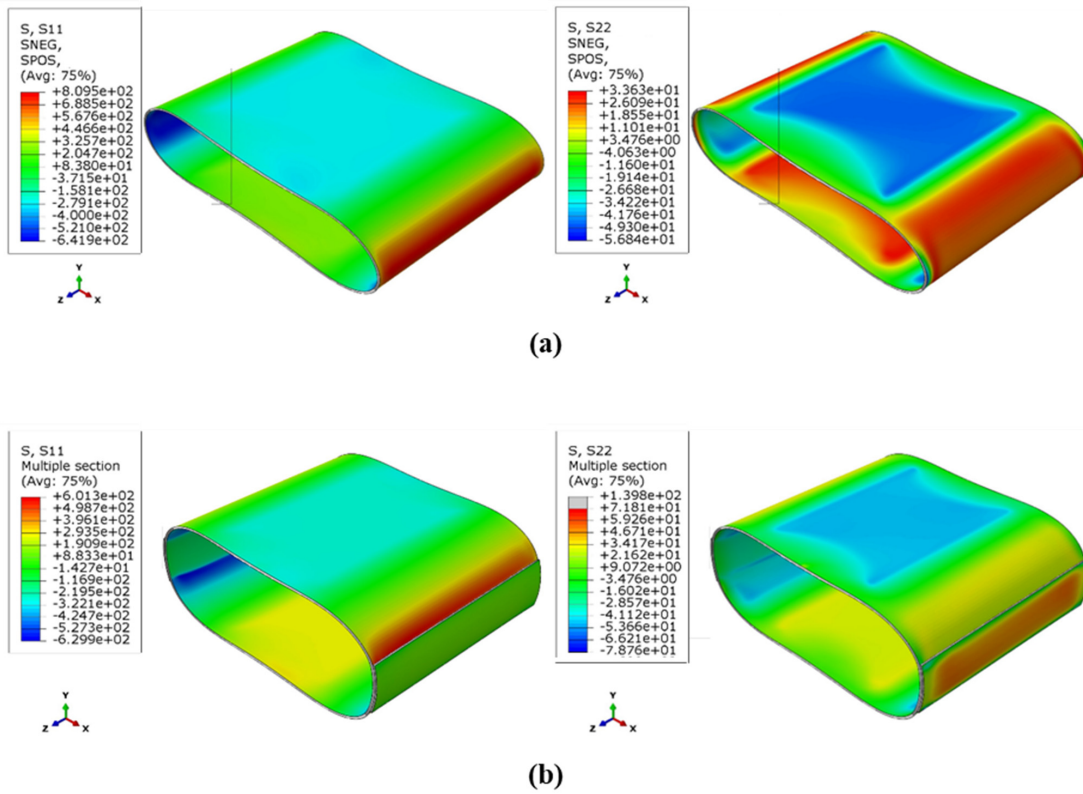
The examination of the damage parameters is crucial for detecting the occurrence of damage and its damage mechanism, as explained in Section 3. To achieve this, the stress distribution was examined as the initiation and propagation of damage mechanisms at any point depend on the stress values present at that point. Figure 9 illustrates the σ_x (S11) and σ_y (S22) stress distributions obtained from the FEM for a reference sample (a) and a reinforced sample (b). The figure divides the cross-section of the cylinders into four hypothetical arcs based on the direction of the stresses (red and blue areas). The upper and lower arcs in contact with the applied load plates are under compression at the outer surface and under tension at the inner surface of the cylinder. By changing the length of these arcs to maintain the cross-section circumference, the two side arcs must have a deformation opposite to the upper and lower arcs, which results in the stress distribution in them to be precisely opposite to the previous state. This finding is in line with similar research results [12].

According to Figure 9b, the addition of a strip patch results in an increase in the value of σ_y stress in the tension direction in the middle of the reinforced area due to the increase in thickness at the point of the bending moment. However, the value of this stress decreased in the compression direction at the location of the patch installation. The stress distribution in the critical regions experiences a significant decrease, but at the edges of the patch, the magnitude of σ_x stress increases, leading to the initiation of interfacial separation. This separation causes the transfer of stress at those points to the filament wound layer, resulting in damage development in the main tube wall.

Figure 9. The σ_x and σ_y stress distributions: (a) the reference sample, (b) the reinforced sample.

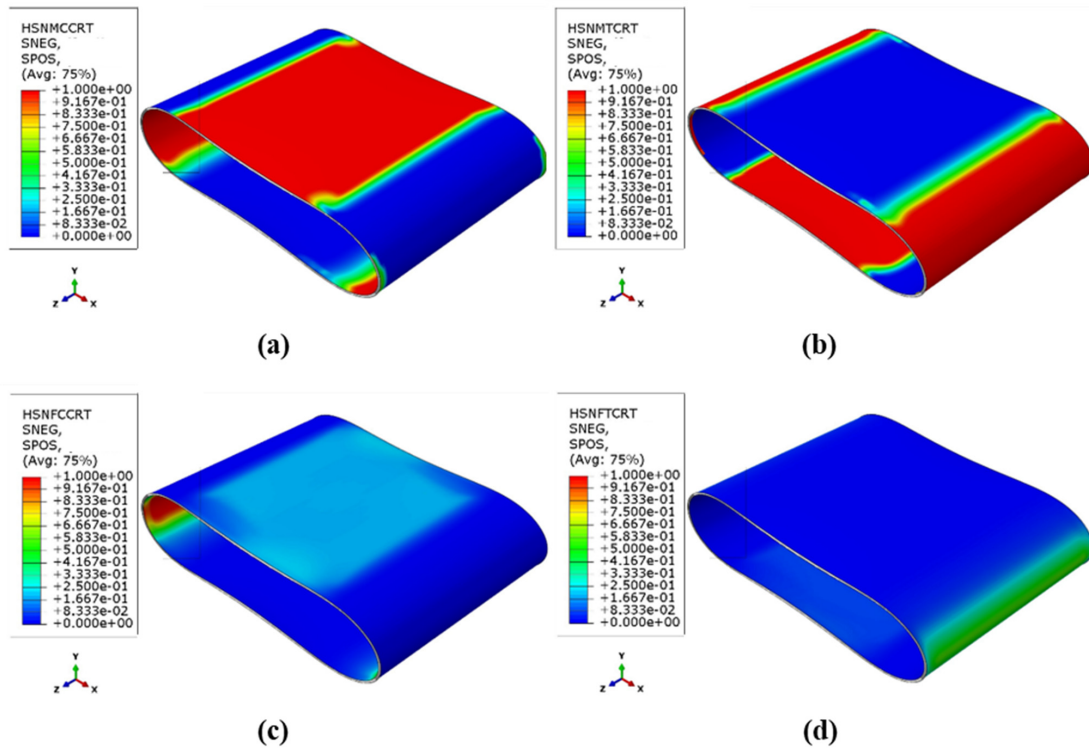
To analyze the spread of the various damage mechanisms using FEM, the count of elements associated with each damage mechanism type (where the damage parameter for the corresponding mechanism equals one) was determined at various loading stages. Figures 10 and 11 depict the distribution of the Hashin damage parameters at the point of catastrophic damage for both types of samples.

Figure 10. Different Hashin damage parameters in the reference sample: (a) Matrix compressive mechanism, (b) Matrix tensile mechanism, (c) fiber compressive mechanism, (d) fiber tensile mechanism.

Based on the stress distribution and the composite strength in different directions, the occurrence regions of the four types of damage mechanisms shown in the figures are justifiable. The tensile and compressive damage mechanisms correspond to the regions under tension and compression, as mentioned in the stress distribution discussion. As is evident, the main damage mechanism for both types of samples is the matrix tensile and compressive damage mechanism, which involves wide regions of the cylinder wall. The fiber compressive damage mechanism is the dominant secondary mechanism observed in the internal surface of the critical zones, followed by the fiber tensile damage mechanism in the external surface of these regions. However, the fiber tensile damage parameter has not reached its maximum value of one in both types of samples, indicating that complete destruction has not occurred in this mechanism. The installation of a patch in critical areas leads to a decrease in the value of all the damage parameters at those points; however, their distribution increases at the edges of the patch. These results agree well with the observations obtained from the experimental tests, and demonstrate the effectiveness of the FEM.

In both types of samples, cluster 1, which is related to matrix damage, has the highest frequency percentage, confirming the numerical results deduced from Figures 10 and 11. After the test, an observation of the reinforced samples revealed almost no fiber failures within the reinforcing patches themselves, and only the edges of the patch were separated from the tube surface, leading to an increase in the percentage of signals corresponding to cluster 2. Moreover, due to the impregnation of the patch and the placement of an additional resin layer in critical areas, the number of signals corresponding to cluster 1 (matrix cracking) is higher in the reinforced samples. Consequently, the percentage of the frequency of cluster 3 (fiber breakage) decreases with the installation of the reinforcing patch.

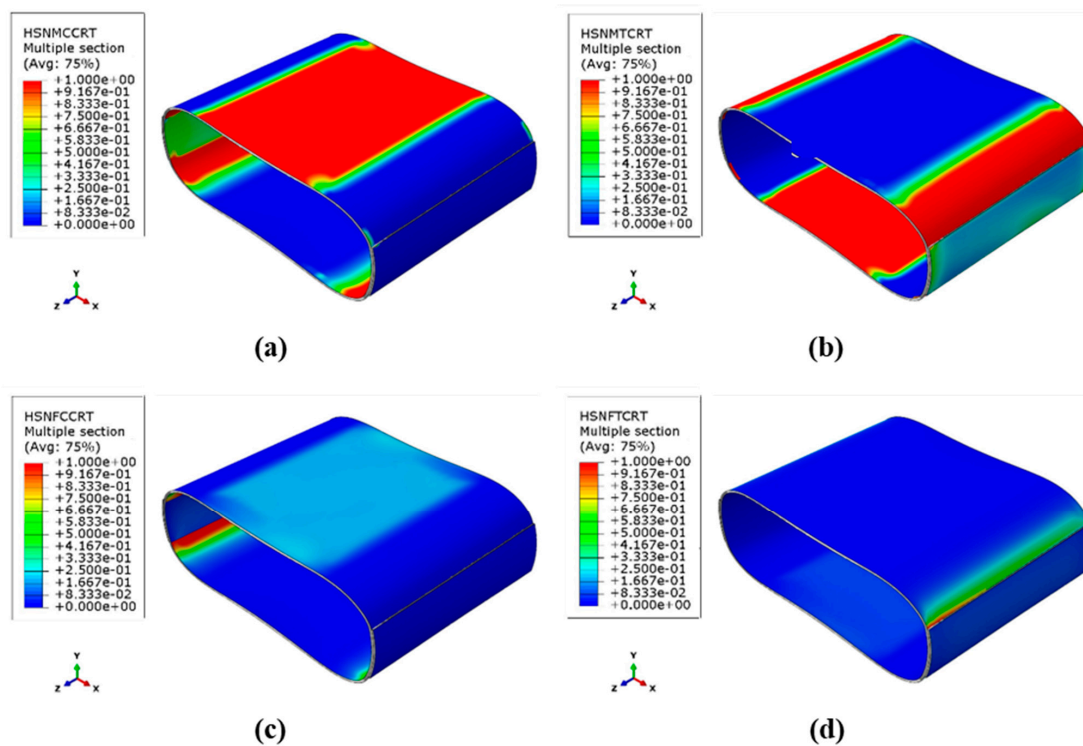
Figure 11. Different Hashin damage parameters in the reinforced sample (a) Matrix compressive mechanism, (b) Matrix tensile mechanism, (c) fiber compressive mechanism, (d) fiber tensile mechanism.

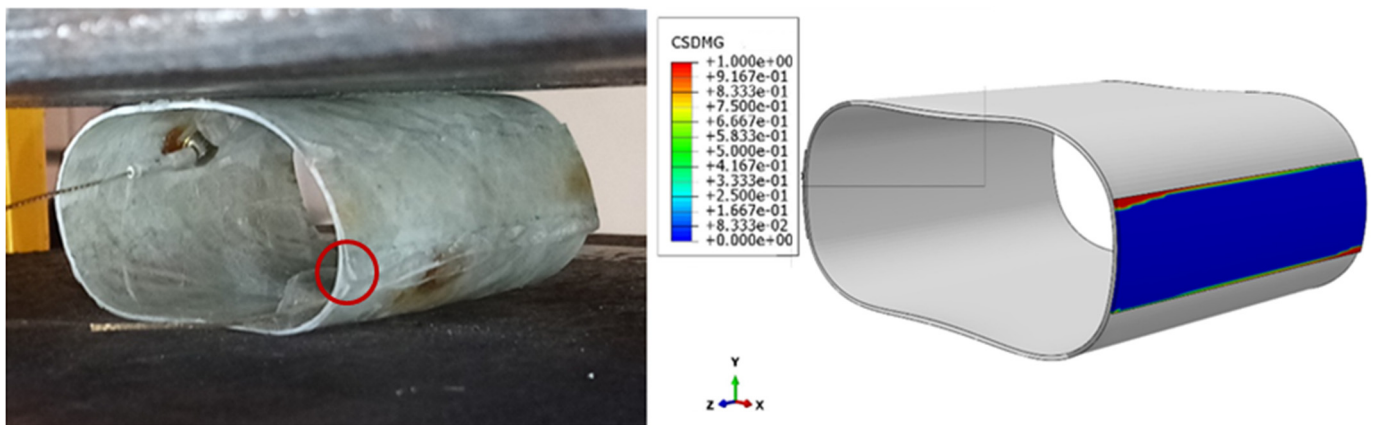
In this study, two samples were observed using video recording in order to document the development and progression of the damage, as well as the detachment of the patch. The videos revealed that the first signs of detachment occurred 5 min and 14 s after the start of the experiment, corresponding to a displacement of 20.93 mm. However, according to the FEM results, the detachment of the patch occurred at a displacement of 22.75 mm. In all cases, the initial detachment was observed at the corner of the patch, as it had less contact with the adhesive surface, and therefore a weaker connection than other points along the edge of the patch. Moreover, the stress concentration was higher in the corners. As the crack propagated, the detachment spread along the edge of the patch until it reached the centerline of the cylinder. The experimental and numerical comparison of the patch separation moment is shown in Figure 12. The red circle indicates the initiation point of patch separation in a reinforced sample.

Figure 12. Experimental and numerical comparison of the patch separation moment.

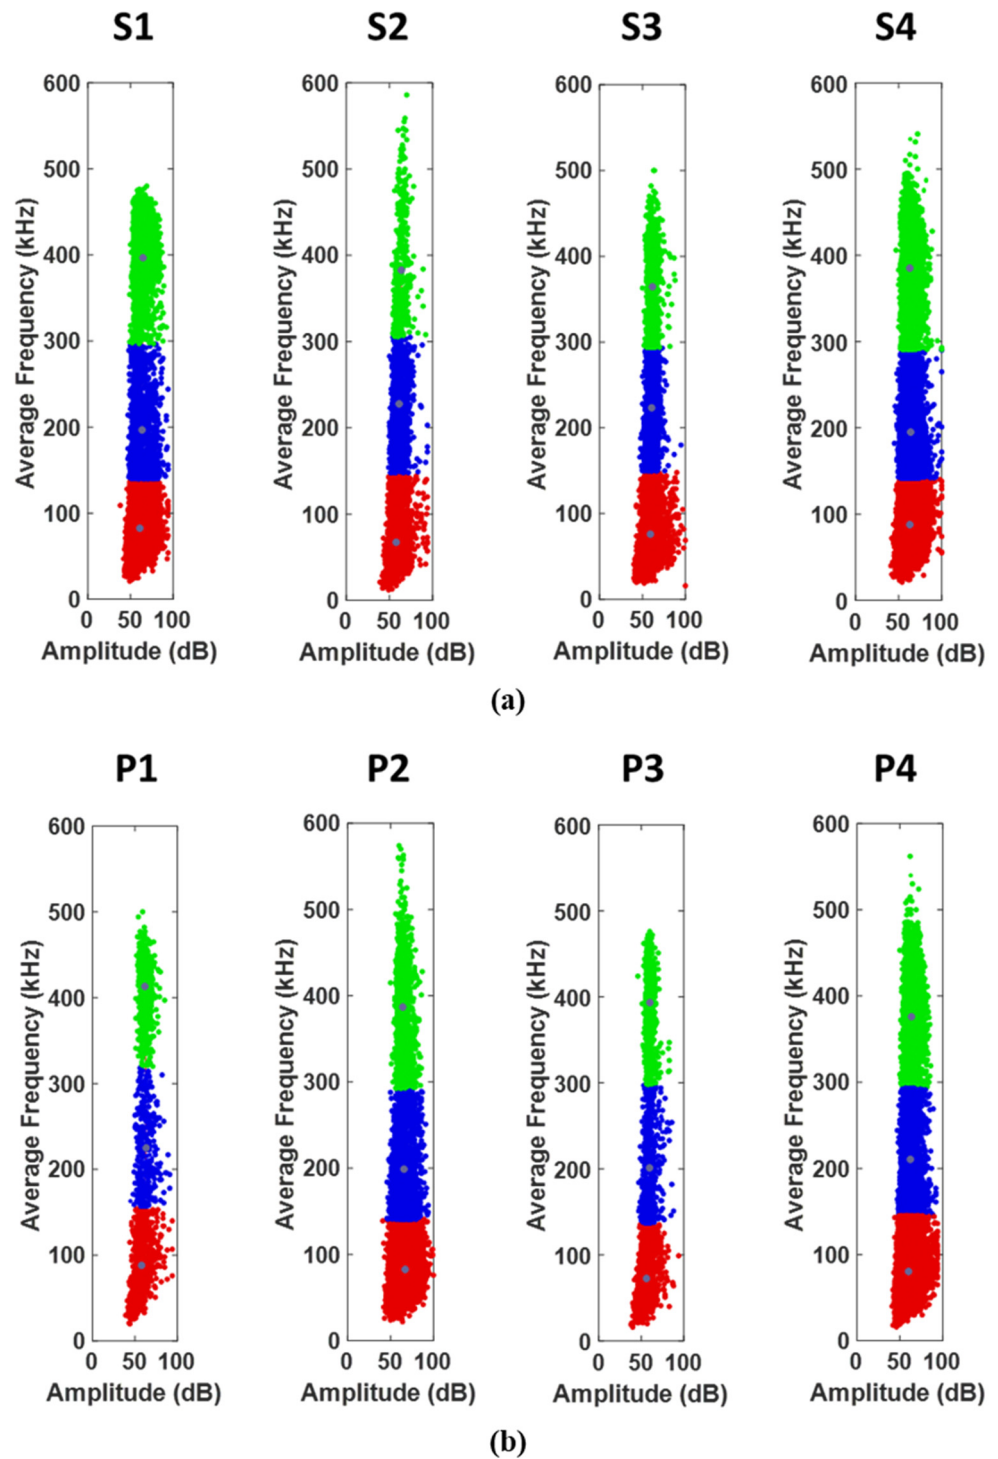
The recorded AE events generated from the damage mechanisms during the experiments were collected by two piezoelectric sensors, and the results demonstrated a good agreement between them. On average, the total number of AE signals recorded for the reference samples was twice that of the reinforced samples, indicating a greater degree of active damage mechanisms. This observation is consistent with the lower load-bearing capacity of the reference samples in comparison to the reinforced samples. However, the number of AE signals alone is not a suitable indicator for examining the damage mechanisms in the samples as it does not provide information about the intensity, energy, and source of these signals. Therefore, to accurately detect the damage created at each stage of the loading, it is necessary to separate and classify the AE signals from different damage mechanisms. The amplitude, average frequency, energy, duration, and count of the signals were used to cluster the AE signals using the SOM algorithm [18], and the best outcome, with the least overlap, was achieved by average frequency and amplitude distributions. The clustering results for the reference and reinforced samples can be seen in Figure 13.

The clustering results in Figure 13a show that the data from the four samples were categorized into three clusters. Most of the previous studies concluded that the lowest frequency range is related to matrix cracking and the highest frequency range is related to fiber fracture, and the frequency range of interlaminar delamination is between these two ranges [19–21]. As those works were related to a similar type of glass/epoxy laminate, the same concept can be used to analyze the AE results. Taking this into consideration, the first cluster, denoted in red, corresponds to a frequency range of 30 and 150 kHz and is primarily associated with matrix cracking, which is also the dominant frequent range. The second cluster (blue) is identified by a frequency range of 150 and 300 kHz and is related to fiber-matrix debonding and delamination. The third cluster (green) corresponds to a frequency range of 300 and 570 kHz, which is related to fiber breakage. The categorization of damage processes solely based on the AE frequency and clustering results is subject to certain limitations, as there is no definitive and strict boundary separating these processes. However, these results provide a general indication of the frequency range associated with each damage mechanism, offering valuable insights into the overall failure process. While the accuracy of the categorization may not reach 100%, these findings contribute to enhancing our comprehension of the underlying mechanisms involved in structural failure. Figure 13b displays the clustering map for the samples with patches. The number of clusters and their frequency range are similar to those of the reference samples, except that the number of signals in the second cluster, corresponding to delamination, is relatively higher than in the reference samples. The average frequency percentage of the data for each cluster is presented in Table 7.

Figure 13. Clustering map: (a) for the reference samples, (b) for the reinforced samples.

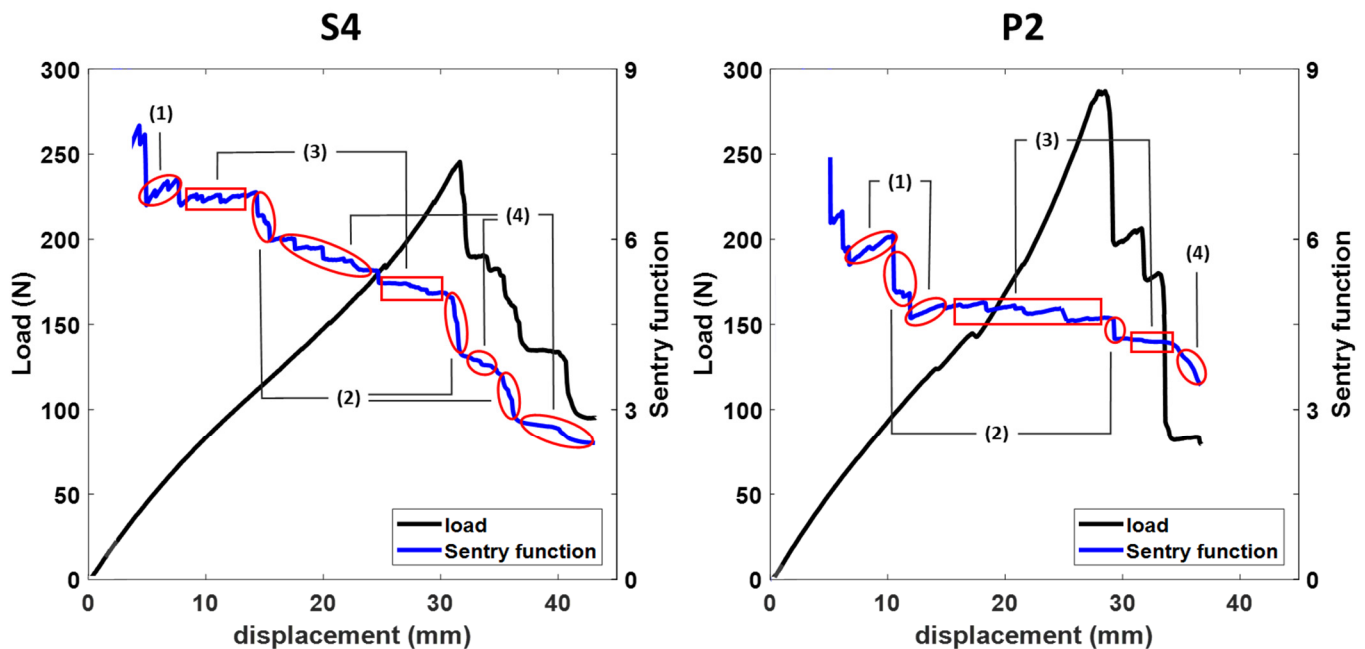
Finally, the sentry function was utilized to monitor the advancement of the damage through analyzing the AE data. This function integrates the mechanical and acoustic properties of composites, providing insight into the degree of the damage progression and the residual strength of the structure under different loads. It is calculated as the logarithm of the ratio of strain energy to acoustic energy [31]. Figure 14 displays the sentry function plotted against the force-displacement curve for both a reference sample and a reinforced sample.

Figure 14. Sentry function graph for a typical reference sample (S4) and reinforced sample (P2).

The sentry function during the test is composed of four states, as shown in the figure above: (1) An increasing function that indicates the stored strain energy and does not show any specific damage; (2) a sudden drop function, indicating significant damage; (3) a constant function that suggests that the material is resistant to damage expansion; (4) a decreasing function, indicating the loss of load-bearing capacity due to damage development and growth [32,38]. Each of these states is identified on the sentry function graph in the figure. It should be noted that the sentry function becomes evident with

the emergence of the initial AE signals, which are associated with microcracks in the matrix. These microcracks cause a decrease in the tube stiffness and are manifested by changes in the slope of the force-displacement curve. The descending portions of the sentry function indicate the initiation and progression of damage, with steeper slopes representing faster rates of damage expansion. Repeated drops and rises correspond to different damage mechanisms [31]. The trend of the sentry function shows good agreement with the force-displacement curve for all of the samples, with regions of changing slope and force drops corresponding to areas of sentry function drops. Some minor declines in the sentry function are noticed prior to a significant decline in the force curve, which is followed by a substantial drop in the sentry function at the time of the force curve drop. This pattern indicates the aggregation and fusion of matrix microcracks, ultimately resulting in significant matrix damage. Following this sharp decline, the sentry function exhibits several gradual decreases, each followed by a significant drop, and this sequence of events persists until the final damage of the sample. The descending trend of the sentry function for reinforced samples has a less steep slope than the reference samples, indicating a slower rate of damage expansion in these samples. The relatively wide constant region signifies that the reinforced structure has good resistance against damage expansion.
