On the necessity of new hydrophobic treatment after repointing of water repellent masonry

Construction and Building Materials

Nijland, T. G., Lubelli, B., van Zundert, K., & van Hunen, M. (2024). On the necessity of new hydrophobic treatment after repointing of water repellent masonry. *Construction and Building Materials*, 411, Article 134732. <https://doi.org/10.1016/j.conbuildmat.2023.134732>

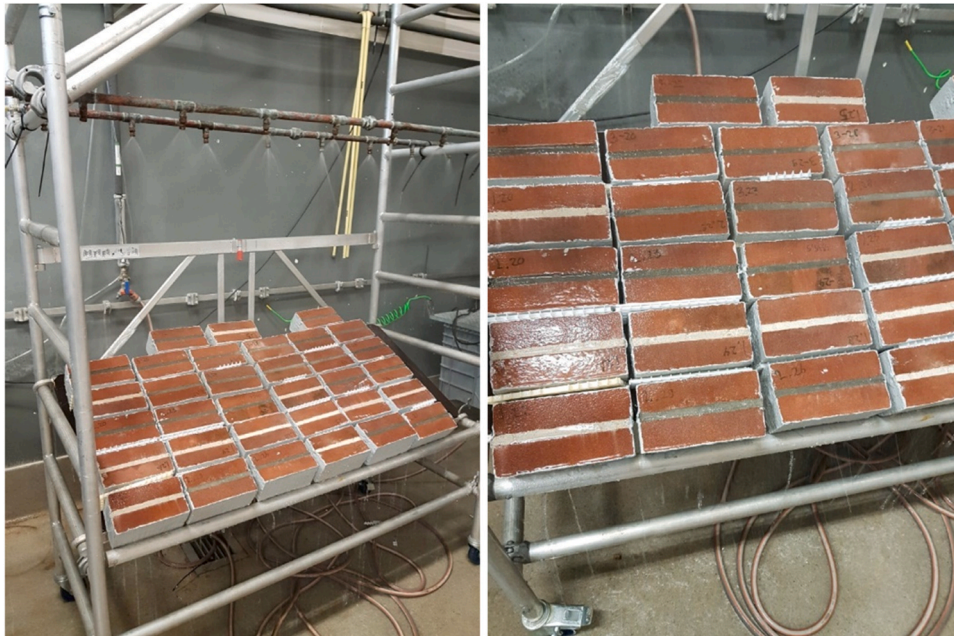
Fig. 3. Rain test.

A rain test has been performed to determine the different saturation degree of HH (treated, pointed and not retreated) and HHH (treated, pointed and retreated). A purpose made test setup has been built (Fig. 3): the specimens were laid on a metal grid, positioned at an angle of approximately 30° , to obtain an even thin water film on the surface; 10 water sprinklers were positioned in two rows, at a distance of 150–200 cm from the specimens top surface, depending on the position of the specimen (Fig. 3). The test involved continuous raining for 8 h a day for four days; this period was enough for the untreated specimens (O) to reach the saturation degree corresponding to moderate saturation as pre-conditioning for the freeze-thaw test (see above). The test was performed under laboratory conditions, i.e. about 20°C , no (artificial) sunning nor wind. To prevent evaporation from the test specimens in periods without rain, the surface of the specimens was covered with a plastic foil. The specimens were weighted after the first, second and fourth 8 h rain period. At the fourth day, the moisture distribution in brick and mortar was determined gravimetrically, on powder samples collected at different depths from the surface.

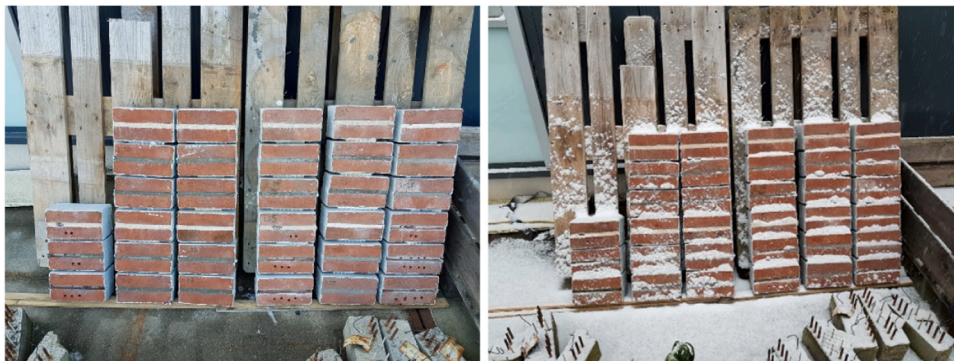
Fig. 4. Test specimens in outdoors exposition. Left October 11, 2018, right January 21, 2019.

After the end of the rain test, specimens were exposed outdoors at the premises of the TNO laboratory in Delft, the Netherlands, from October 11, 2018 til April 8, 2021 (Fig. 4). Relevant climate data are given in Fig. 5. The masonry walls faced east and were placed under angle to enhance exposure to precipitation. The masonry walls were periodically inspected visually; after 2.5 years exposure, the state of the pointing, the hydrophobicity (including penetration depth of the treatment) and moisture contents of brick and mortar were determined.

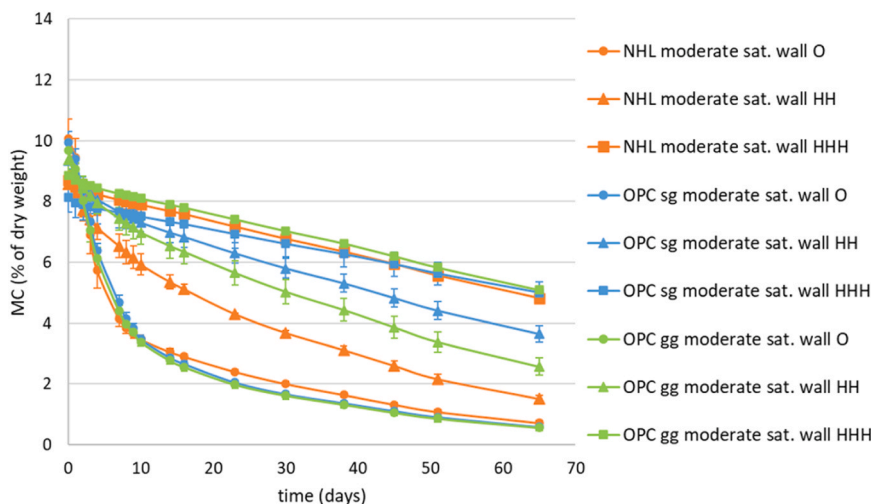
Fig. 13. Effect of one or two treatments with water repellent for specimens with moderate saturation. The graph shows the drying curves of the untreated walls (O), of the walls with treatment and subsequent repointing (HH) and of the walls treated, repointed and re-treated (HHH). Each line represents the average of 3 specimens, the vertical bars report the standard variation.

Fig. 13 compares the drying behaviour of treated and repointed (HH) and untreated walls (O), starting at moderate saturation. The water repellent treatment considerably delays the drying of the masonry walls. Also when present only on brick (specimens treated once, HH), the water repellent significantly reduces the drying rate. After 65 days, walls that have been treated once and moderately saturated still have a moisture content between 1.5 wt% (NHL) and 4.5 wt% (cement with standard sand). The difference between untreated (O) and treated walls (HH) is more evident for cement-based pointing: as the brick cannot dry fast (because of the water repellent) and the pointing does not dry fast (because of fine porosity within the cement paste), these walls dry very slowly.
