Proceedings of 14th International Railway Engineering-2017conference in Edinburgh, UK: 2017

USING DATA ANALYTICS TO UNDERSTAND WHY CERTAIN RAIL SECTIONS AT THE DUTCH HIGH-SPEED TRACK ARE AFFECTED BY RCF

R. Schalk^{1,2}, A. Zoeteman¹, A. Nuñez³ and R. Wolfert¹

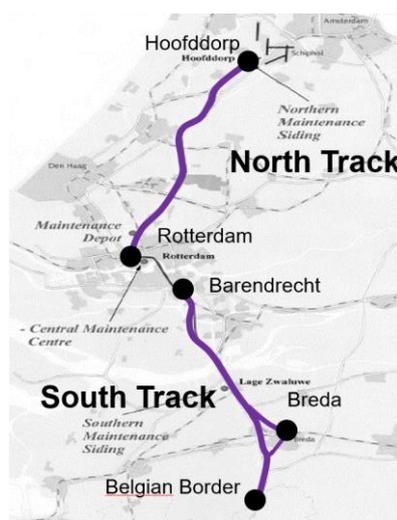
Fig. 1 Track overview of the HSL-Zuid

The HSL-Zuid consists of two main sections; the North Track, running from Hoofddorp to Rotterdam and the South Track, running from Barendrecht to the Belgian border with turnouts halfway from- and to Breda. At Hoofddorp, Rotterdam and Breda the HSL-Zuid connects to the Dutch conventional track. Both sections consist of about 45km double track.

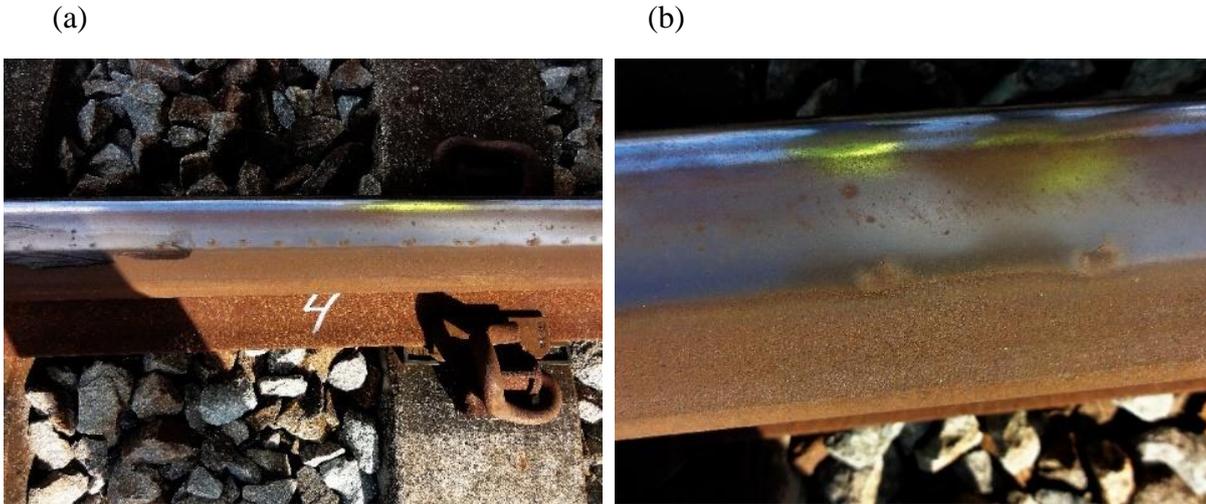
Fig. 2 (a) showing lots of damage at one of the Hotspots at Hoofddorp, a ballast track transition zone. (b) close up at the same hotspot, damage is located at the rail head.

In November 2014, during a visual inspection along the tracks of the HSL-Zuid, unexpected severe damages had been found. These damages were unexpected as regular measuring campaigns didn't indicate these were to be found. The regular measurements executed were eddy current gauge corner measurements and ultrasonic measurements. Following these findings the whole track was inspected. This procedure resulted in the finding of five other major affected areas, so-called hotspots. Fig. 2 (a) and Fig. 2 (b) show the damage among one of these hotspots which were typical for the findings among the HSL-Zuid among the transition zone ballast sections.

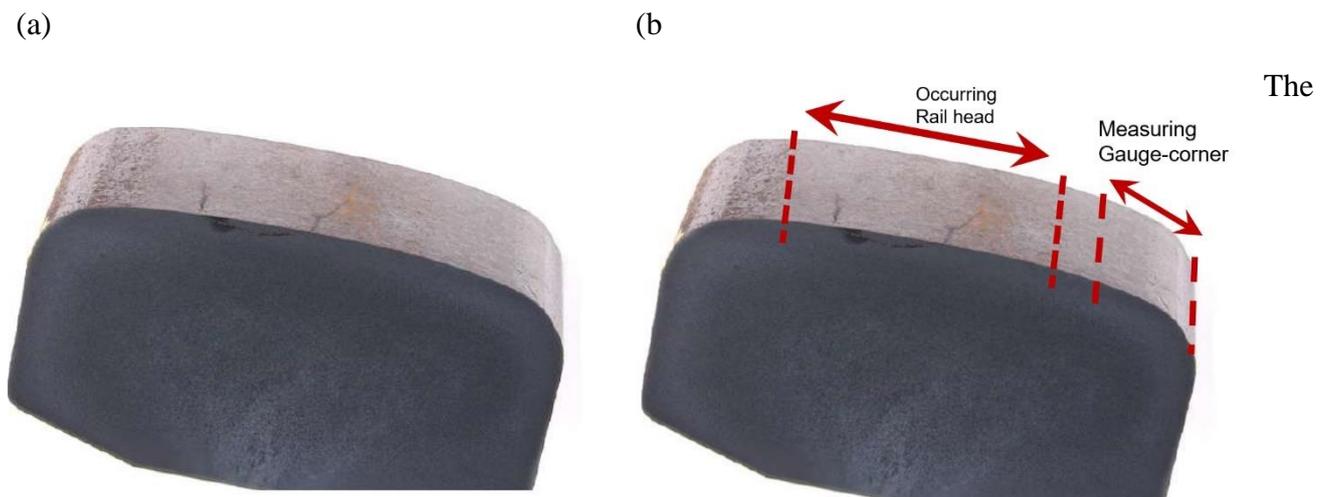
Fig. 3 (a) examined rail with damage on top of rail. (b) Same rail showing the mismatch in the measuring campaign.

Characteristic to the RCF found at the HSL-Zuid is their location on top of the rail head. Therefore a new measurement method was introduced; the Sperry eddy current walking stick. Using this new tool the whole track had been measured between July and October 2015. Using the walking stick the cracks were measured. An examined piece of rail with the damage is shown in Fig. 3 (a). Fig. 3 (b) shows the mismatch in the measuring campaign for the smallest cracks by eddy current. Eddy current measures cracks up to 5.00 mm of depth.

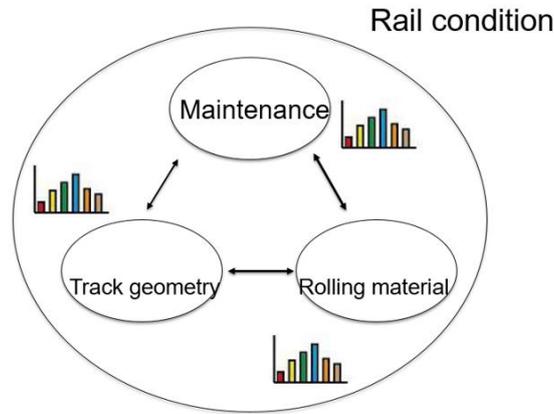
Fig. 4 visual representation of the rail condition approached as the interaction between groups of parameters.

In order to find the causes for the RCF at the HSL-Zuid an approach called the ‘bottom up’ (B-U) approach has been developed. Using: eddy current measurements, design and alignment data, maintenance data and rolling stock data. In this approach the rail condition, whether its affected by RCF or not- and by what amount was approached by the interaction of track geometry, rolling stock and maintenance parameters as shown in Fig. 4.

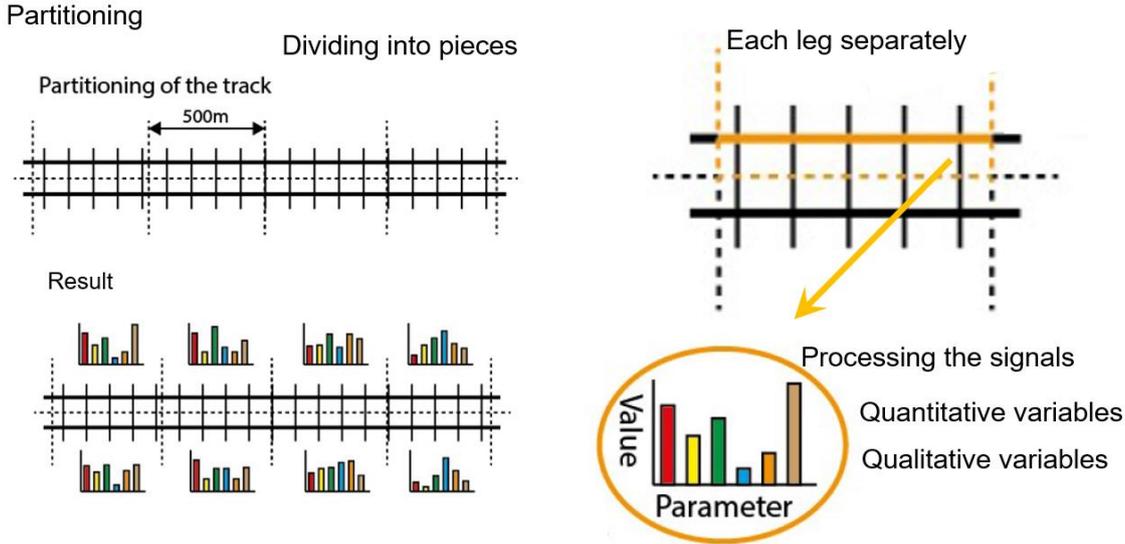
Fig. 5 Visualization of the partitioning process

With the introduction of the intensity parameter the track can be modelled dividing it in a number of partitions. Each of these partitions will be characterized by its respective parameter values. In general, the smaller the partitions the more accurate the results are to be expected. The partitioning is proposed to be done for each leg separately in order to evaluate the respective values throughout curves. The partitioning process has been visualized in Fig. 5.

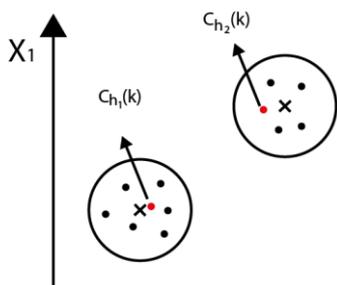
Fig. 6 How the clustering works according two hotspot types.

The clusters will consist of sets of characteristic similar parameters for a certain hotspot type according the formulas and **Error! Reference source not found.:**

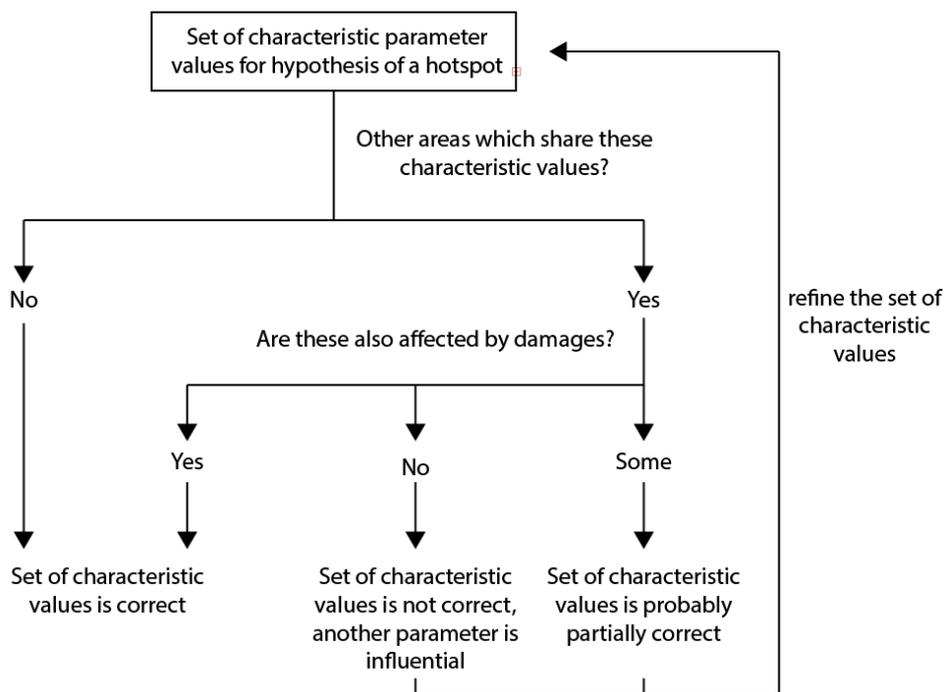
Fig. 7 Flow chart regarding the checking of the hypothesis for the hotspots

However, this set of characteristic parameter values for each hotspot can also be used checking the hypothesis, testing it against the rest of the track to identify other areas which share the same characteristic parameter values. A flow chart is introduced to help checking the set of characteristic parameter values, as shown in Fig. 7.

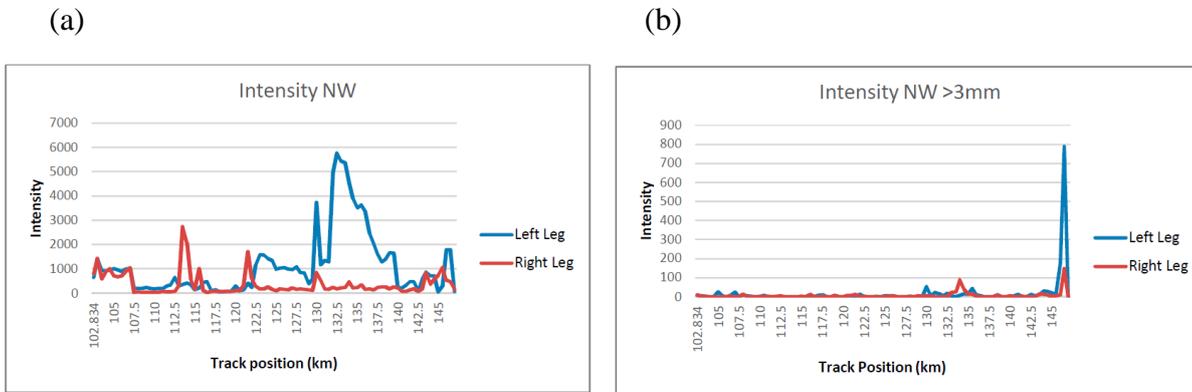
Fig. 8 (a) showing the intensity of the North-West track for all cracks (b) showing the intensity for cracks larger than 3.00mm, showing one single peak which is the hotspot near Hoofddorp.

The application of the B-U approach resulted in some unexpected findings for the HSL-Zuid. Partitioning values of 500m have been used, resulting in over 700 partitions. Intensity has been introduced with two additional thresholds to identify hotspots, filtering cracks larger than 1.00mm and 3.00. Results from this application are shown in Fig. 8.
