Acoustic emission-based damage characterization of 70 MPa Type IV hydrogen composite pressure vessels during hydraulic tests

Abstract: This paper aims to apply an acoustic emission (AE) method to characterize the damage mechanisms of composite hydrogen pressure vessels (Type IV) with a service pressure of 70 MPa. First, AE signals were captured during the multi-step loading of two vessels. Second, AE feature parameters in time-domain and frequency-domain analyses such as amplitude, frequency, and energy were studied. A multi-parameter statistical analysis (MPSA) method based on empirical mode decomposition (EMD) and *K*-means algorithm was performed to cluster AE events. Intrinsic mode functions (IMFs) were decomposed by EMD and three IMFs with high frequency were chosen to reconstruct the feature parameters and provide signal pre-processing for *K*-means clustering analysis. Based on the relationship between AE features and the damage modes, three main clusters with distinguished amplitude, absolute energy, and energy were correlated to matrix cracking, fiber-matrix debonding, and fiber breakage. Besides, the effectiveness of MPSA method for signal classification is validated by

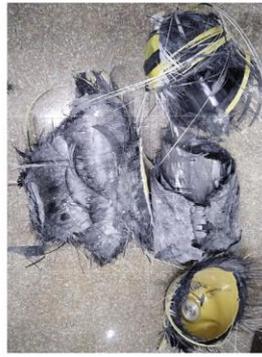
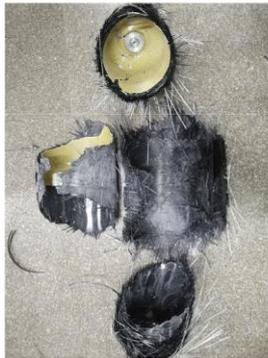
Macroscopic burst status

Microscopic SEM image

Fig.10 Burst status and SEM observation of damage mechanisms for (a) Vessel V1 and (b) Vessel V2.

In addition, SEM microscopy was employed to observe the damage mechanisms on the burst pressure vessels. Macroscopic images of the vessels after burst and microscopic SEM images of the two vessels are presented in Fig.10a and Fig.10b. The figures clearly show the three damage mechanisms found in the current literature, which is consistent with the results of MPSA clustering analysis.
