An assessment based on bow-ties

Chemical Engineering Transactions

Mechanical Integrity of Process Installations: an Assessment Based on Bow-Ties

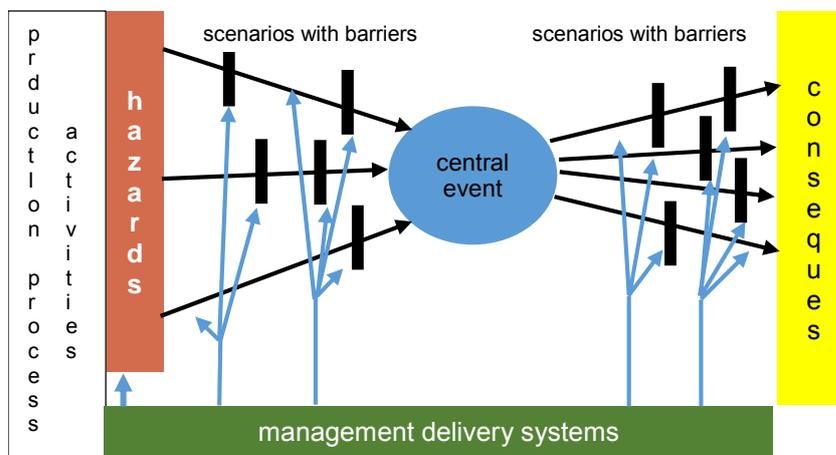
Figure 1: Bow-tie metaphor (Visser, 1998)

Bow-ties are appropriate and user-friendly for the mapping of scenarios (Chevreau et al., 2006, de Ruijter and Guldenmund, 2016). It is a metaphor for an accident process and shows the initiating event of a scenario, the consequences and the barriers that can stop the scenario from happening (Swuste et al., 2016). The simple, sequential design of bow-ties is strongly reminiscent of the 'Swiss cheese model' by Reason (1990) with the cheese slices as barriers. Figure 1 shows a bow-tie of which the explanation is included in a paper of Swuste et al., entitled "Process safety indicators, how solid is the concept?" and also published in the LP 2019 conference proceedings.

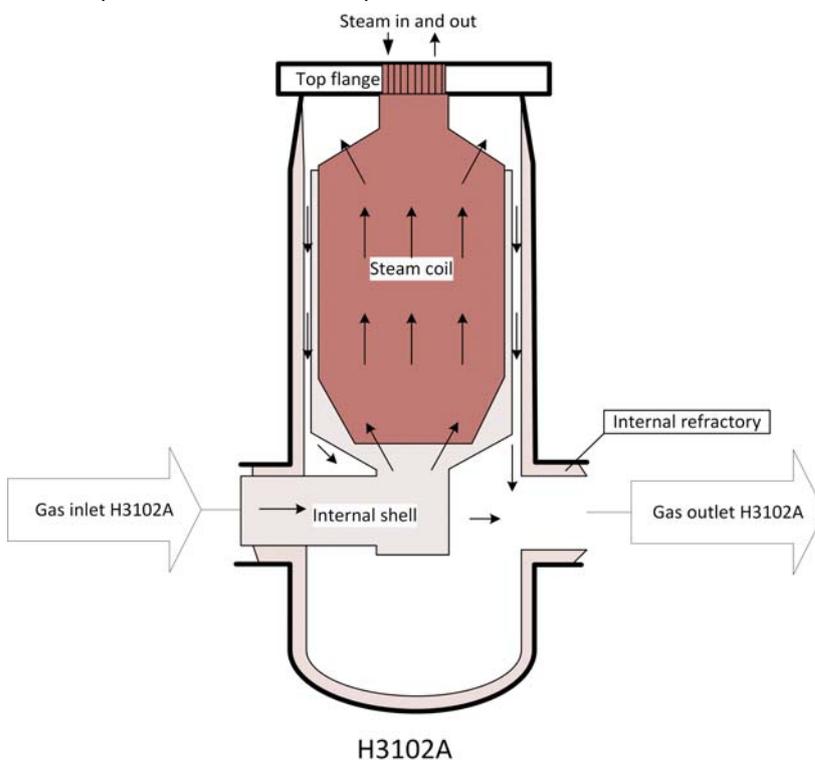
Figure 2: Steam superheater

In the steam superheater, high pressure steam of 125 bar is superheated by means of hot process gas, which consists of about 35% hydrogen. The process gas decreases from 600 °C to 475 °C. Figure 2 shows the flow of the process gas which is led upwards via the internal heat exchanger and returns along the wall after which it exits on the right-hand side. The process gas that leaves the internal heat exchanger at the top passes the internal brickwork (refractory) that protects the outer wall against a too high temperature. Two time-related mechanical failure mechanisms have been identified, which can cause the steam superheater to fail catastrophically, i.e. a sudden, unstopable, total loss of the containment. In the case of damaged refractory,

the outer wall can be exposed to excessive heat for a prolonged period of time which may lead to creep (slow plastic deformation under the influence of stress and temperature) and Nelson hydrogen attack (diffusion of H-atoms into the metal causing methane to form stresses cracking).

In case of refractory defects hot spots can occur on the outside of the wall. Although they can be observed visually during an operator round, they can easily be overlooked. The quality of the current detection and monitoring of the failure mechanism (D) is classified as poor. The internal refractory is inspected every four years during a turn-around. As indicated above, only minor defects have been found. This barrier is therefore qualified as good. In the current situation, the criticality C ($P \times D \times B$) is equal to 24 ($3 \times 4 \times 2$). The scenario must be provided with extra or improved barriers.

It appears that it is possible to provide this heater on the outside with indicator paint, which discolors on the hot spot due to the higher surface temperature where the internal refractory is no longer intact. Indicator paint reduces the chance that hot spots are overlooked. In addition, the outer wall can be provided with a number of temperature measurements that alarm at a high temperature. In case of a discolored indicator paint and / or one or more temperature alarms, the wall can be examined with an IR camera in order to determine whether a 'fitness for service' (FFS) analysis should be carried out. This should then indicate whether an inspection is necessary. The inspection should reveal the need for replacement or repair. If this procedure receives management attention, the quality of the detection and monitoring of the failure mechanism (D) can be regarded as good in accordance with equivalent procedures within the company. The procedure should not only be included in the safety management system but also contain some kind of management involvement when in use. In addition, the temperature alarms should not only raise an alarm in the control room but also be passed on to those who are responsible for the integrity and asset management. The criticality in the improved situation is 12 ($C = P \times D \times B = 3 \times 2 \times 2$) and thus the scenario is sufficiently safeguarded. No additional barriers are required if the detection and monitoring are implemented as proposed above.

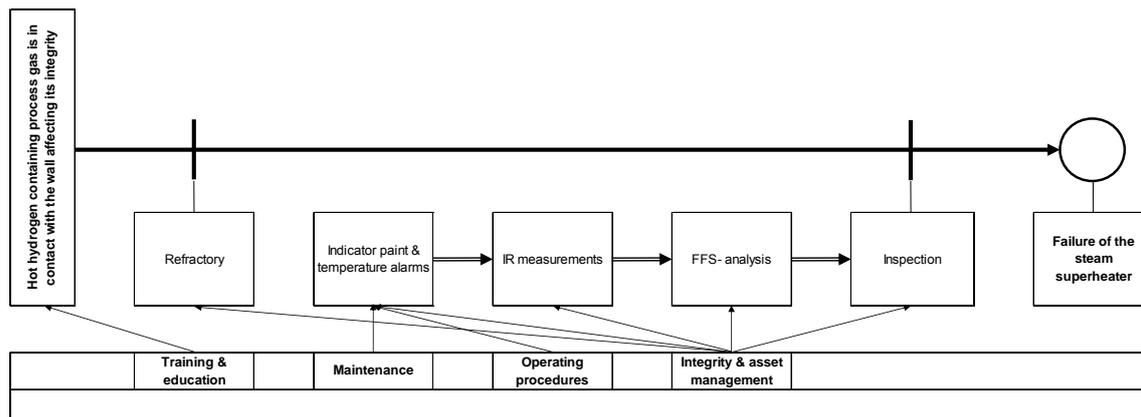
Figure 3: Bow-tie with regard to creep and Nelson hydrogen attack of the steam superheater

Figure 3 shows the bow-tie of the scenario with the newly implemented detection and monitoring. Together with the internal refractory, this forms a 1-out-of-2 system, that is to say that the scenario is provided with two barriers connected in series. The existing internal refractory is a technical barrier, whereas the proposed detection and monitoring of the failure mechanism is a non-technical, procedural barrier. The latter consists of a detection via the indicator paint, temperature alarms and IR measurement after which a procedure with management attention should ensure monitoring of the failure mechanism in the form of an FFS analysis and inspection. The temperature alarms can be seen as an 'early warning' regarding the failure mechanisms creep and Nelson hydrogen attack.

The figure below also shows which different departments or 'management delivery systems' support and maintain the various barrier components. The influence of the organizational factors on the barriers and how this influence can be monitored is beyond the scope of this research.
