Behavior of reinforcing steel and reinforced concrete undergoing stray current

Keywords: Stray current, anodic polarization, steel rebar, corrosion, mortar, interface, bond, electrochemical response, rebar orientation.

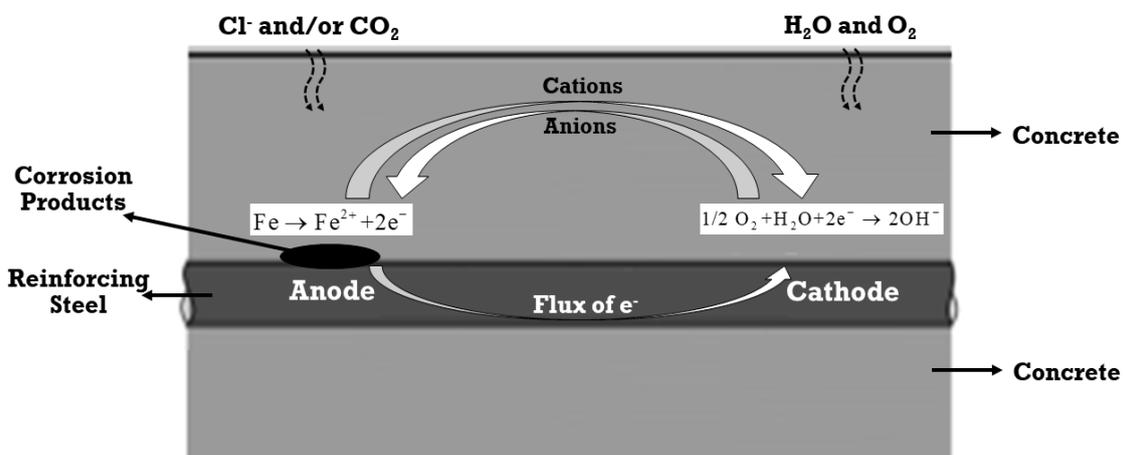
Figure 1.1: Schematic illustration on corrosion of reinforcing steel in concrete.

However, penetration of aggressive substances and specific environmental factors can lead to a premature degradation of reinforced concrete structures due to steel corrosion. The ultimate consequence of reinforcement corrosion is failure of the whole structure. Embedded reinforcing steel corrodes mainly because of: (1) Carbonation of the concrete cover and bulk matrix, subsequently loss of alkalinity at the steel-concrete interface; (2) The presence of chloride ions (Cl^-) in sufficient amounts in the vicinity of the steel surface. The schematic illustration of the corrosion cell formation on reinforcing steel in concrete is shown in Figure 1.1.

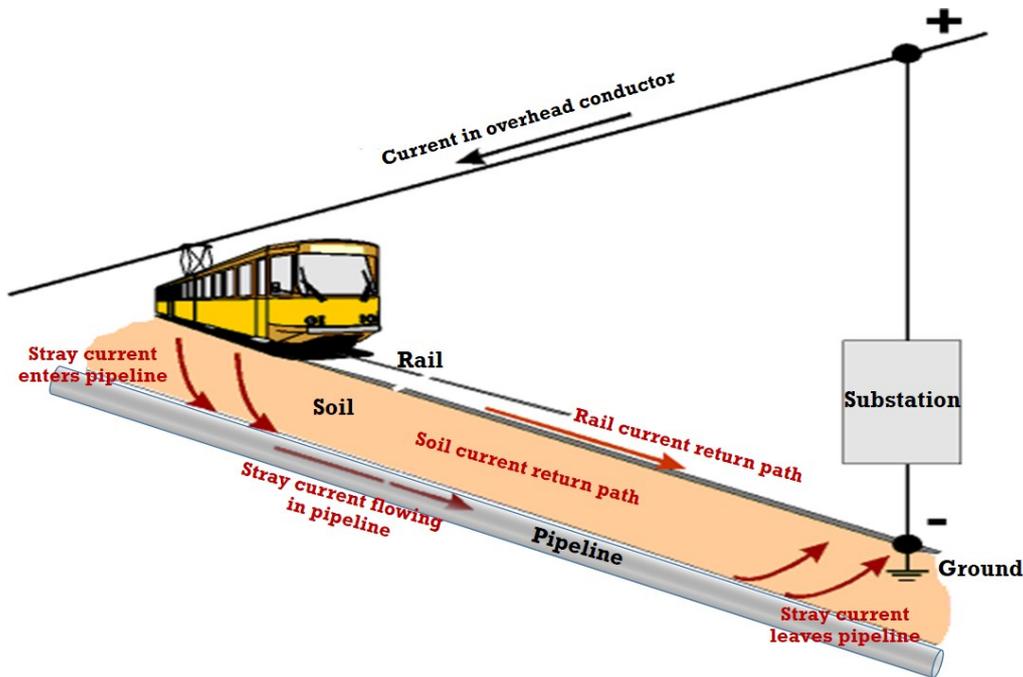
Figure 1.2: Example of stray current from a railway line picked-up by pipeline.

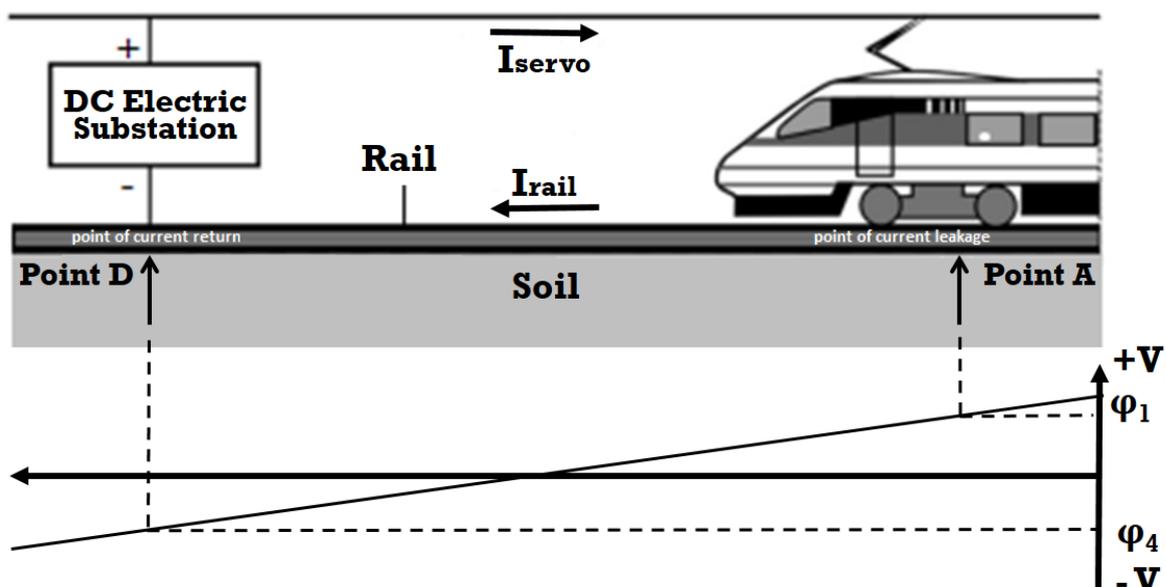
Figure 2.1: Schematic of rail-to-earth voltage profile for rail system - modified from [81].

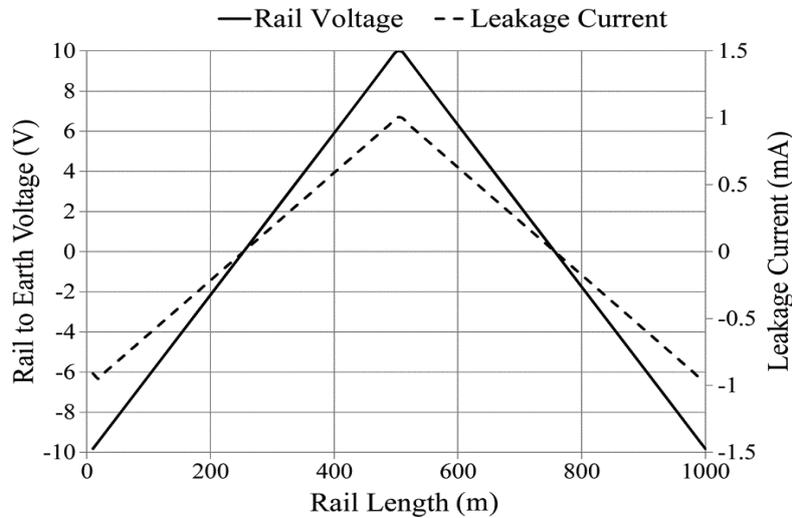
Figure 2.2: Simulated rail-to-earth voltage and leakage current [82].

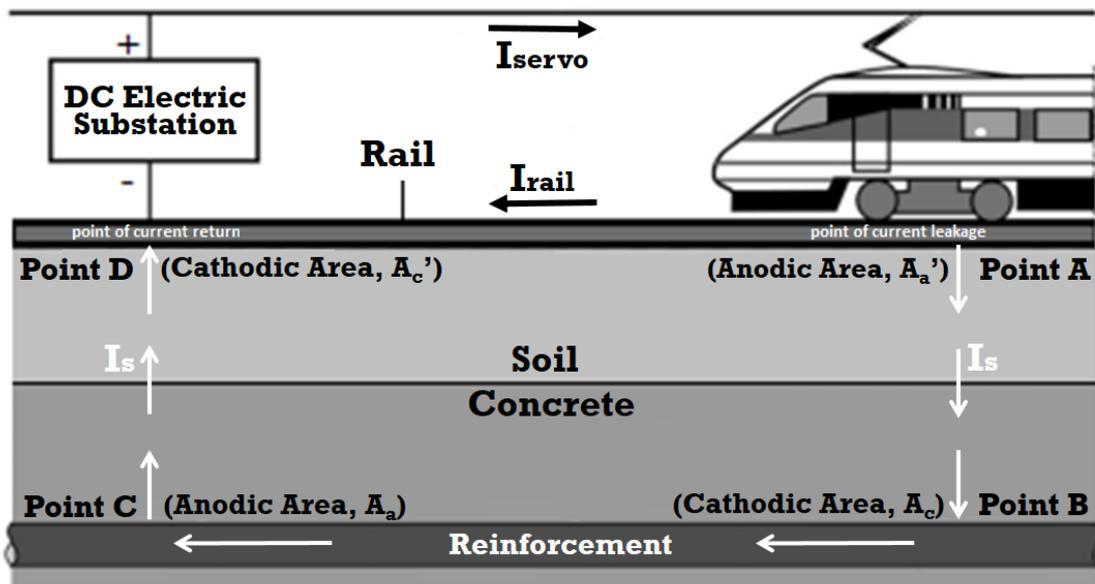
Figure 2.3: Example of stray current (I_s) from a DC railway line picked-up by steel reinforcement in concrete - modified based on [81].

As any underground metallic structure has (in general) a lower electrical resistance than soil, the stray current can flow through it. Similarly, stray current will flow through the conductive portion of a reinforced concrete structure, which is the reinforcing steel. The example of stray current from a DC railway line picked-up by reinforcement in concrete is illustrated in Figure 2.3.

The concept of stray current related with reinforcement was already illustrated in Figure 2.3. The stray current (I_s) inducing reinforcement corrosion in a reinforced concrete element is illustrated in Figure 2.10.

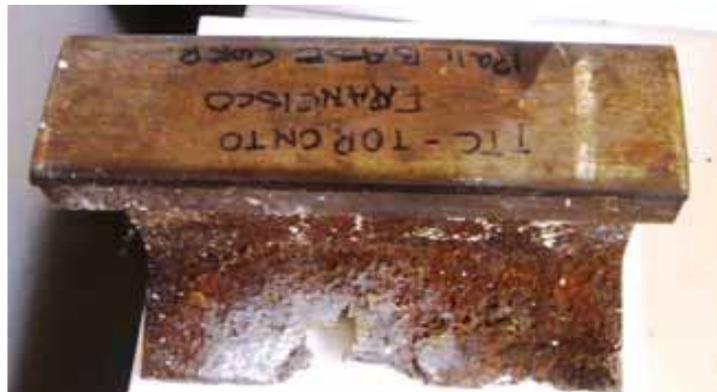
Figure 2.4: View of a section of 115-lb rail showing severe corrosion at the base of the rail [88].

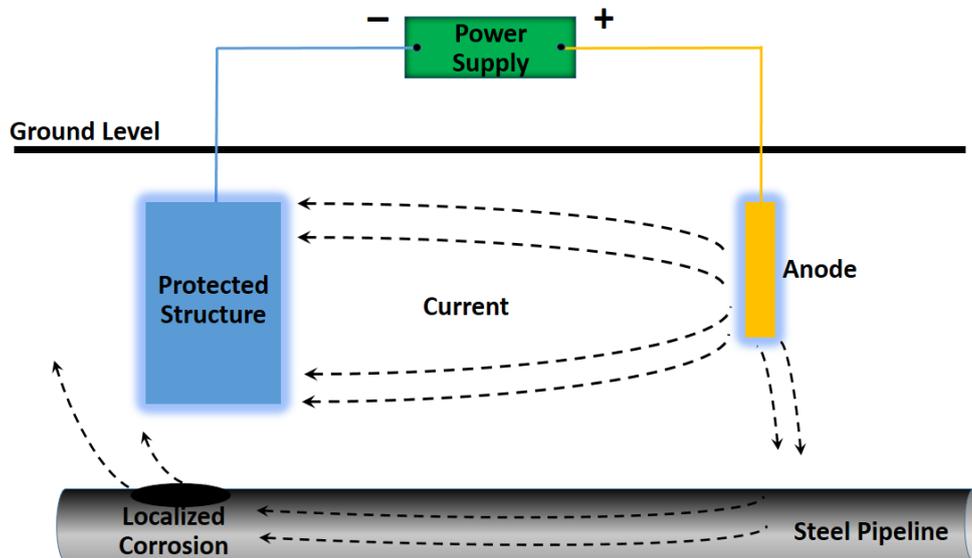
Figure 2.5: Stray current resulting from cathodic protection.

One of the cases for this situation is illustrated in Figure 2.5: the current path originating from the components of the CP system flows through the soil (from the anode to the cathode e.g. a steel tank to be protected) and can be picked-up by a low-resistance metallic object, as a pipeline. Depending on the soil resistivity, part of the current flown through the anode of this impressed current CP system, will just flow into another conductor (the steel pipe nearby); accordingly, in the neighborhood of the protected structure (the cathode or the steel tank in this case), the picked-up current leaves the pipeline and returns to the closed circuit of protection current. The existence of stray current can also reduce the efficiency of the cathodic protection system, since the current supposed to protect the intended structure is attenuated.

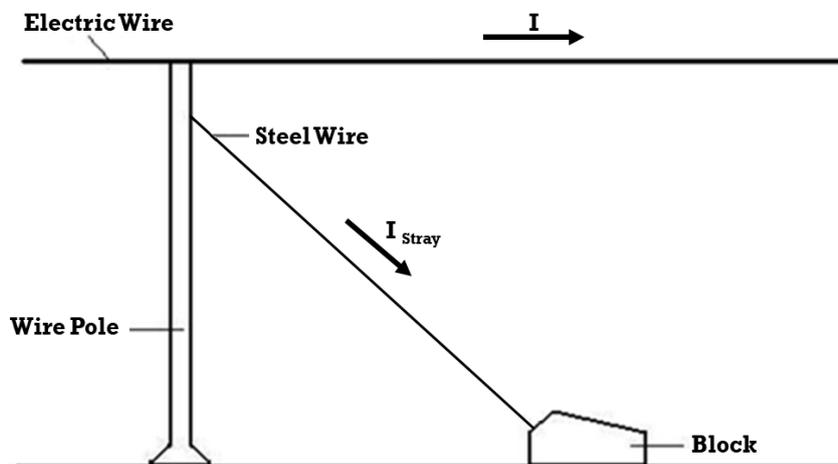
Figure 2.6: Schematic of the setup of block, steel wiring, wire pole and electric wire.

This is also found along railways near Utrecht (The Netherlands) [105]. In this case the wire poles are fixed by the steel wire connected to a reinforced concrete block (Figure 2.6). It is found that the anchors in the block used to connect the steel wiring and the reinforcement in the block suffer from corrosion at an extremely high rate. In some exceptional cases, the blocks with the design service life of 80 years, were damaged totally only after 3 years, due to steel corrosion and corrosion-induced cracks around the anchors (Figure 2.7). The rebars in the block were also corroded. According to the investigation [105], the corrosion damage here was also induced by stray current from the electric wiring.

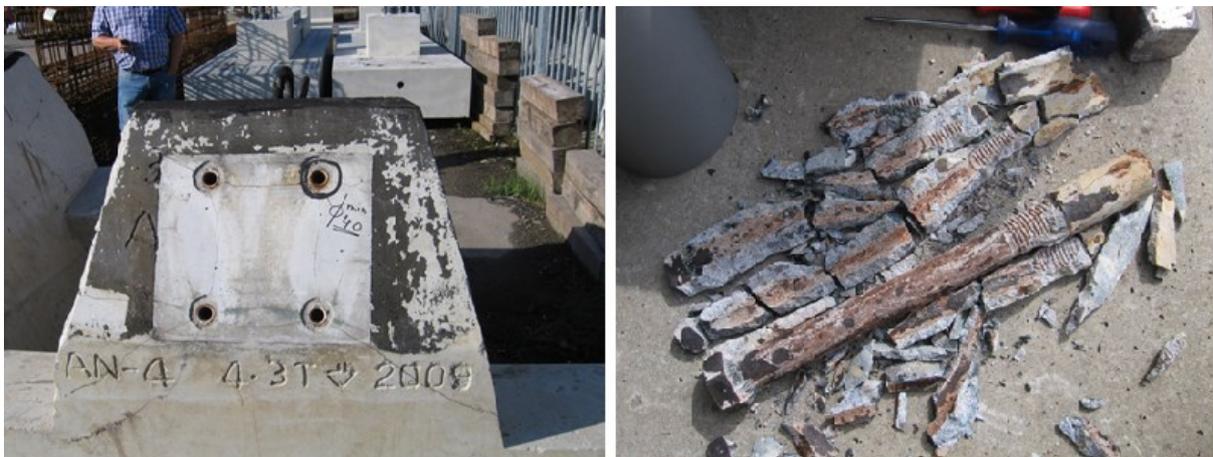
Figure 2.7: Damaged block due to the corrosion of anchor induced by stray current [105].

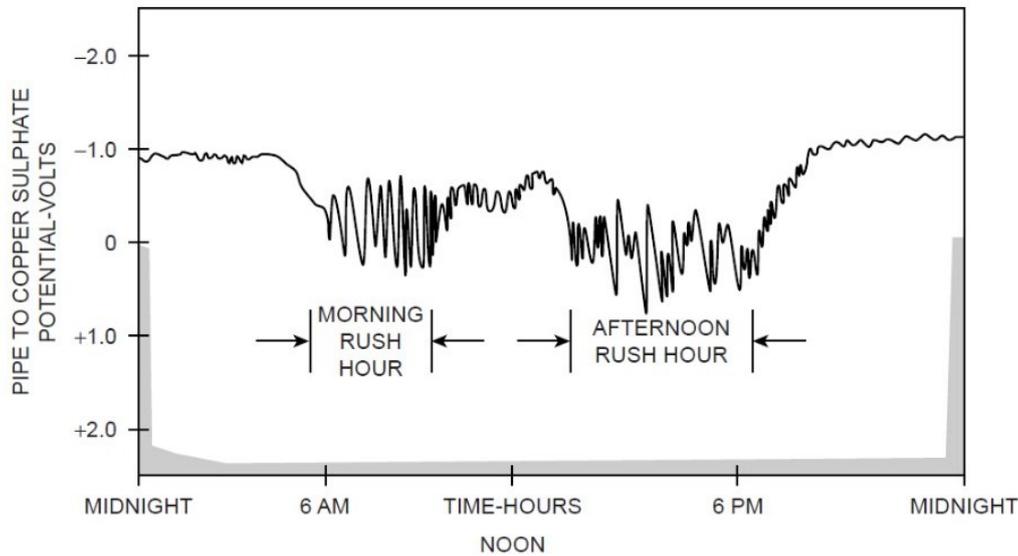
Figure 2.9: Pipe-to-earth potential at traction system stray current discharge area [85].

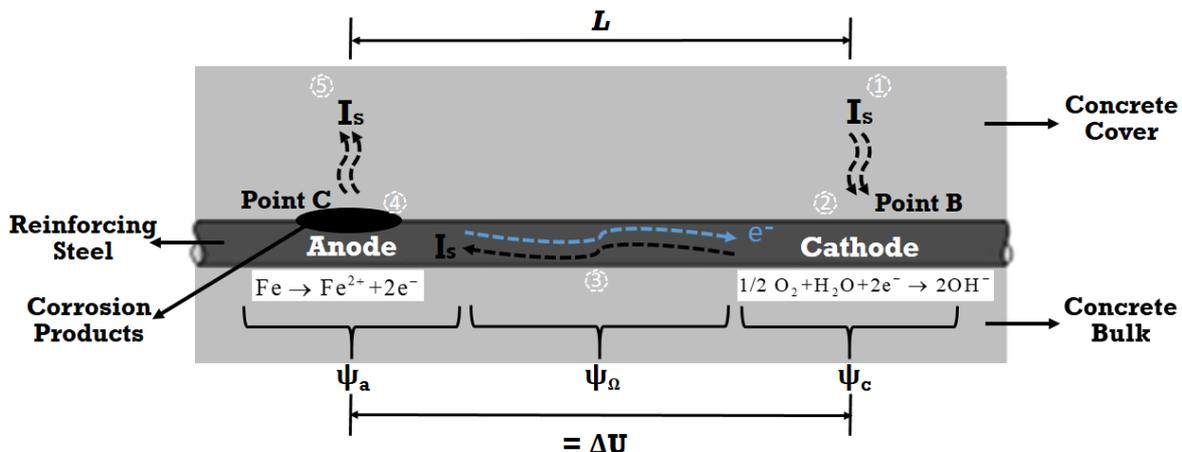
Figure 2.10: Schematic of the stray current interference (I_s) on reinforcement in concrete.

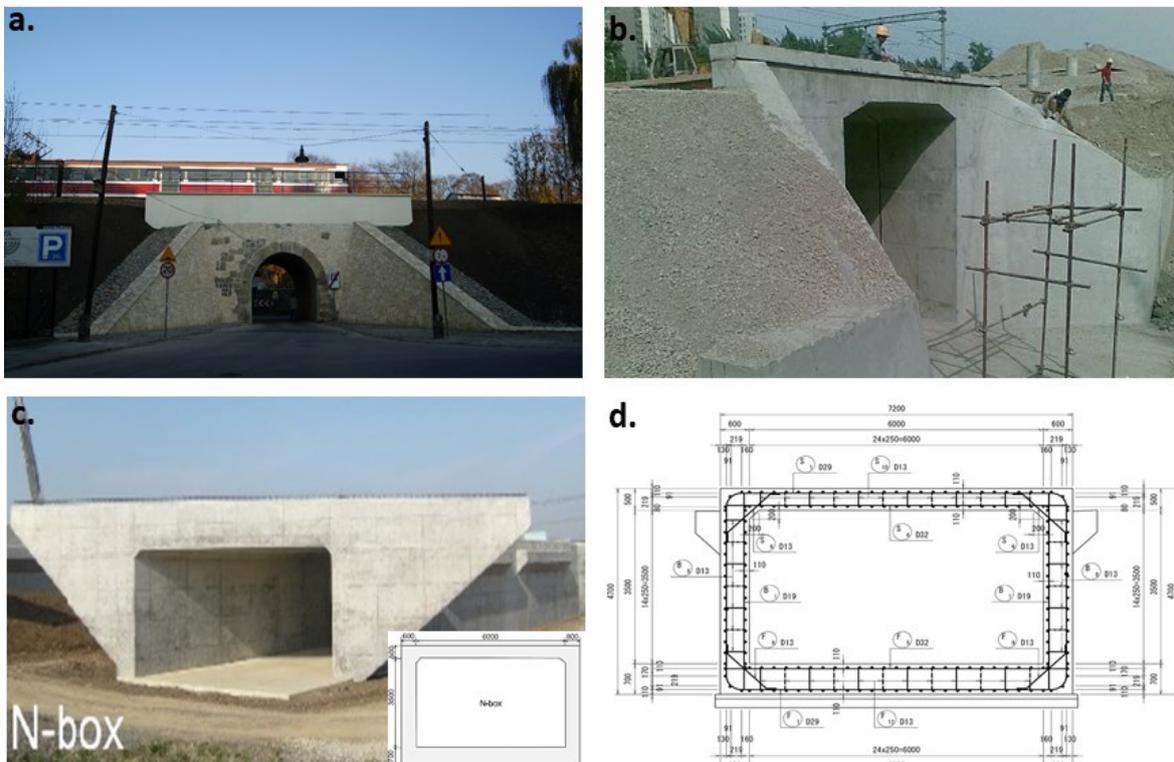
Figure 3.1: a). A traditional railway culvert (stone arch), Miodowa street, Kazimierz, Krakow, Poland [359]; b). Construction of a concrete box culvert under railway [360]; c). A precast reinforced concrete box culvert [337]; d). Detailed reinforcement drawing of culvert in Figure 3.1c [337].

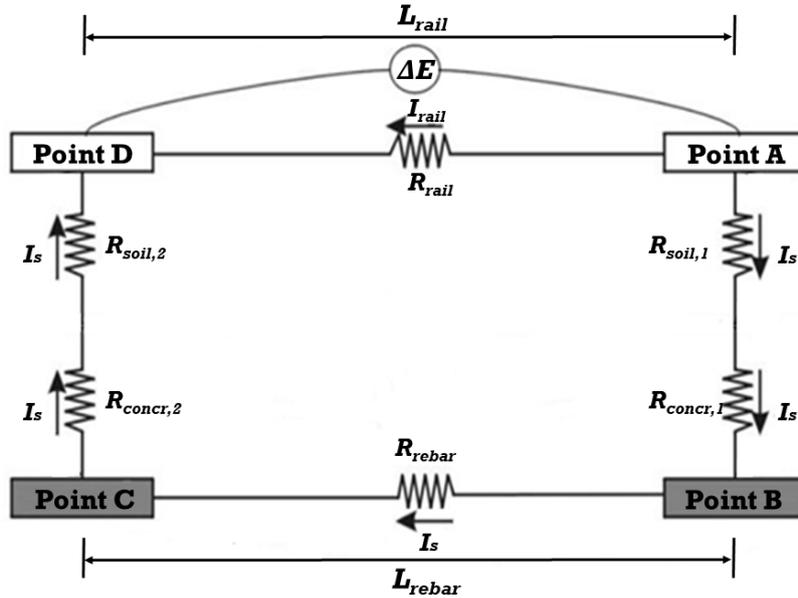
Figure 3.3: Equivalent electrical circuit to the scenario shown in Figure 3.2.

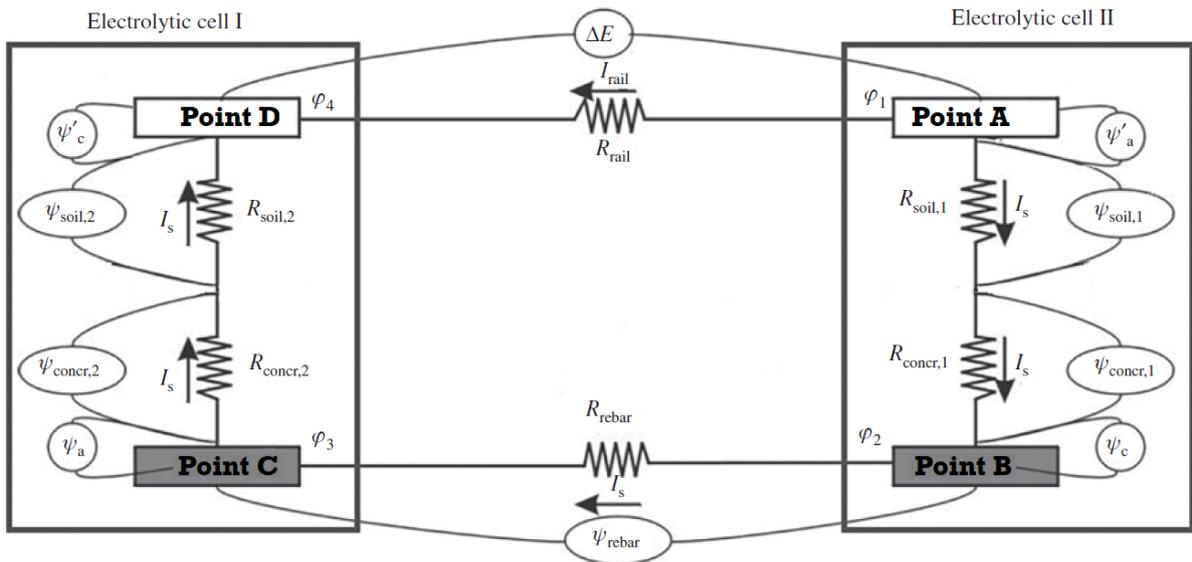
Figure 3.4: Schematic of stray current path considering the polarization and ohmic drop.

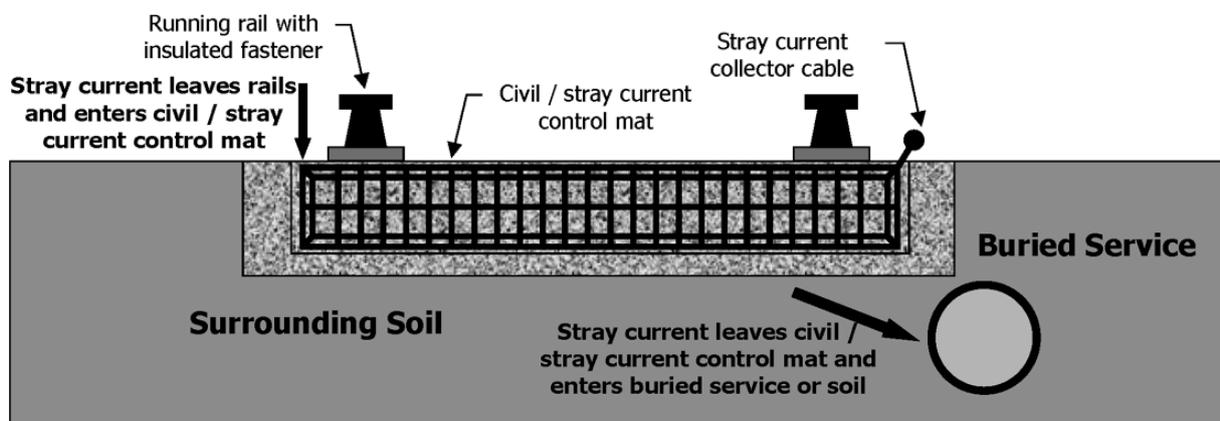
Figure 3.6: Stray current collection system under the rail [75].

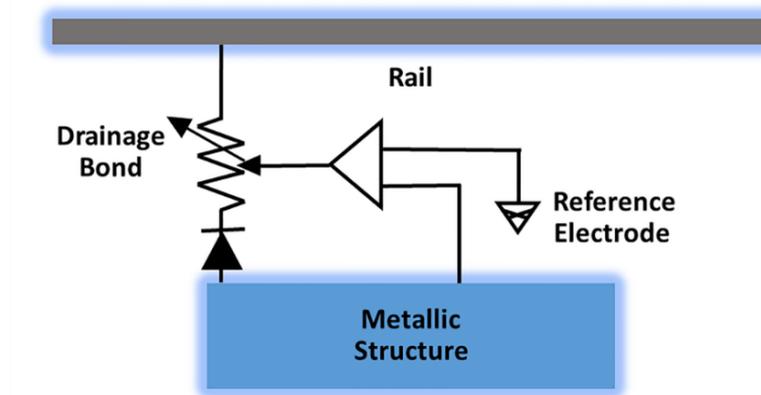
Figure 3.7: Schematic of drainage bond for mitigating the corrosion effects of stray current [367].

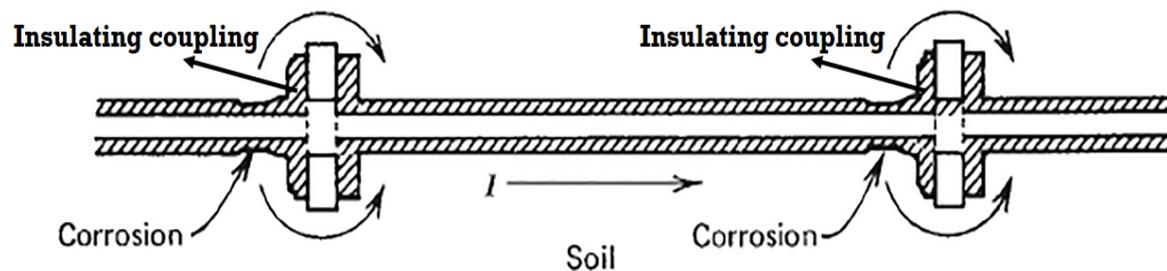
Figure 3.9: Effect of current flowing along a buried pipeline on corrosion near insulated couplings [55].

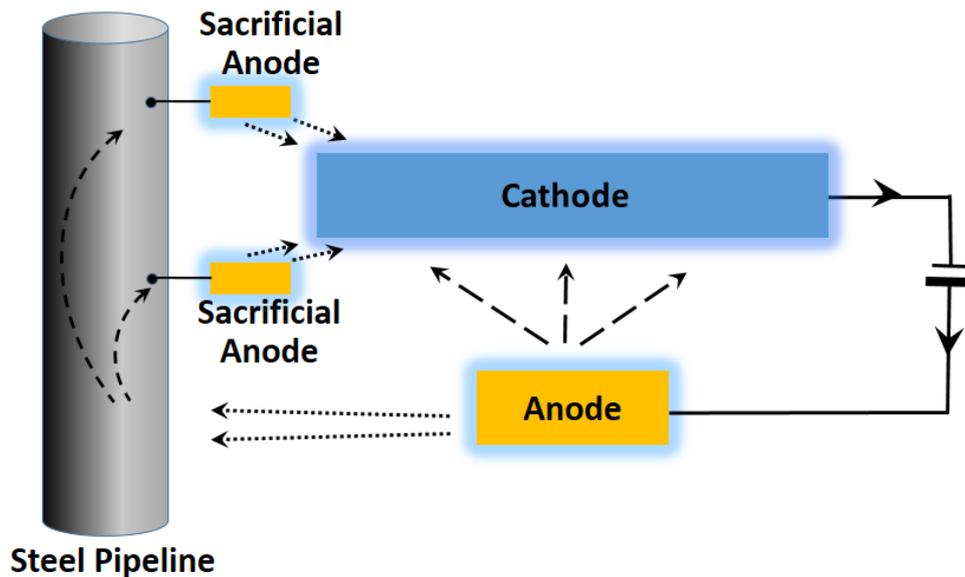
Figure 3.10: Schematic of sacrificial anodes to mitigate cathodic interference.

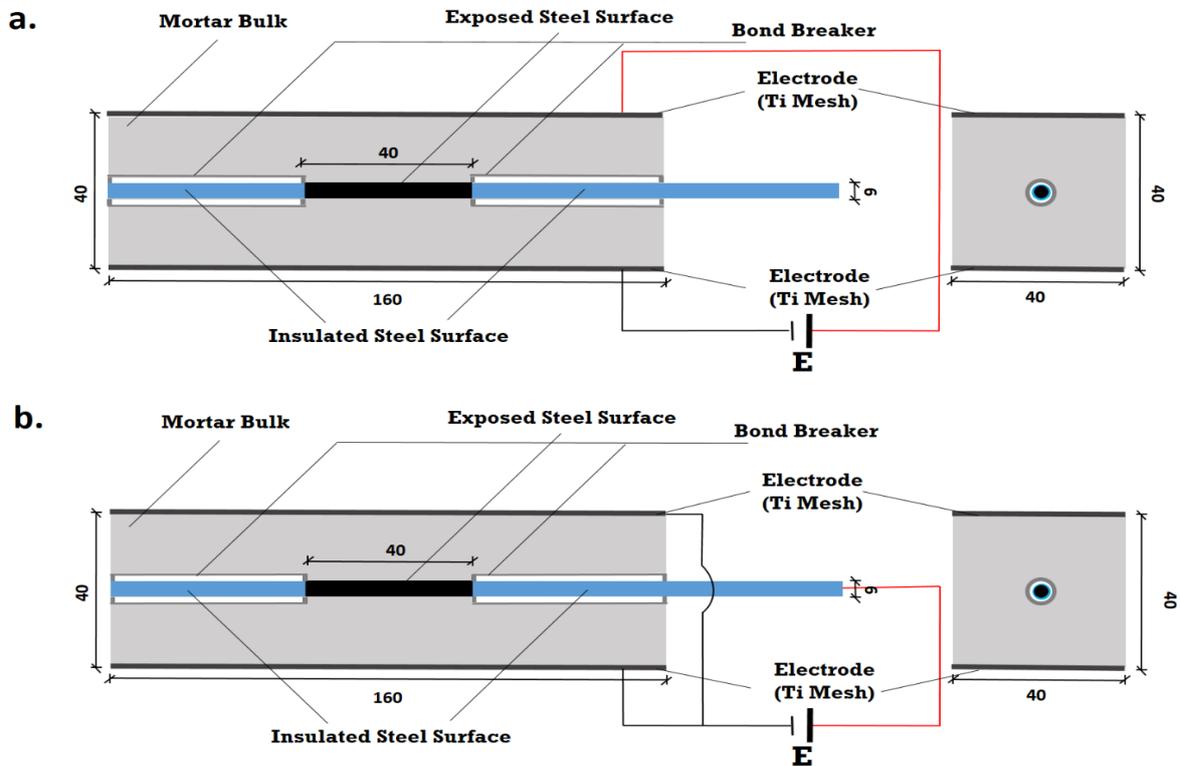
Figure 4.2: Experimental set-up for current supply and position of electrodes: a). Stray current; b). Anodic polarization.

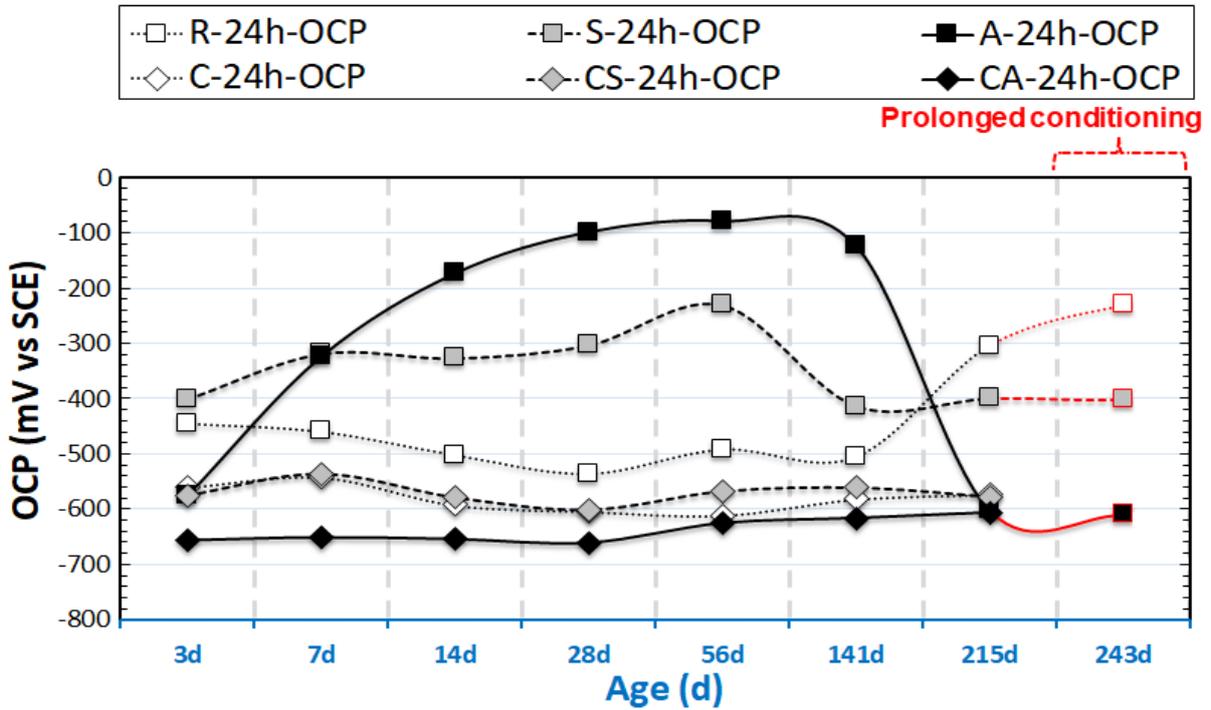
Figure 4.3: OCP evolution of samples with time: R-24h: Reference; S-24h: Stray Current; A-24h: Anodic Polarization; C-24h: Corroding (NaCl medium); CS-24h: Corroding (NaCl) + Stray Current; CA-24h: Corroding (NaCl) + Anodic Polarization – after 24h curing.

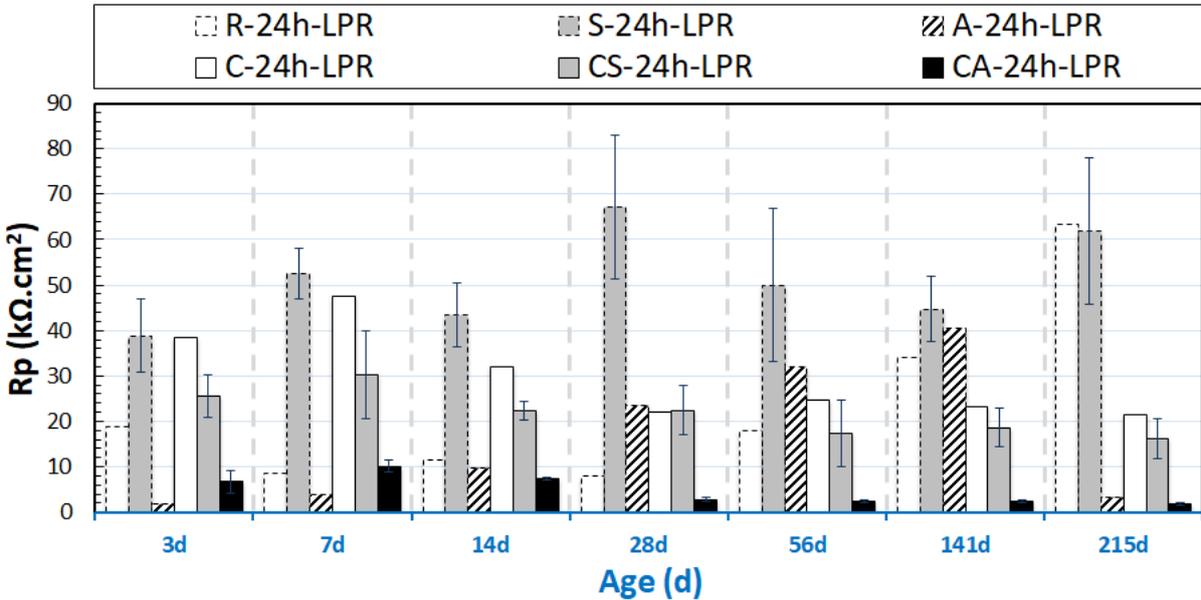
Figure 4.4: R_p evolution of samples with time: R-24h: Reference; C-24h: Corroding (NaCl medium); S-24h: Stray Current; CS-24h: Corroding (NaCl) + Stray Current; A-24h: Anodic Polarization; CA-24h: Corroding (NaCl) + Anodic Polarization – after 24h curing.

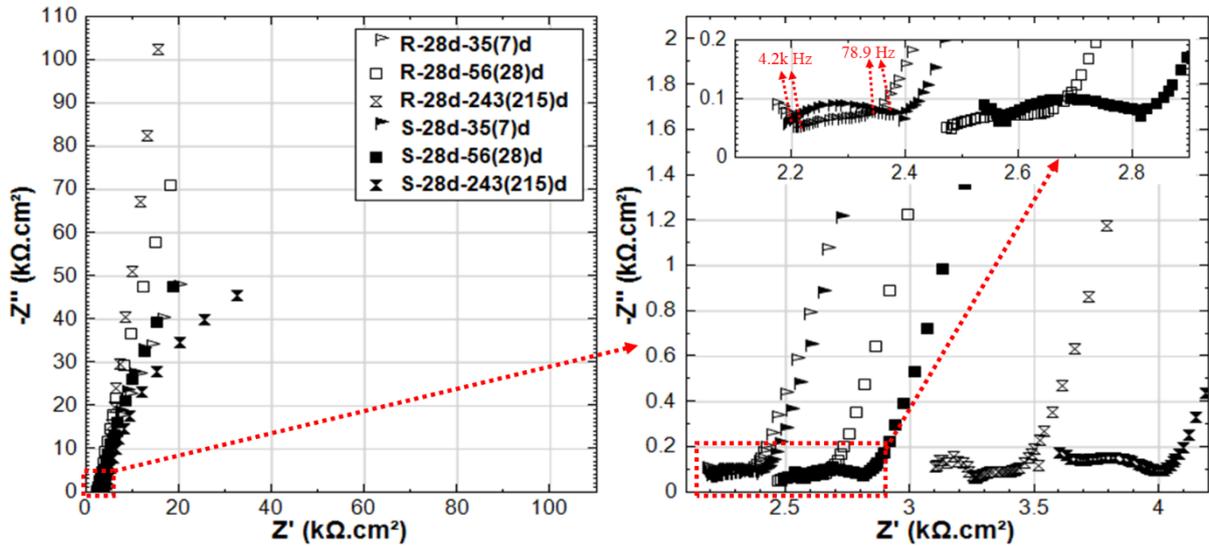
Figure 4.9: EIS responses overlay in Nyquist format of R-28d and S-28d (R-28d: Reference, S-28d: Stray Current, 28d-cured specimens treated in water).

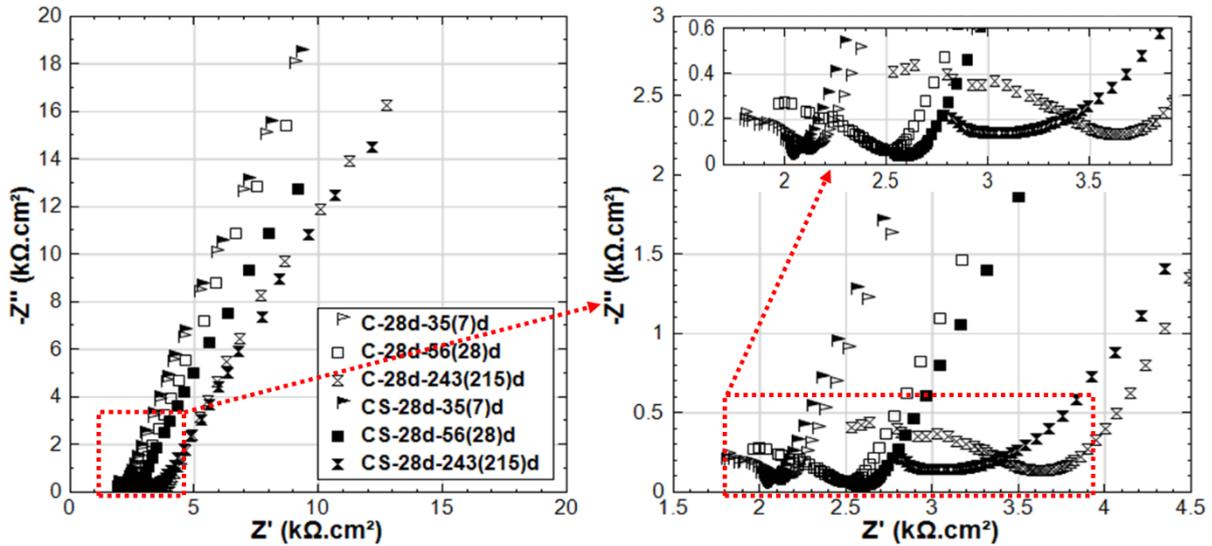
Figure 4.12: EIS responses overlay in Nyquist format of C-28d and CS-28d (C-28d: NaCl medium, CS-28d: NaCl + Stray Current, 28d-cured specimens treated in 5% NaCl).

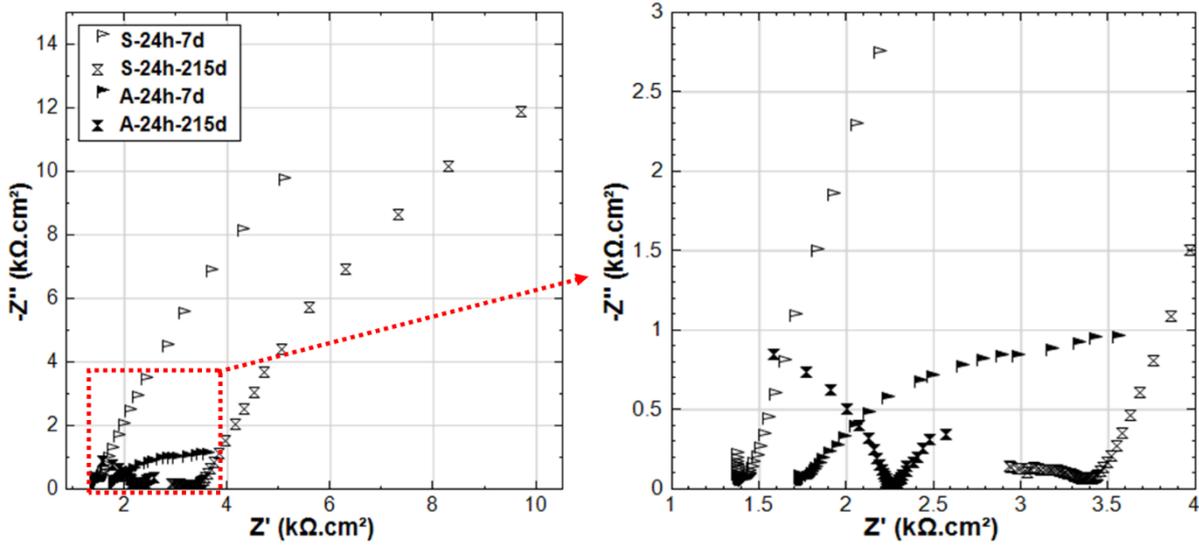
Figure 4.13: EIS responses overlay in Nyquist format of S-24h and A-24h (S-24h: Stray Current, A-24h: Anodic Polarization, 24h-cured specimens treated in water) at age of 7d and 215d.

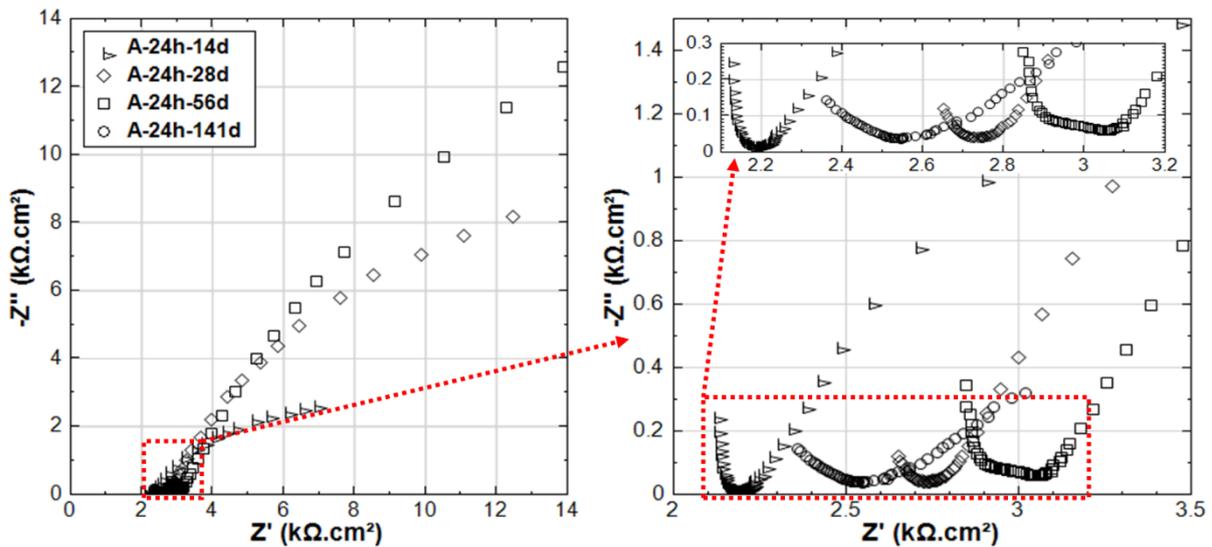
Figure 4.14: Overlay of EIS responses of A-24h in Nyquist format, at age of 14, 28, 56 and 141 days.

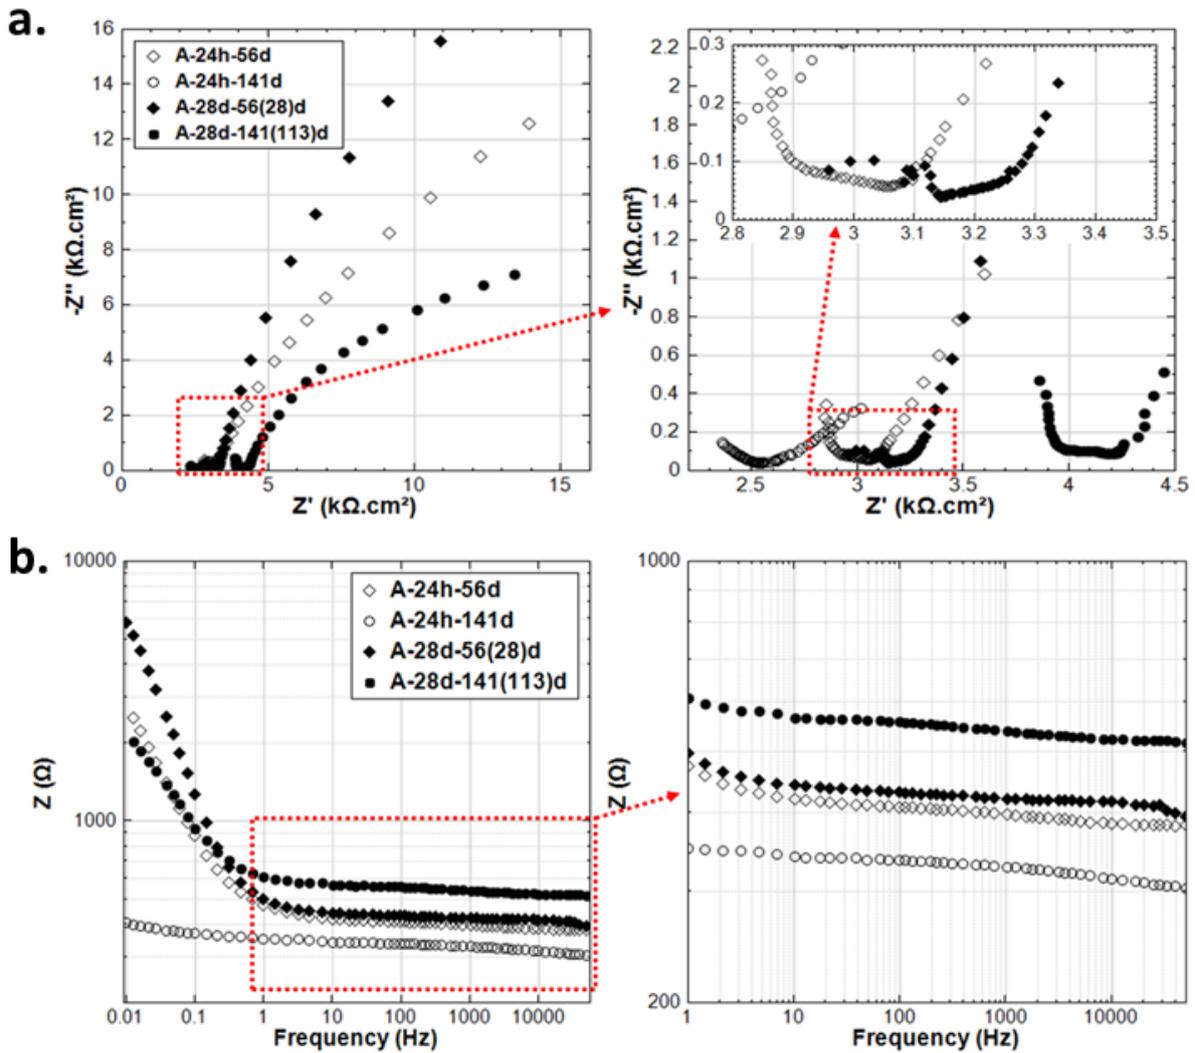
Figure 4.15: Overlay of EIS response of A-24h and A-28d in: a). Nyquist format; and b). Bode format; at age of 56 and 141 days.

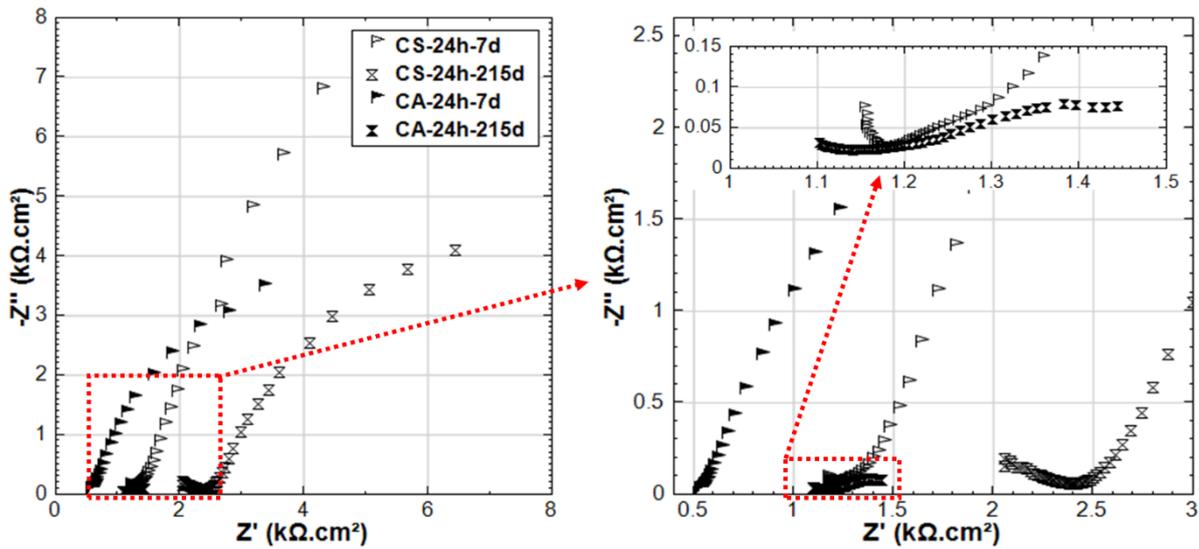
Figure 4.17: EIS responses overlay in Nyquist format of CS-24h and CA-24h (CS-24h: NaCl + Stray Current, CA-24h: NaCl + Anodic Polarization, 24h-cured specimens treated in 5% NaCl) at age of 7d and 215d.

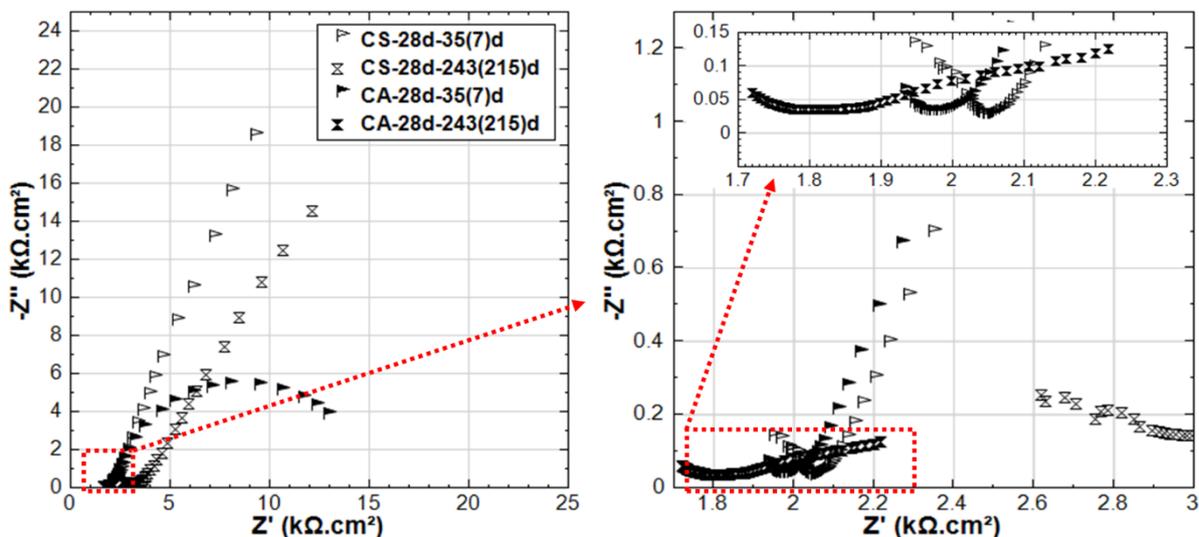
Figure 4.18: EIS responses overlay in Nyquist format of CS-28d and CA-28d (CS-28d: NaCl + Stray Current, CA-28d: NaCl + Anodic Polarization, 28d-cured specimens treated in 5% NaCl) at age of 35(7)d and 243(215)d.

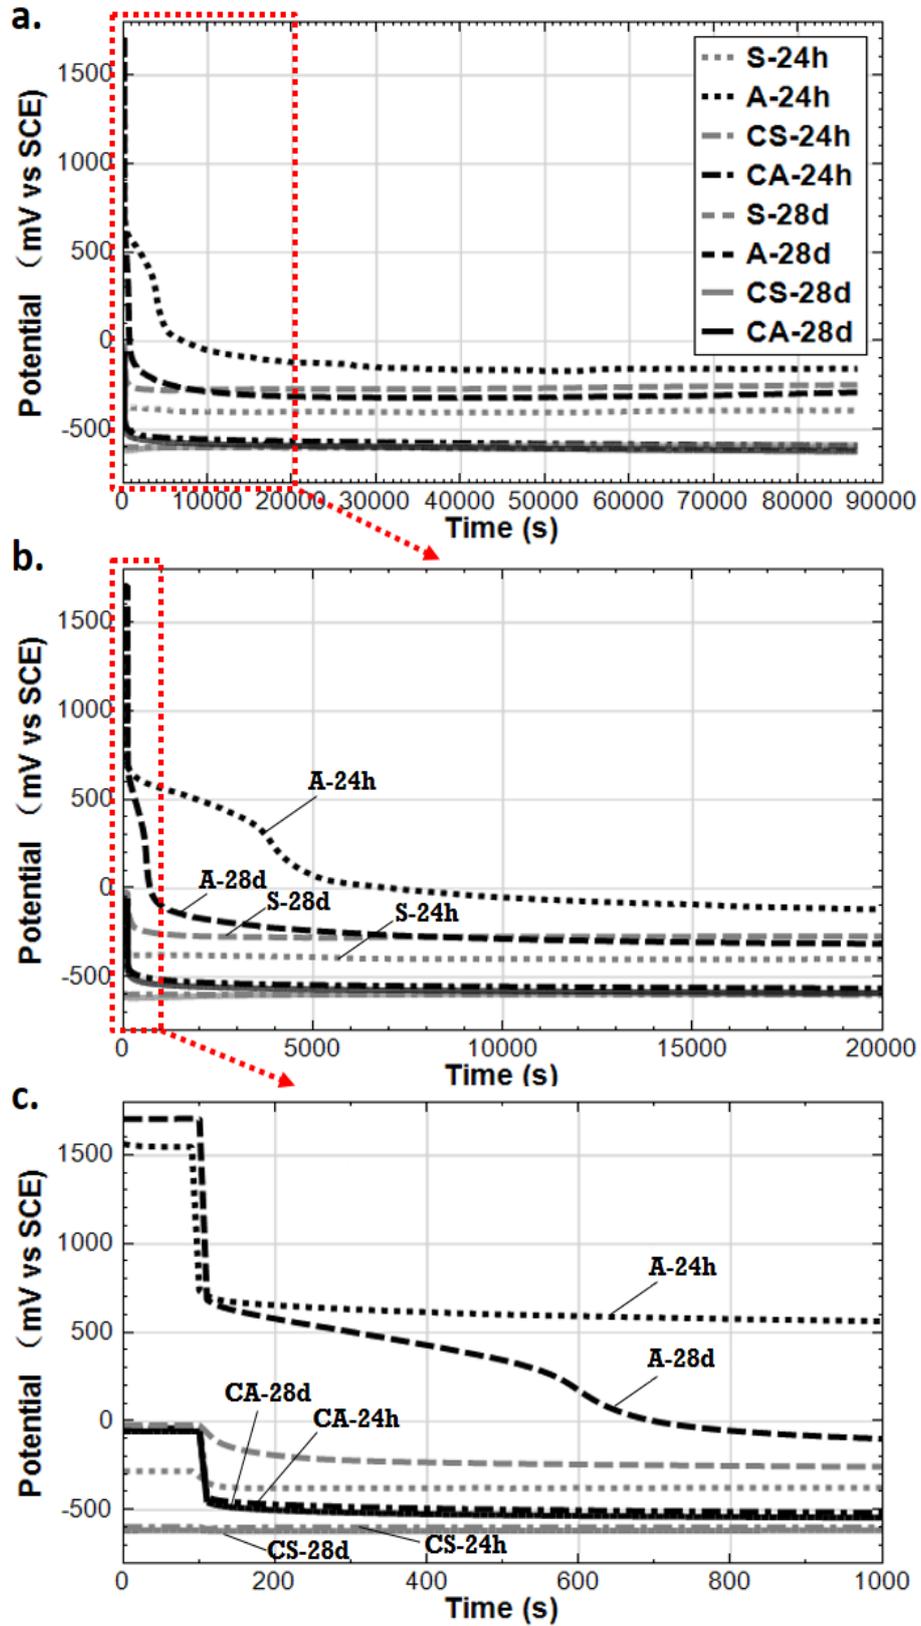
Figure 4.19: Potential decay monitoring over 24h de-polarization process.

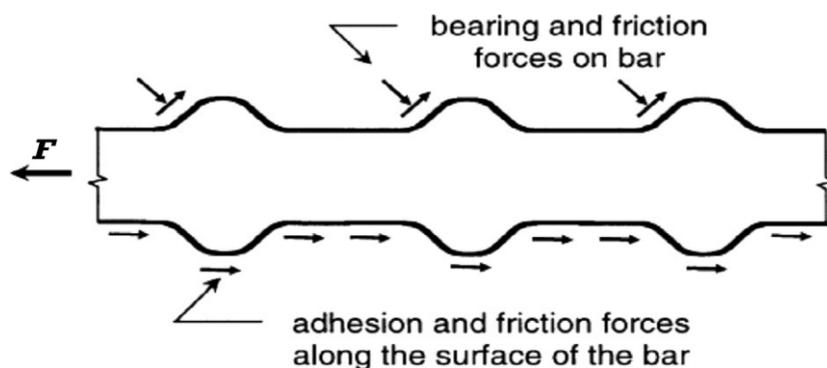
Figure 5.1: Bond force transfer mechanism [460].

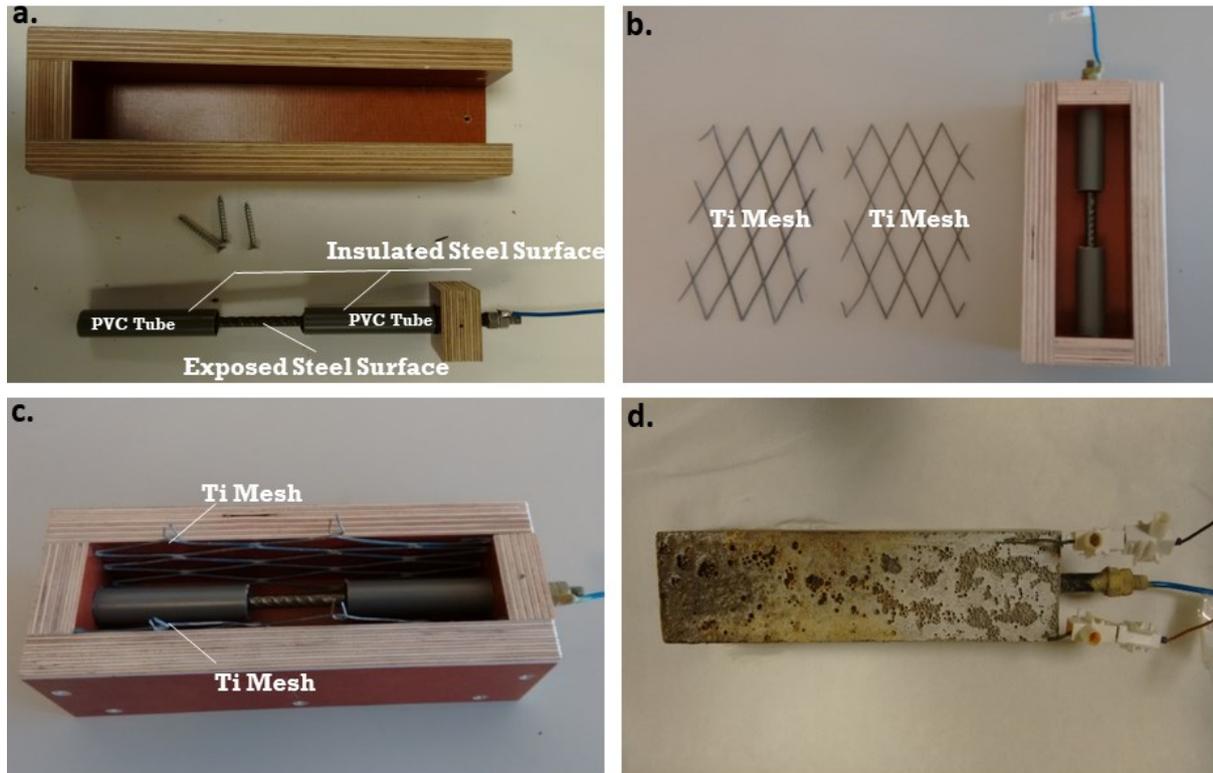
Figure 5.2: Pictures of moulds and specimens fabrication.

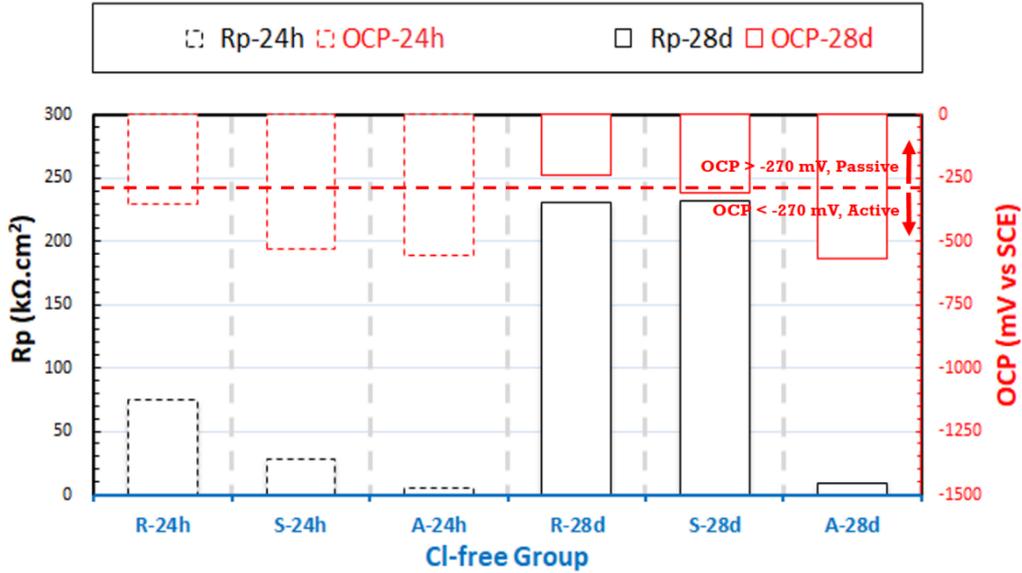
Figure 5.4: OCP and R_p values (derived from LPR) of specimens in water (as summarized in Table 5.1 and 5.2), at 490 days.

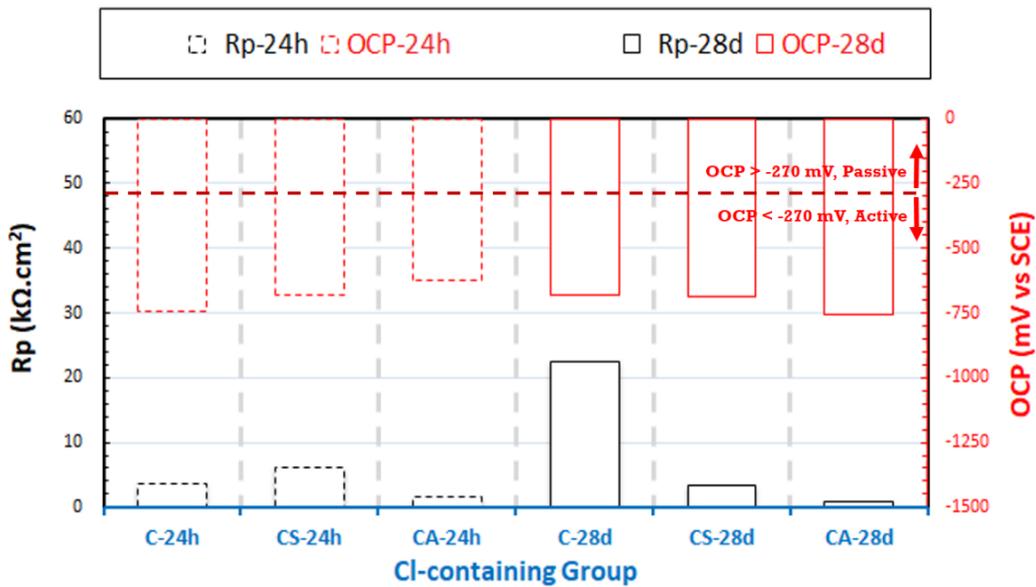
Figure 5.5: OCP and R_p values (derived from LPR) of specimens in 5% NaCl (as summarized in Table 5.1 and 5.2), at 490 days.
