Behavior of reinforcing steel and reinforced concrete undergoing stray current

Keywords: Stray current, anodic polarization, steel rebar, corrosion, mortar, interface, bond, electrochemical response, rebar orientation.

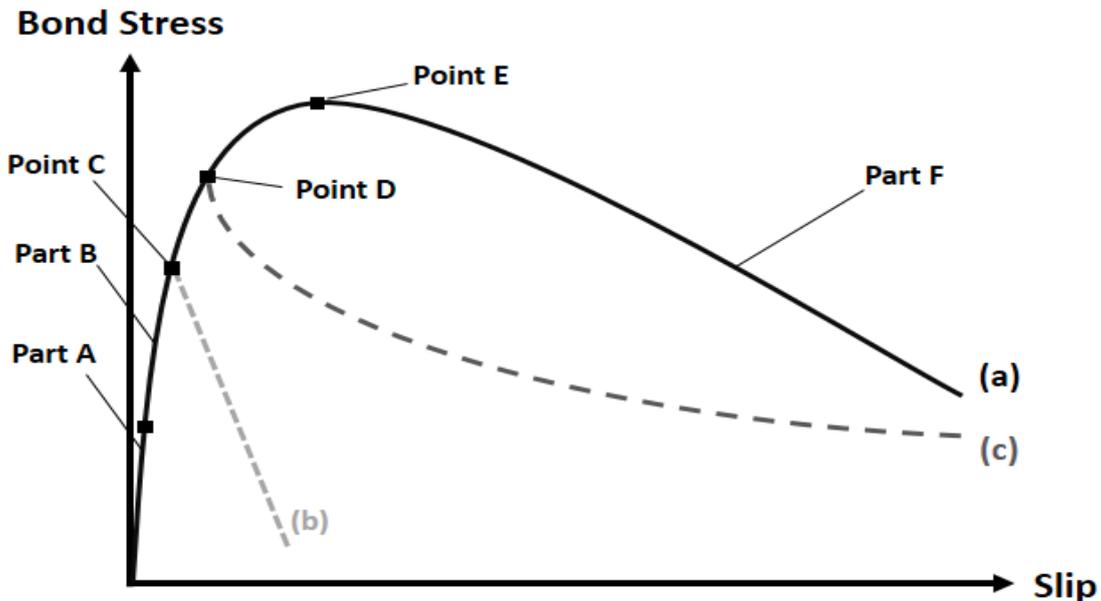
Figure 5.6: Curve of bond stress-slip for: a). well-confined concrete: pull-out failure; b). unconfined concrete: splitting failure; c). confined concrete: splitting induced pull-out failure. Reproduced on the basis of [467].

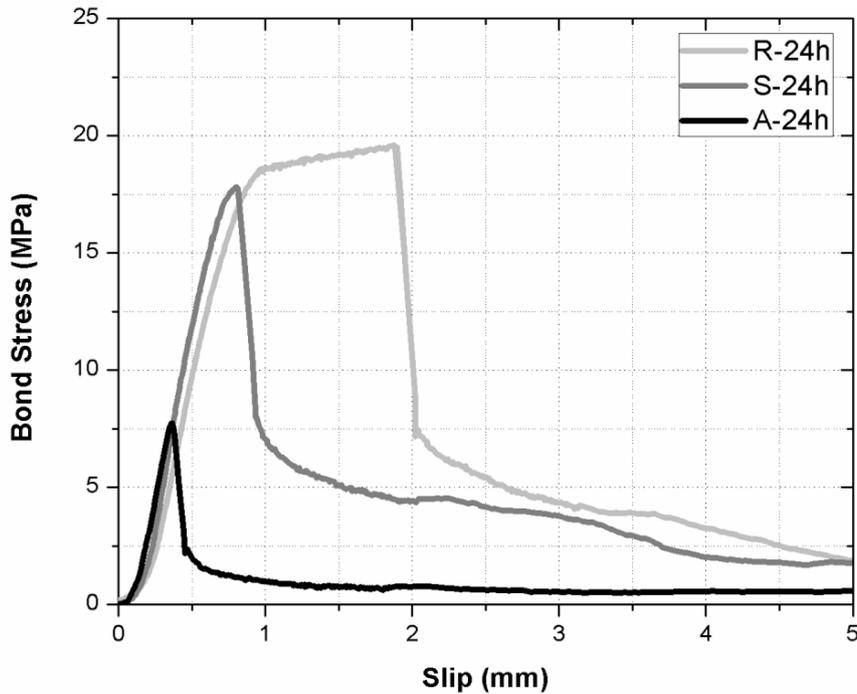
Figure 5.7: Bond stress-slip relationship of 24h-cured specimens (treated in water). R-24h: Reference; S-24h: Stray Current; A-24h: Anodic Polarization – after 24h curing in fog room.

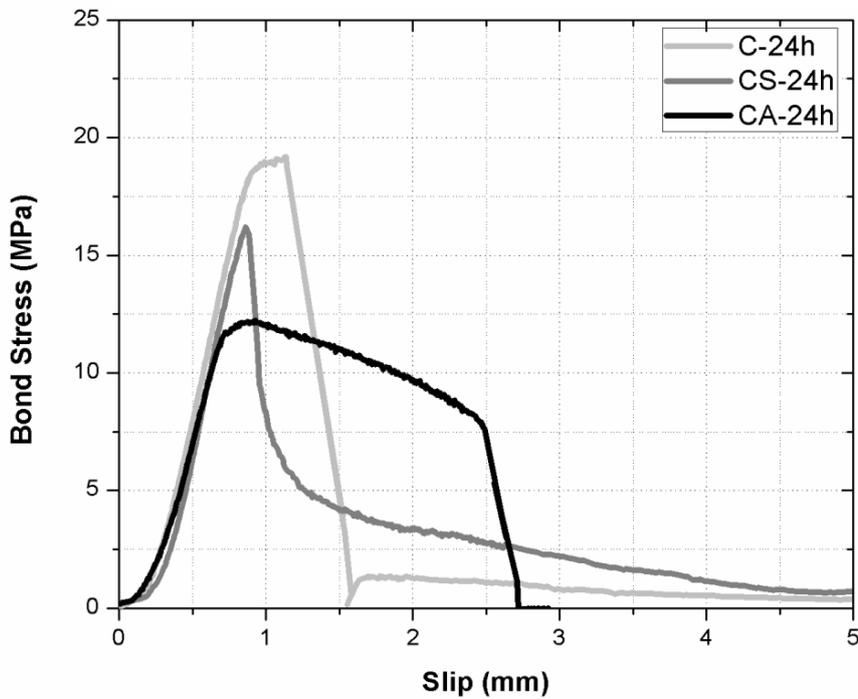
Figure 5.9: Bond stress-slip relationship of 24h-cured specimens (treated in 5% NaCl). C-24h: Corroding (NaCl medium); CS-24h: Corroding (NaCl) + Stray Current; CA-24h: Corroding (NaCl) + Anodic Polarization – after 24h curing in fog room.

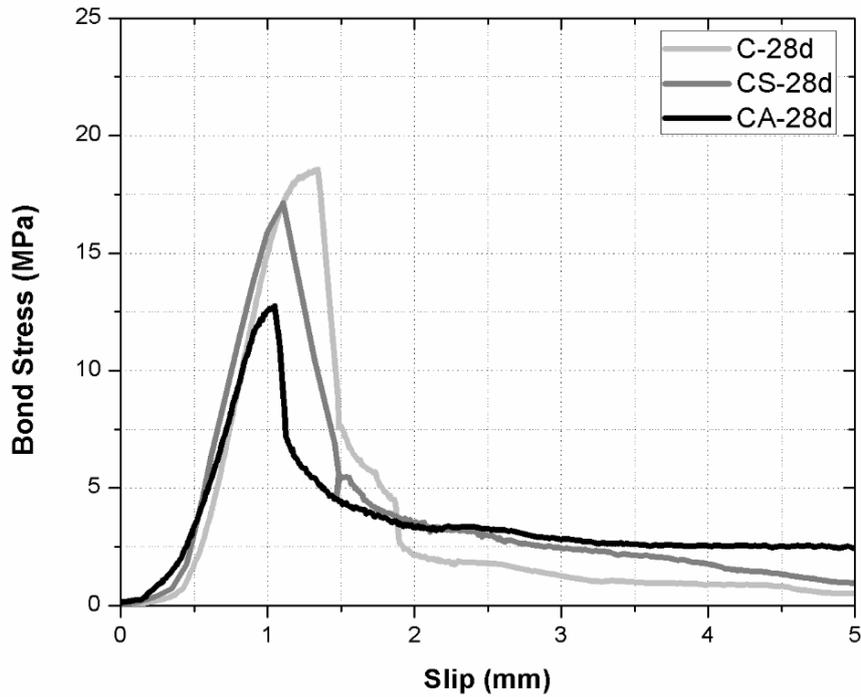
Figure 5.10: Bond stress-slip relationship of 28d-cured specimens (treated in 5% NaCl). C-28d: Corroding (NaCl medium); CS-28d: Corroding (NaCl) + Stray Current; CA-28d: Corroding (NaCl) + Anodic Polarization – after 28d curing in fog room.

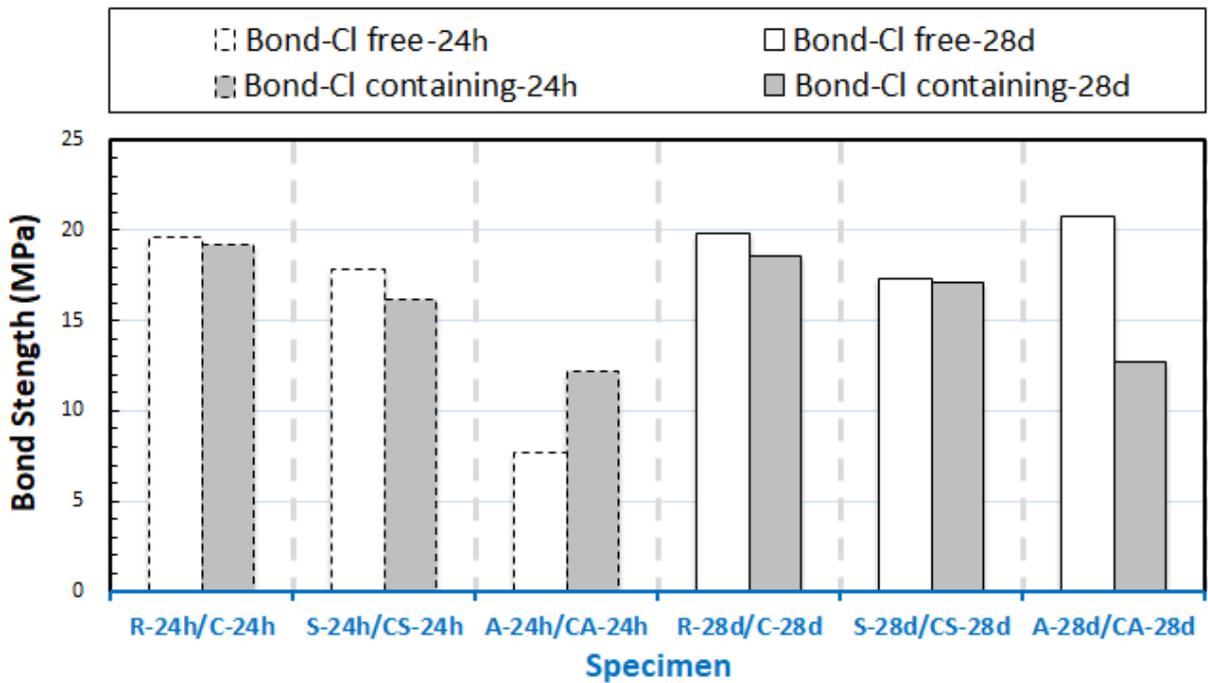
Figure 5.11: Comparison of bond strength of all specimens.

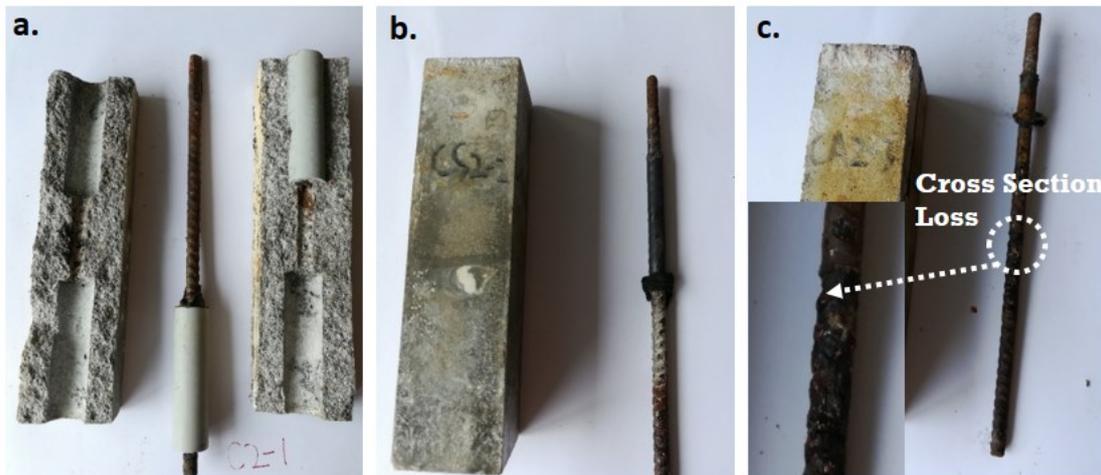
Figure 5.16: Specimens after pull-out: a). C-28d; b). CS-28d; c). CA-28d.

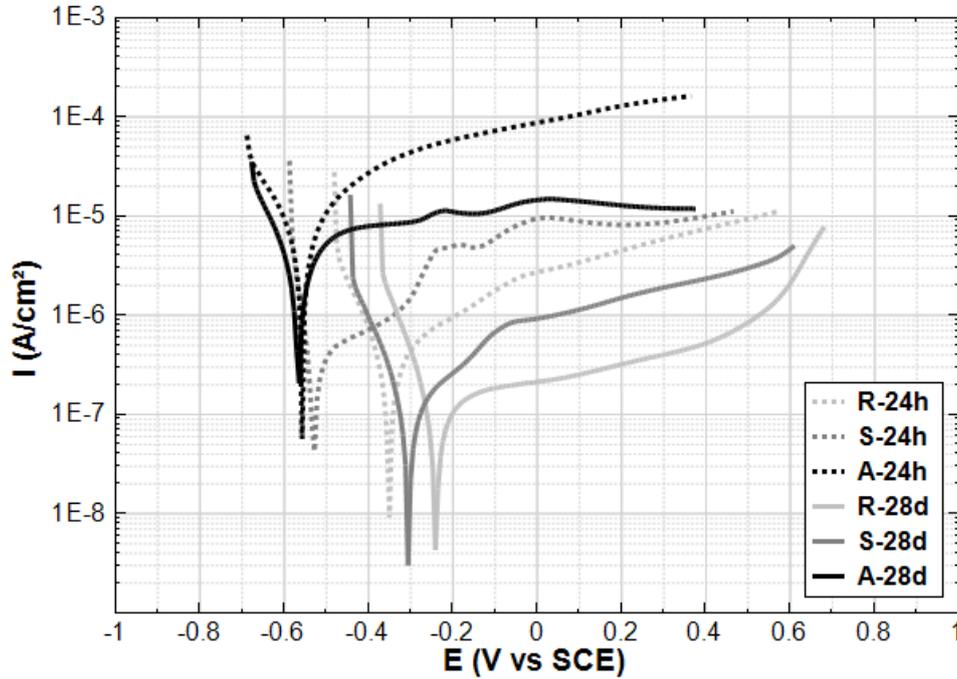
Figure 5.17: Overlay of PDP curves for specimens in water at 490 days.

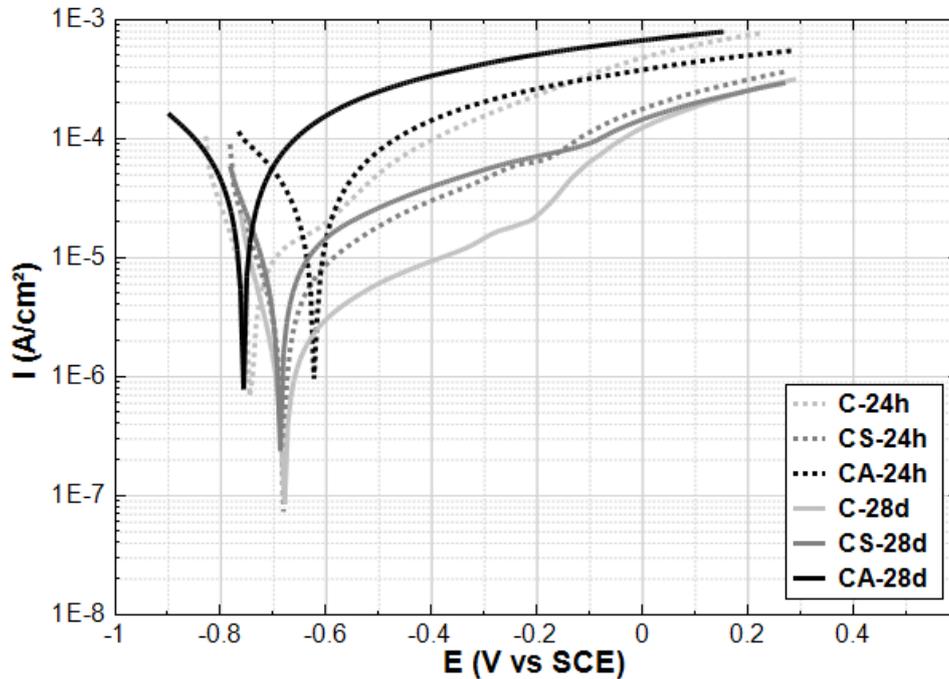
Figure 5.18: Overlay of PDP curves for specimens in 5% NaCl at 490 days.

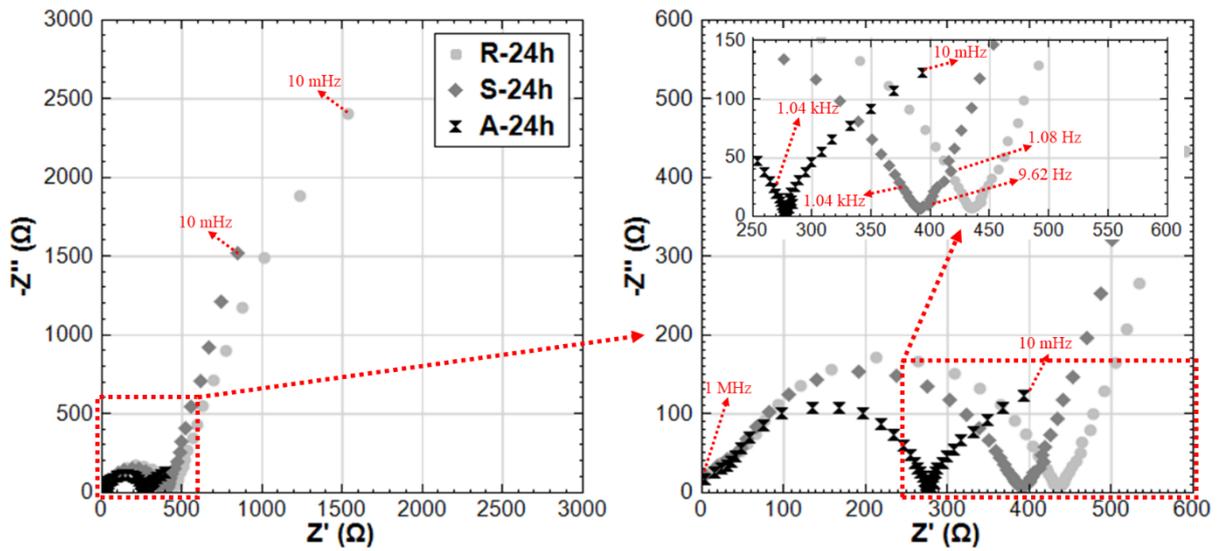
Figure 5.19: EIS responses in Nyquist format of 24h-cured specimens (treated in water).

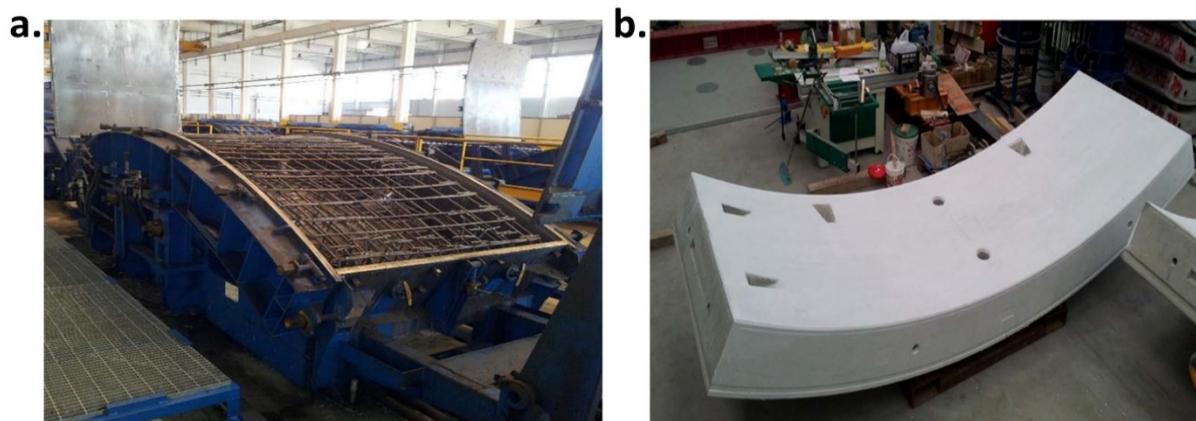
6.1a: Reinforcing steel cage before casting.

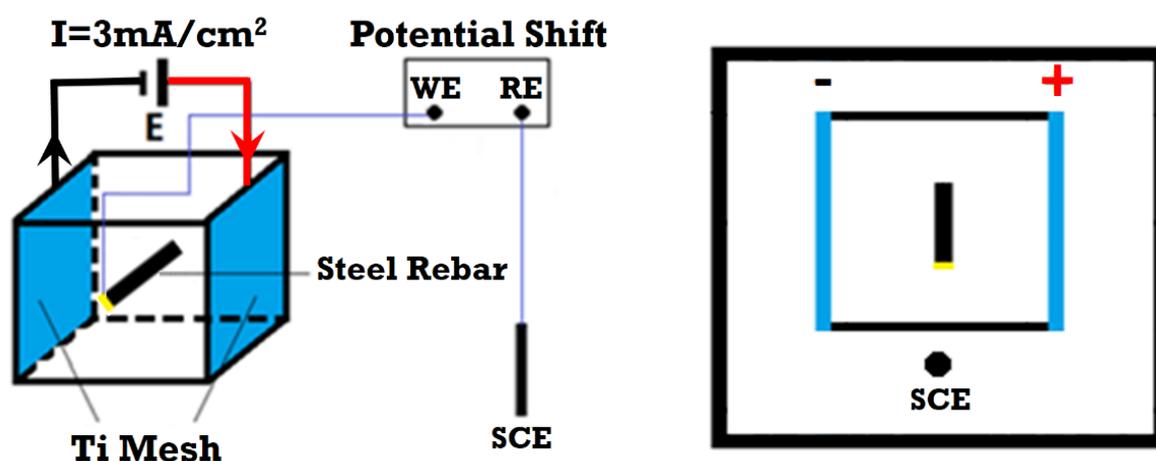
Figure 6.3: Schematic and top-view of specimen and reference electrode arrangement for potential shift monitoring on individual specimens.

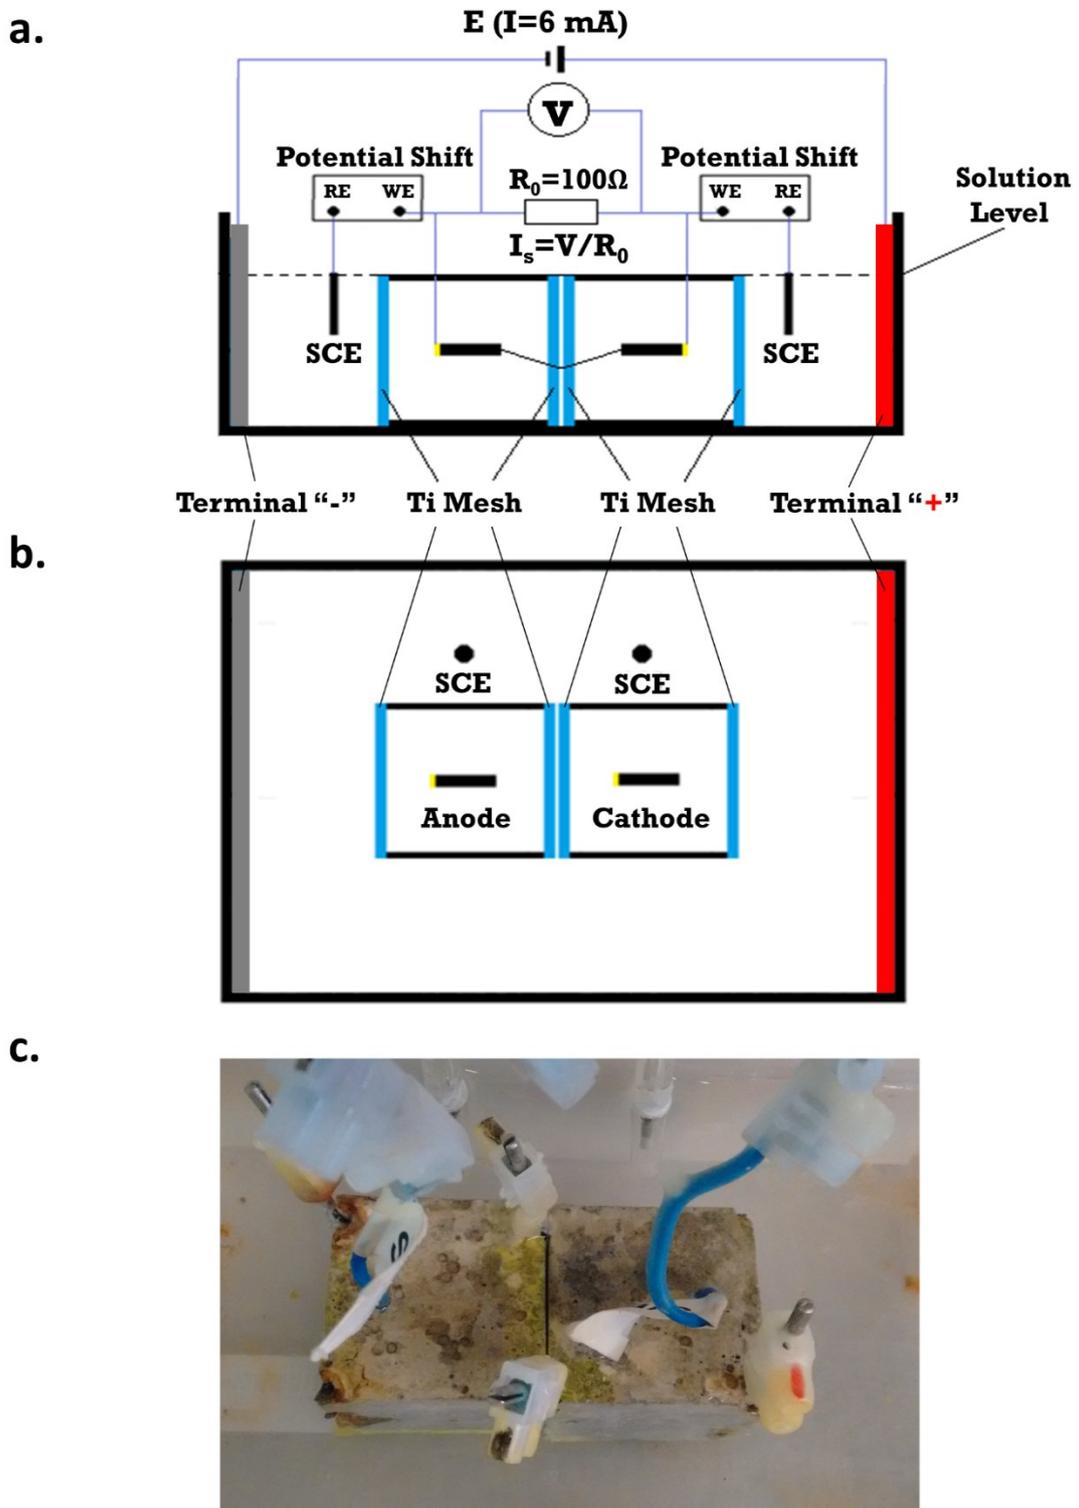
Figure 6.4: Basic testing arrangement for simulation of practical stray current electric field: a). Cross-section; b). Top-view; c). Actual testing setup.

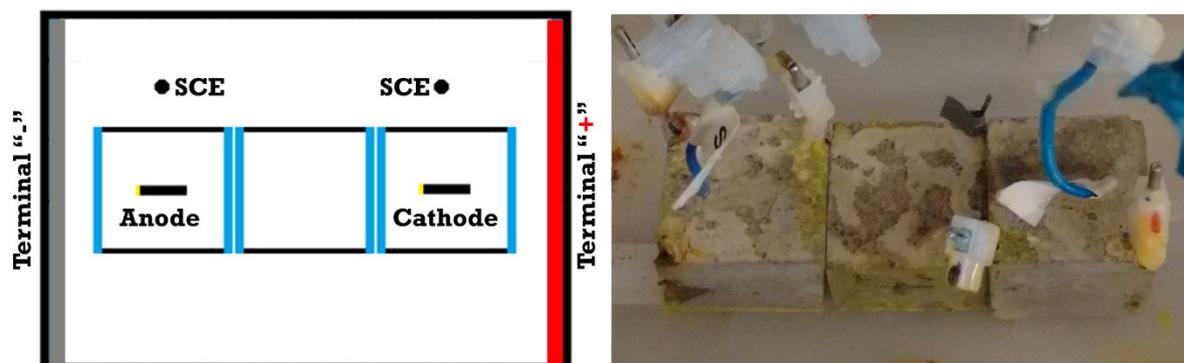
Figure 6.5: Advanced testing arrangement for simulation of practical stray current electric field: longer length of steel undergoing stray current interference.

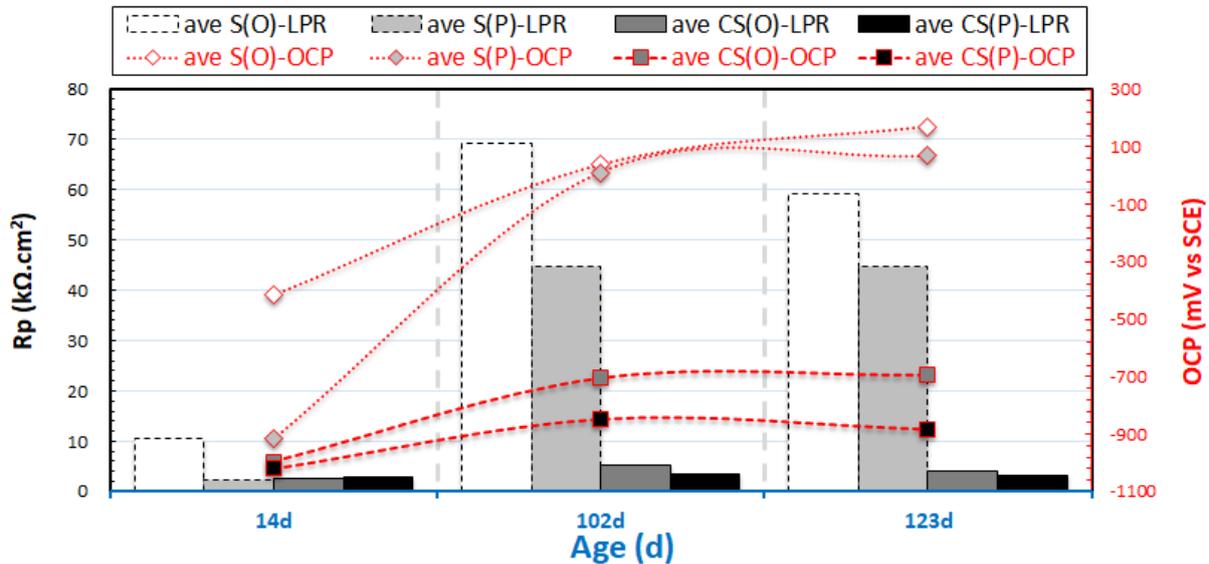
Figure 6.7: Comparison of average OCP/ R_p values of Cl-free groups: S(O) and S(P); and Cl-containing groups: CS(O) and CS(P).

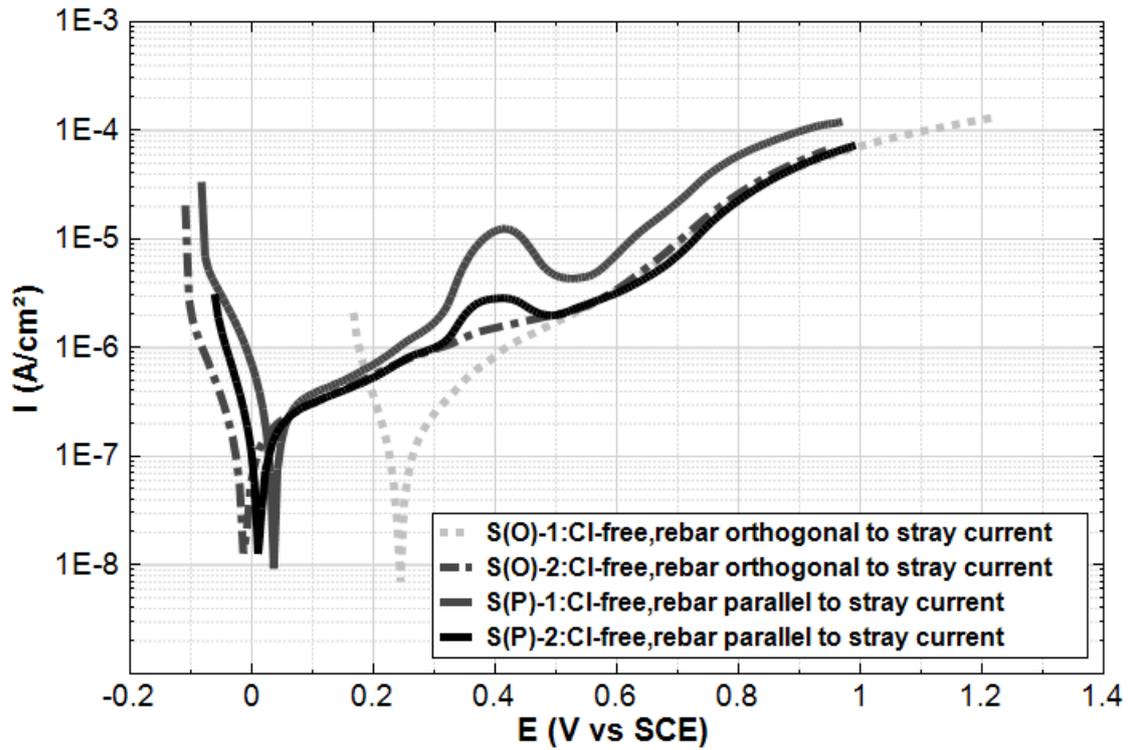
Figure 6.8: Overlays of PDP response for Cl-free specimens at 123 days.

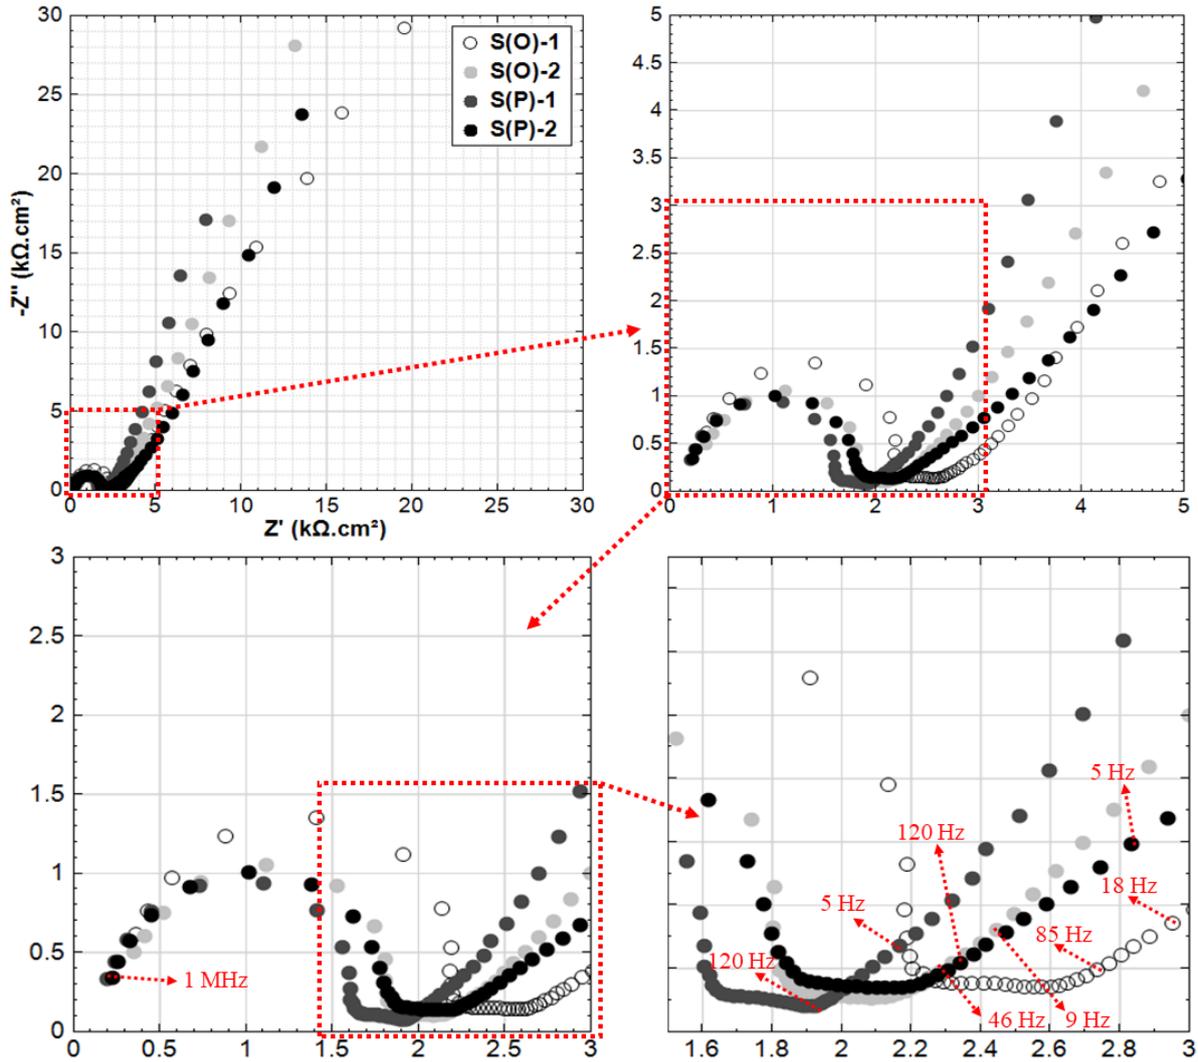
Figure 6.10: Overlays of EIS response for Cl-free specimens at 123 days.

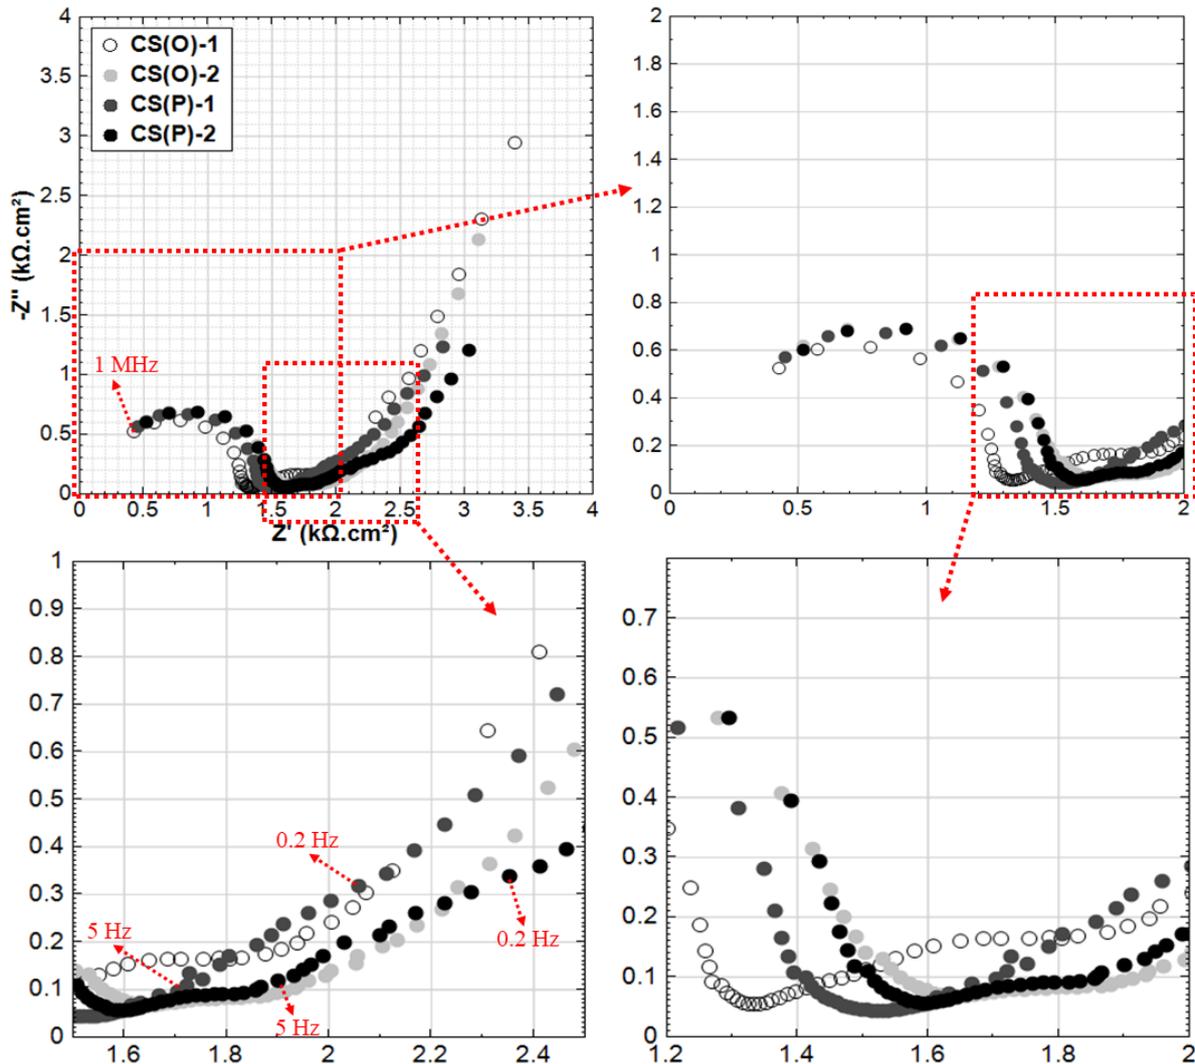
Figure 6.11: Overlays of EIS response for Cl-containing specimens at 123 days.

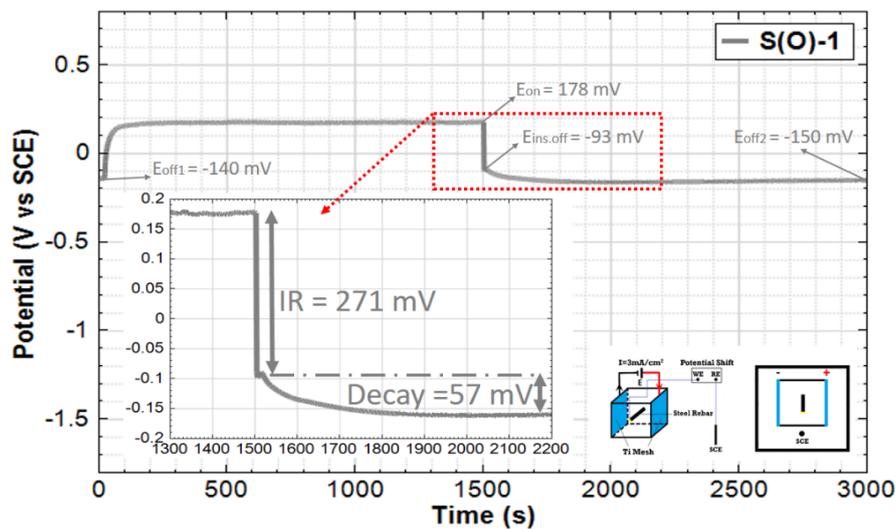
Figure 6.12: Monitoring of potential shift undergoing stray current: S(O)-1. (specimen and reference electrode arrangement for potential shift monitoring in Figure 6.3).

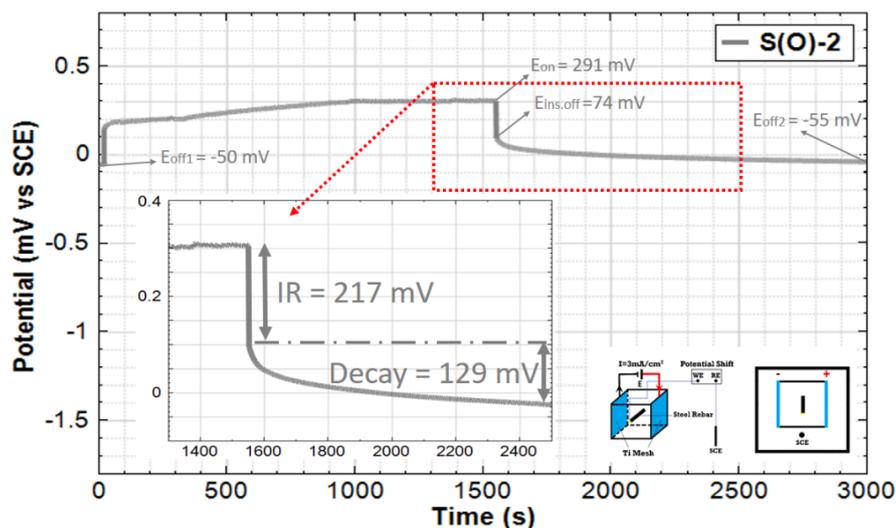
Figure 6.13: Monitoring of potential shift undergoing stray current: S(O)-2. (specimen and reference electrode arrangement for potential shift monitoring in Figure 6.3).

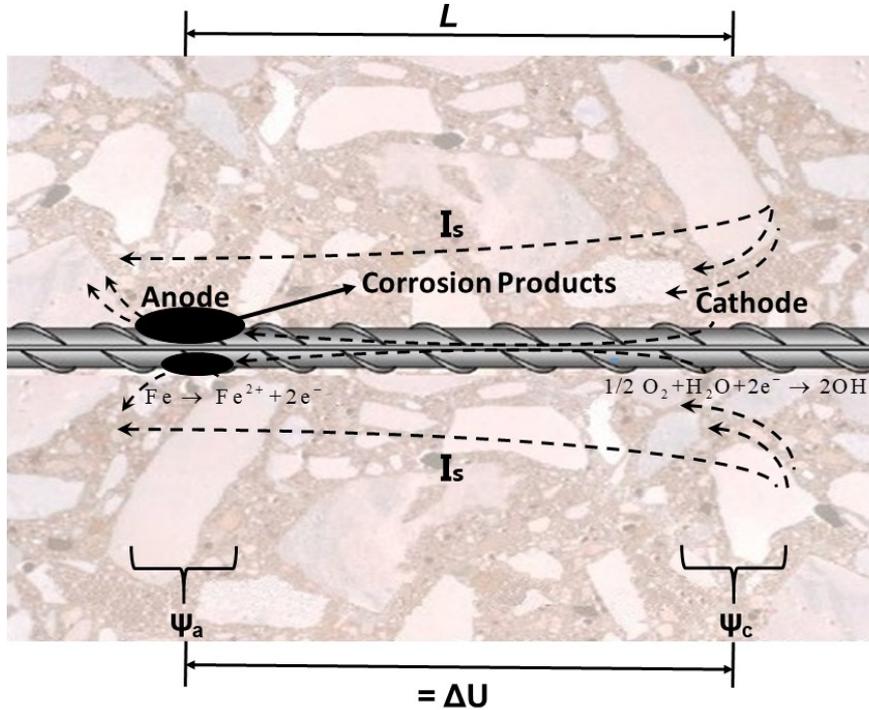
Figure 6.14: Schematic of stray current parallel to steel rebar: Macrocell-like, tends to induce localized corrosion.

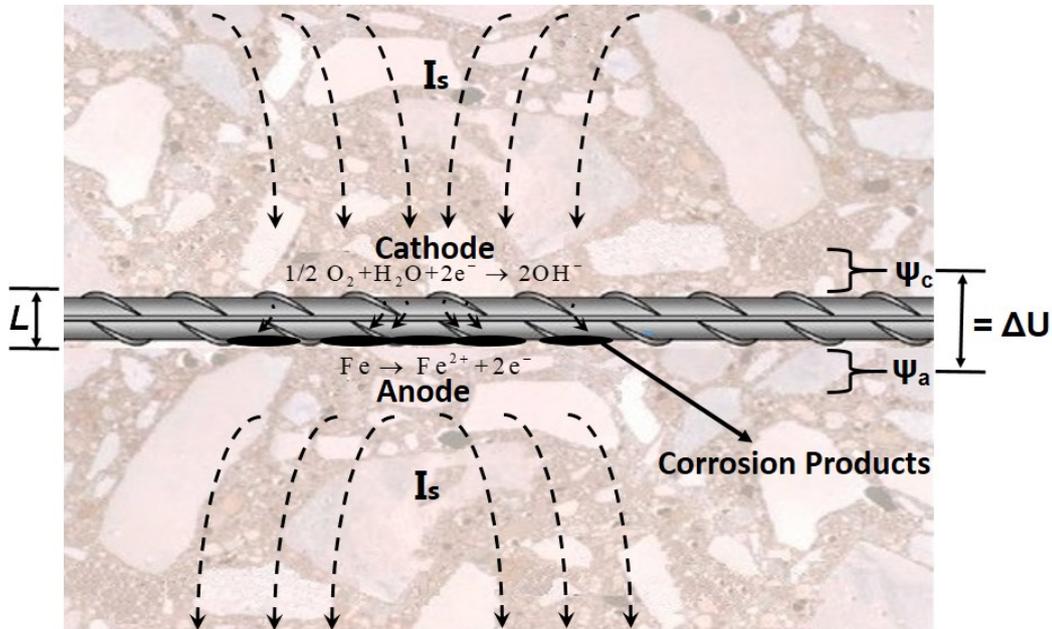
Figure 6.15: Schematic of stray current orthogonal to steel rebar: Microcell-like, tends to induce general/uniform corrosion.

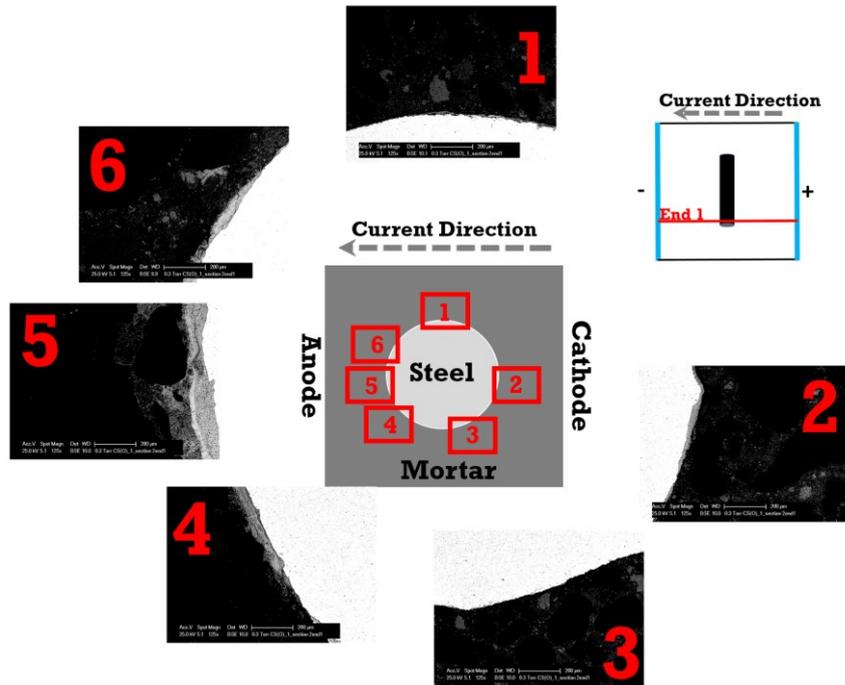
Figure 6.16: ESEM images (BSE mode) at different locations of the steel-mortar interface, the “End 1” cross-section of CS(O)-1.

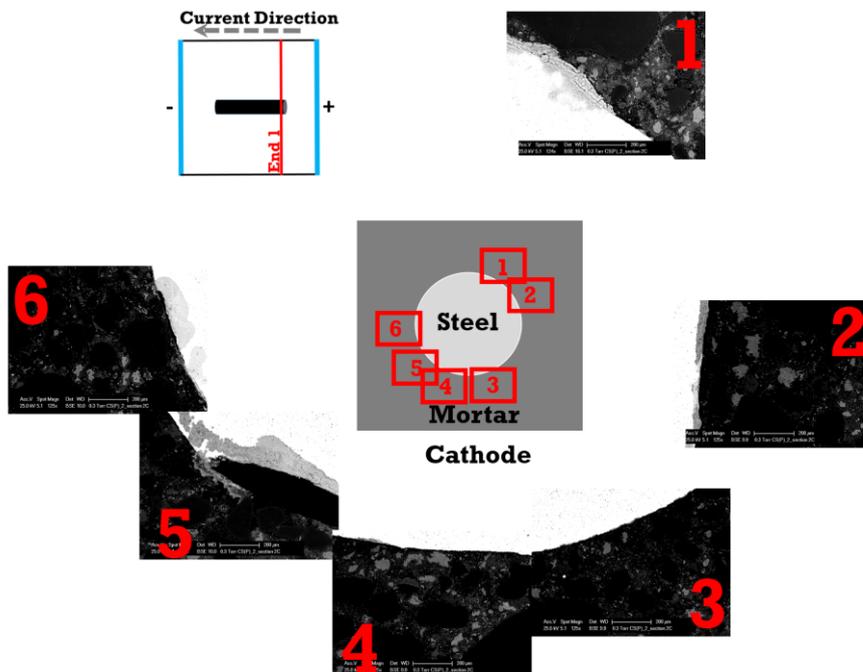
Figure 6.19: ESEM images (BSE mode) at different locations of the steel-mortar interface, the “End 1/Cathode” cross-section of CS(P)-2.

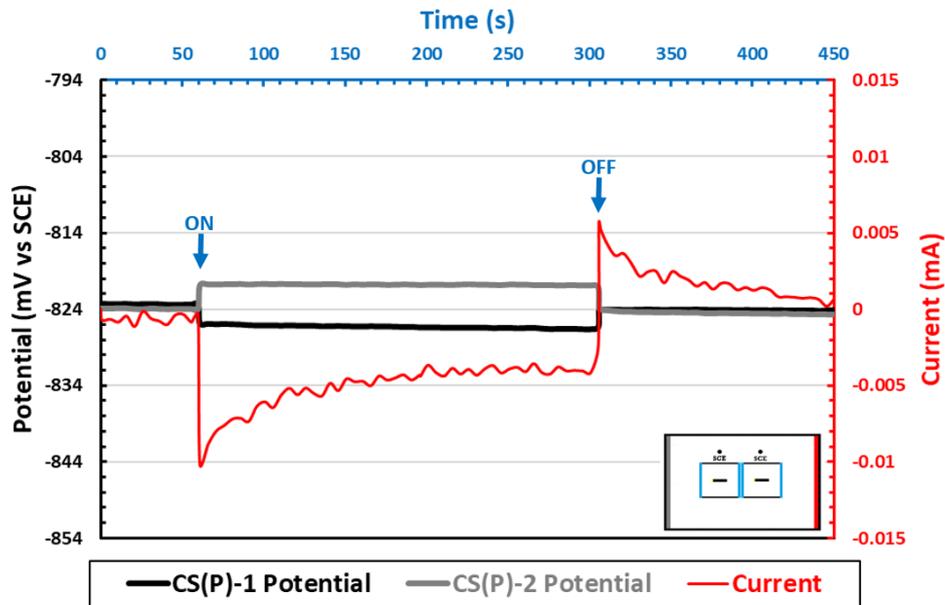
Figure 6.20: Response of CS(P)-1/CS(P)-2 (basic arrangement) undergoing simulated practical stray current electric field (6 mA) in Cl^- containing environment. (test arrangement in Figure 6.4, performed after 123d).

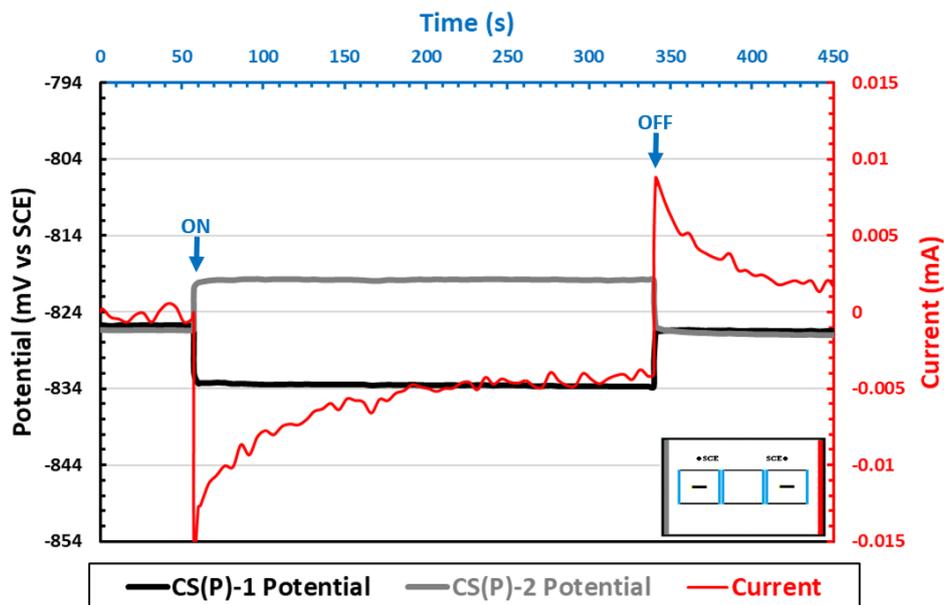
Figure 6.21: Response of CS(P)-1/CS(P)-2 (advanced arrangement, longer length of steel undergoing stray current) undergoing simulated practical stray current electric field (6 mA) in Cl^- containing environment. (test arrangement in Figure 6.5, performed after 123d).

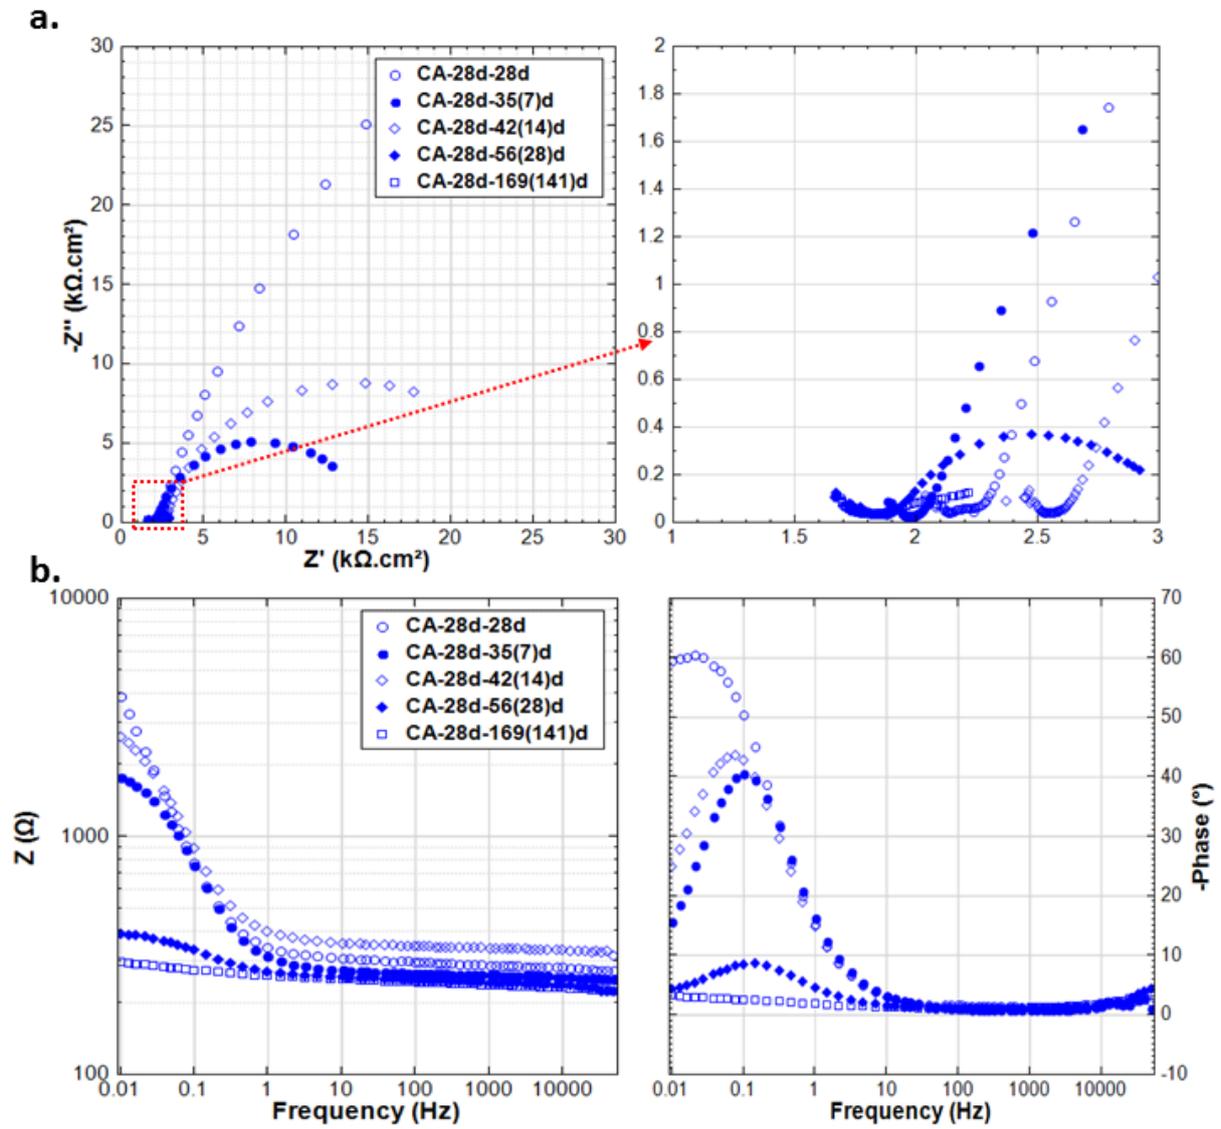
Figure A.12: EIS responses in a). Nyquist and b). Bode format, for specimen CA-28d at different intervals.

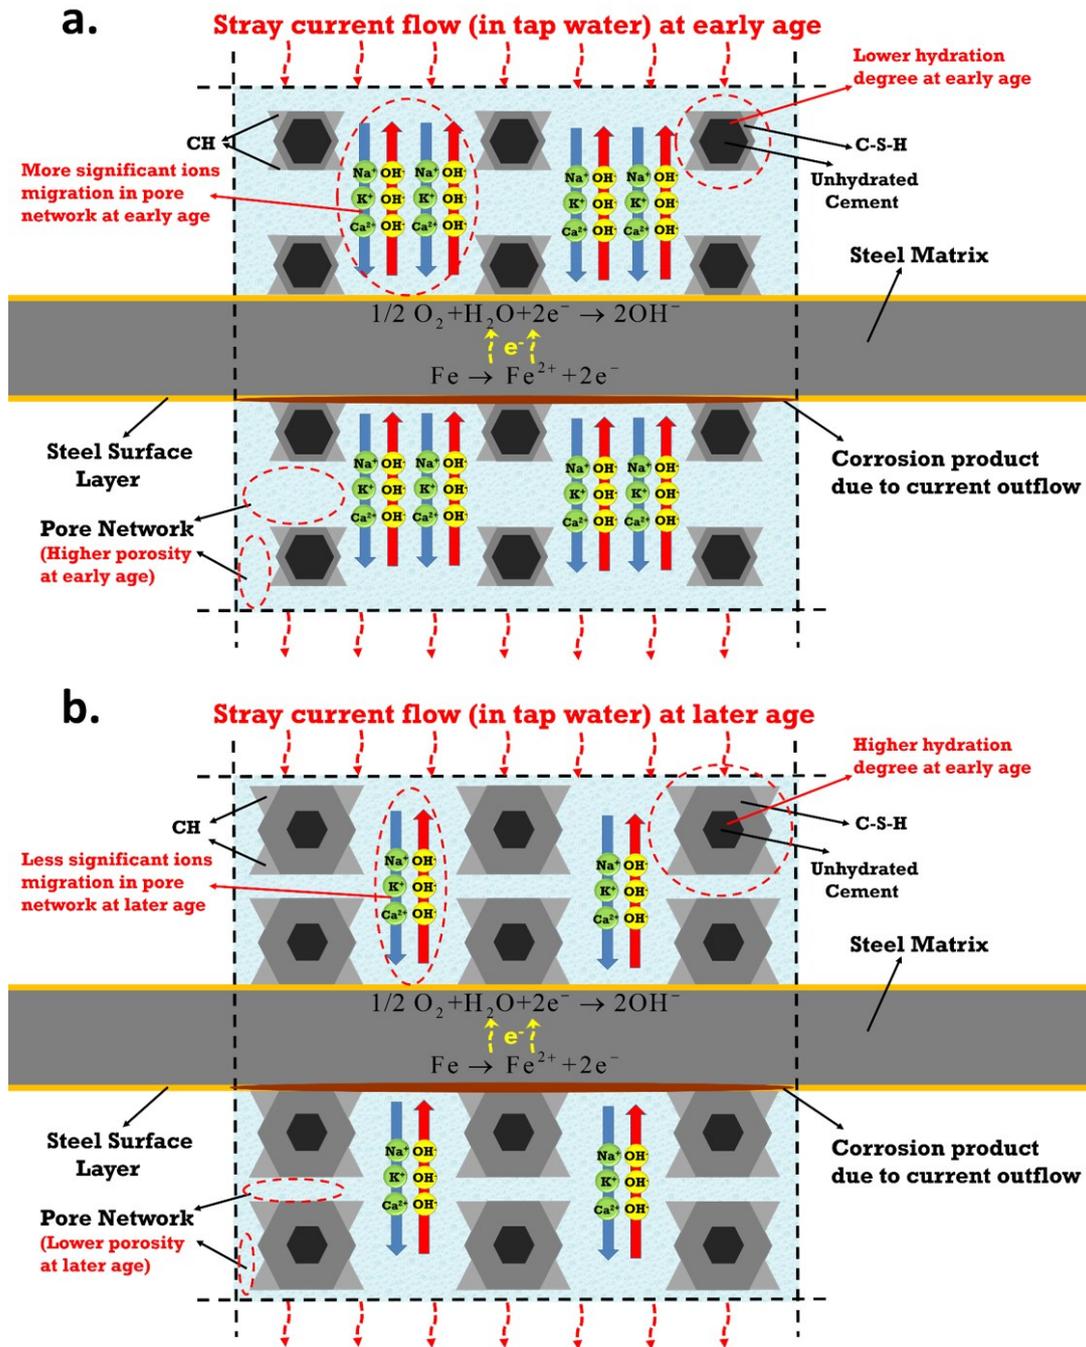
Figure B.1: Schematic of stray current effect in Cl-free matrix: a). Stray current supply started at early age (24h, when bulk matrix was still young); b). Stray current supply started at later age (28d, bulk matrix was already hardened).

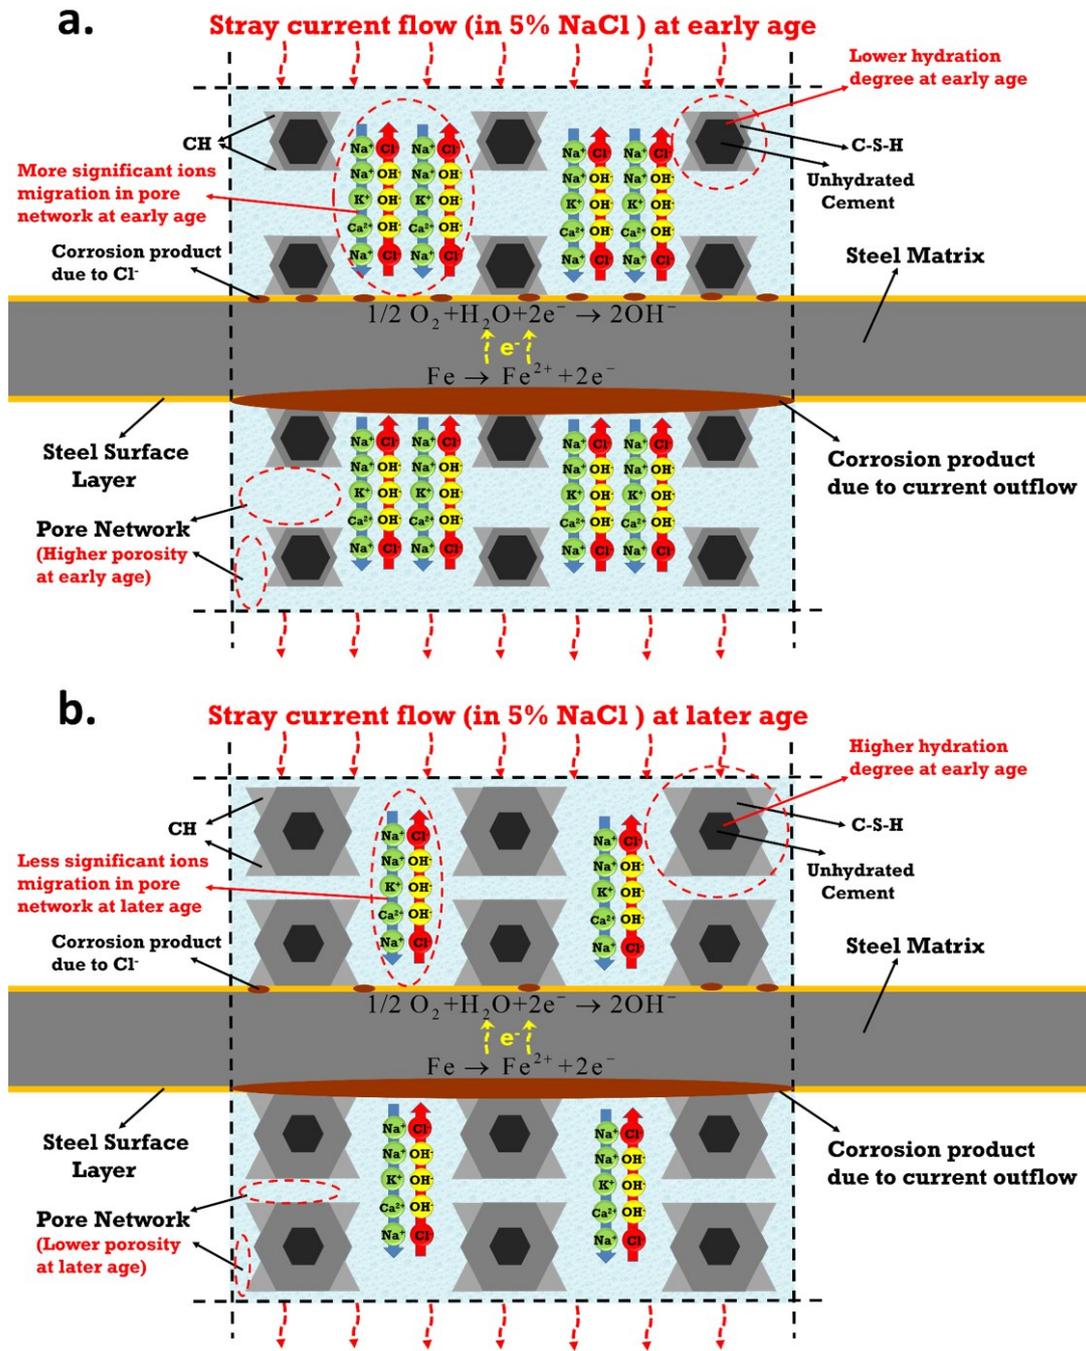
Figure B.2: Schematic of stray current effect in Cl-containing matrix: a). Stray current supply started at early age (24h, when bulk matrix was still young); b). Stray current supply started at later age (28d, bulk matrix was already hardened).
