Behavior of reinforcing steel and reinforced concrete undergoing stray current

Keywords: Stray current, anodic polarization, steel rebar, corrosion, mortar, interface, bond, electrochemical response, rebar orientation.

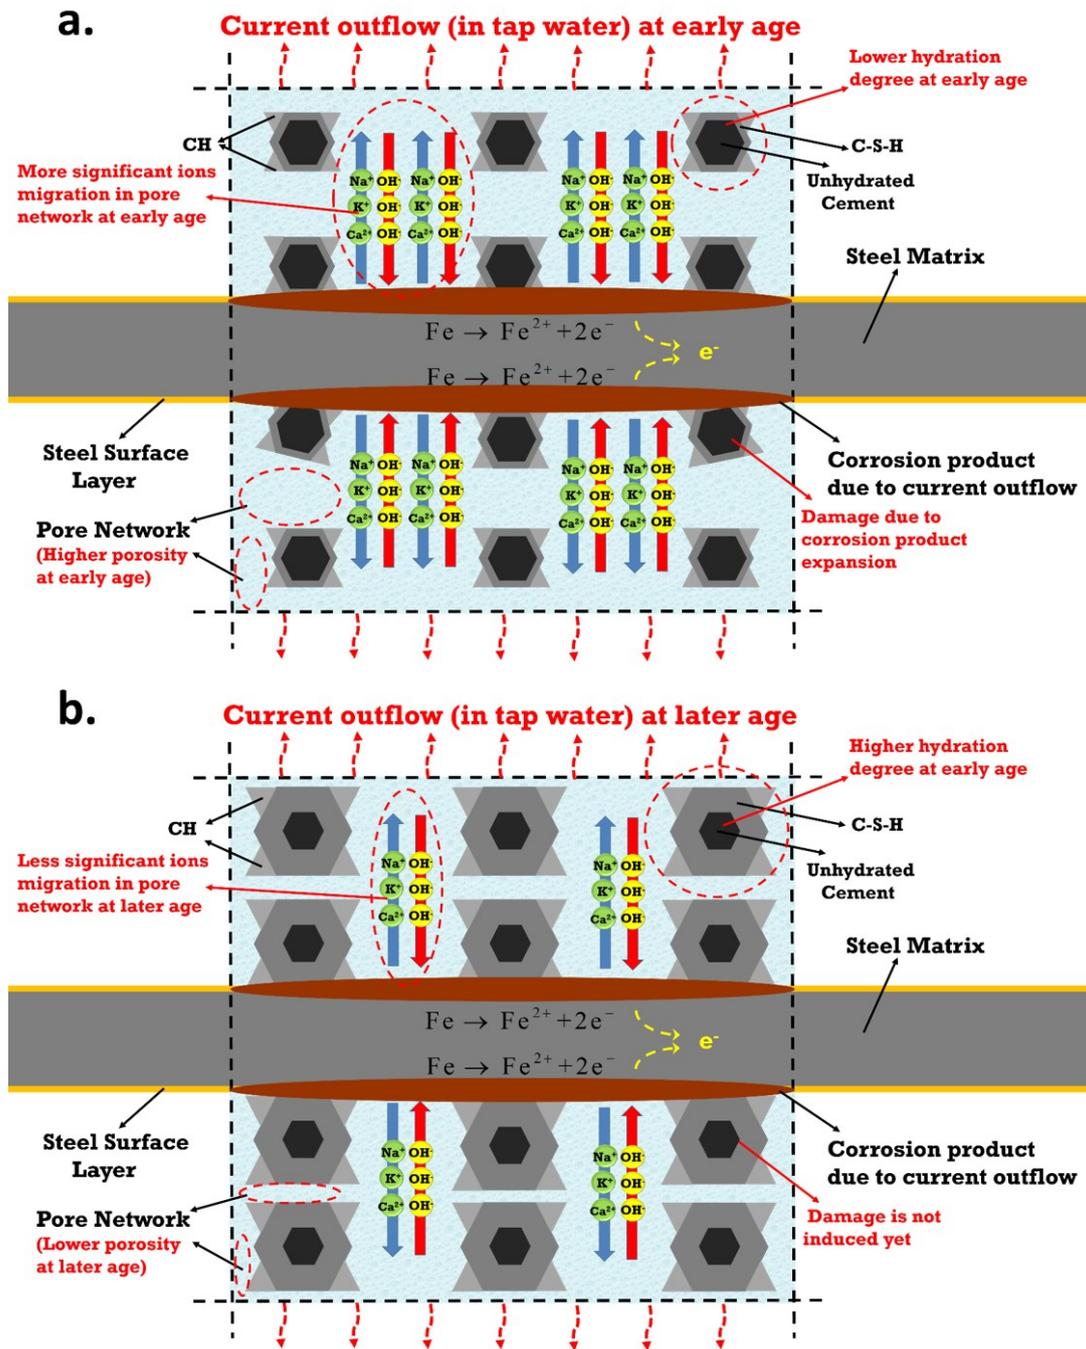
Figure B.3: Schematic of anodic polarization effect in Cl-free matrix: a). Anodic polarization started at early age (24h, when bulk matrix was still young); b). Anodic polarization started at later age (28d, bulk matrix was already hardened).

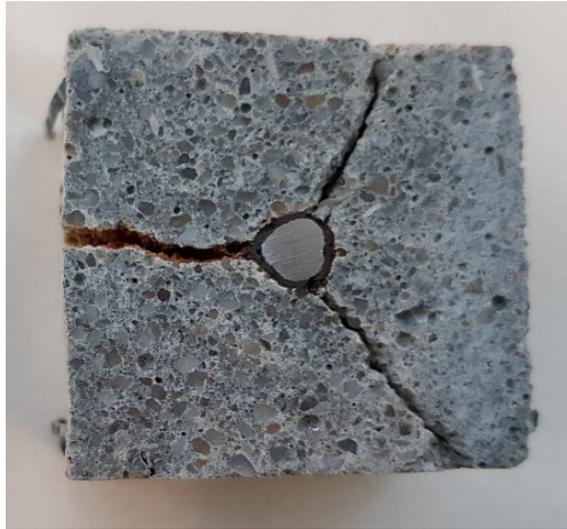
Figure B.5: Cross section of A-24h at the end of conditioning.

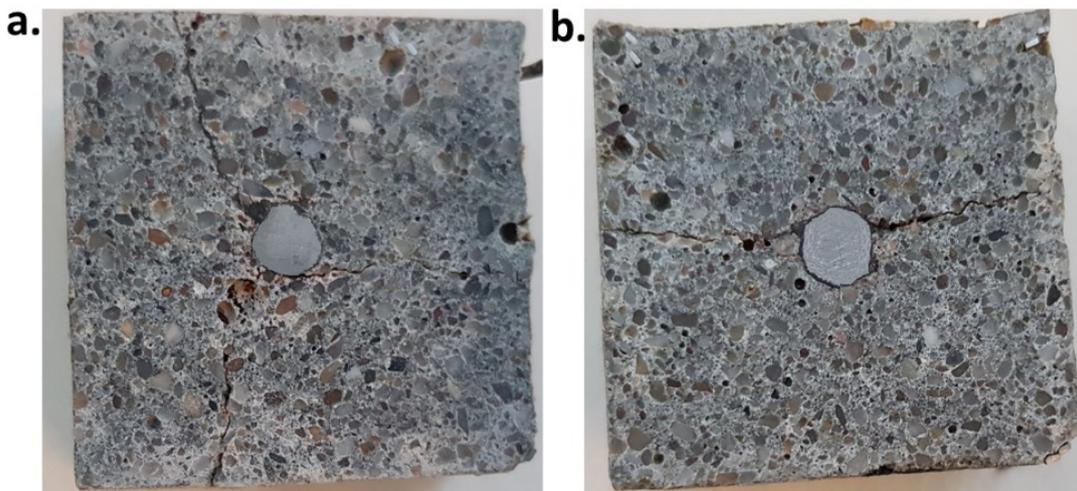
B.6a: Cross section of: CA-24h.

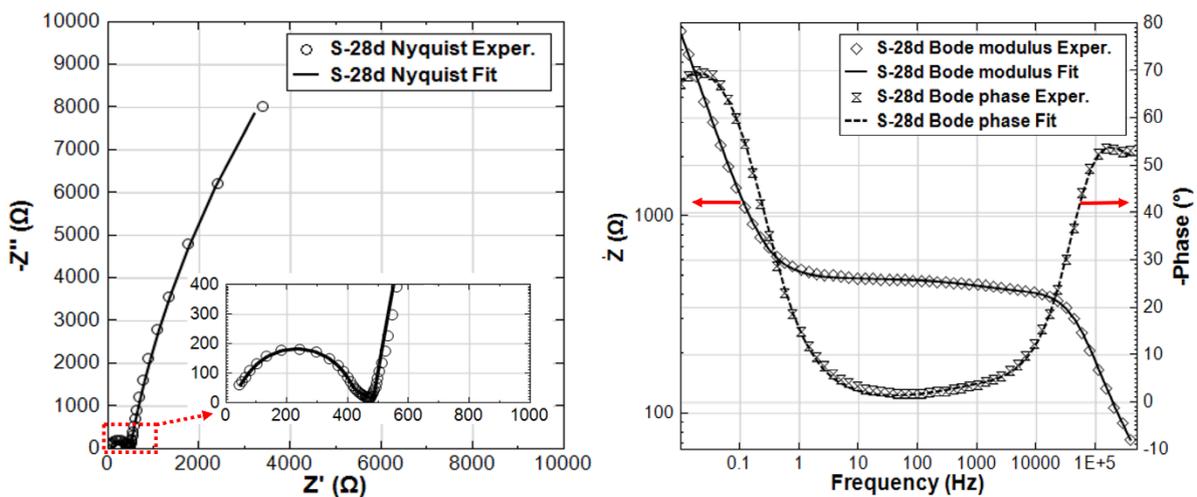
Figure C.1: EIS experimental response (symbols) and fit (lines) of S-28d at age of 490 days, in Nyquist and Bode format. (S-28d: 28d-cured in fog room, then treated by supplying stray current in water).
